Symposium:  
"Pile design and displacements"  
May 27th, 2016  
The Hague

# A case study of large screw pile groups behavior

Em. Prof. Dr.ir. William Van Impe  
Presented by ir Maurice Bottiau

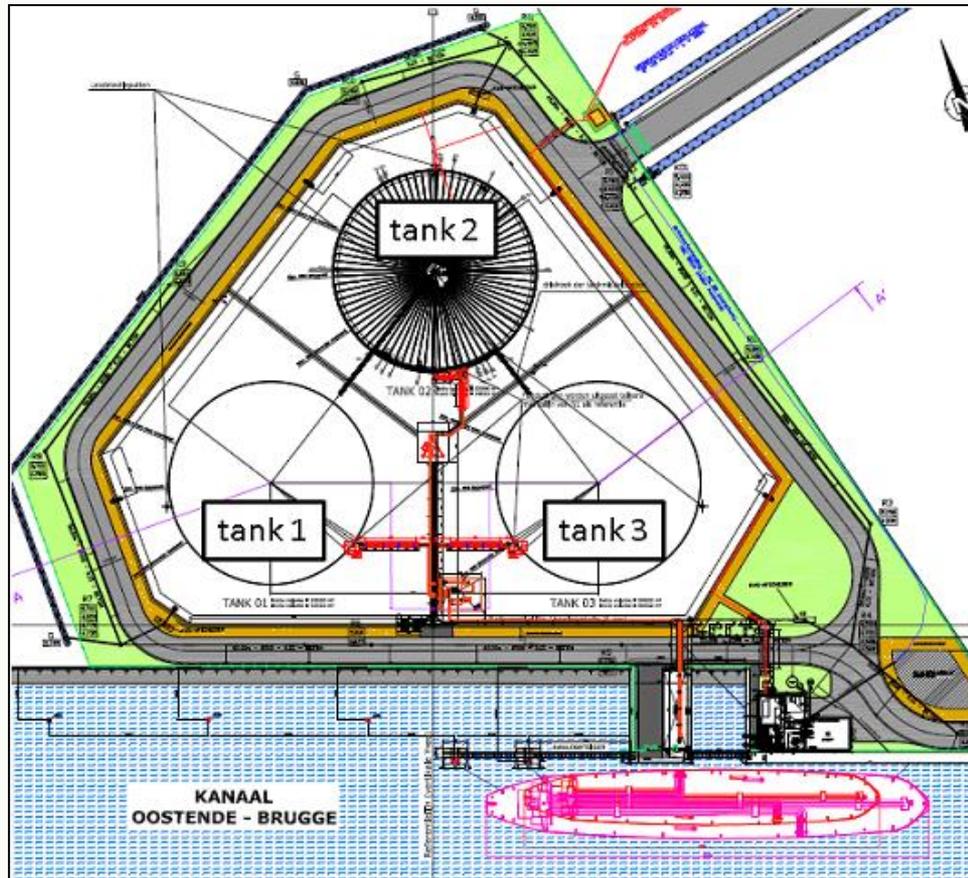
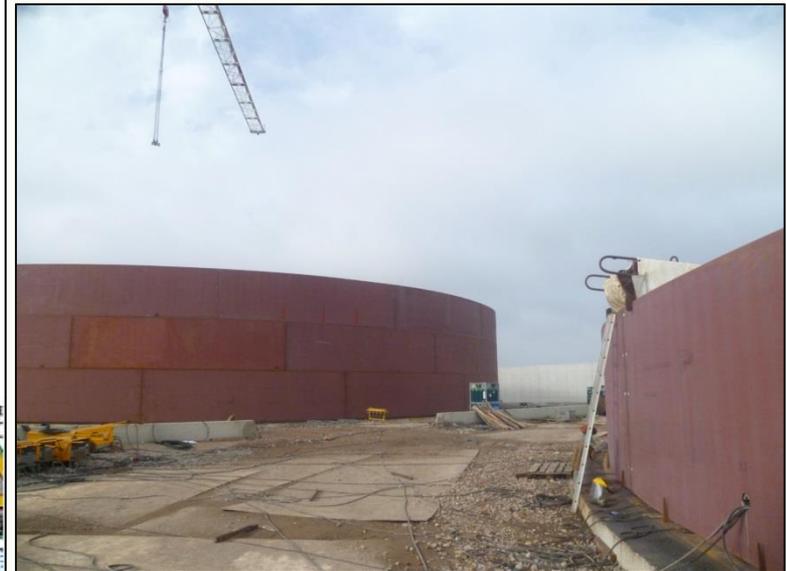
Fuel tanks under construction  
(Ostend, autumn 2012)

3 oil tanks (on very soft deposits), each of 33000 m<sup>3</sup>: steel structures of D=48 m and H=19 m, positioned in a triangular shape at a center to center inter-distance of about 65 m

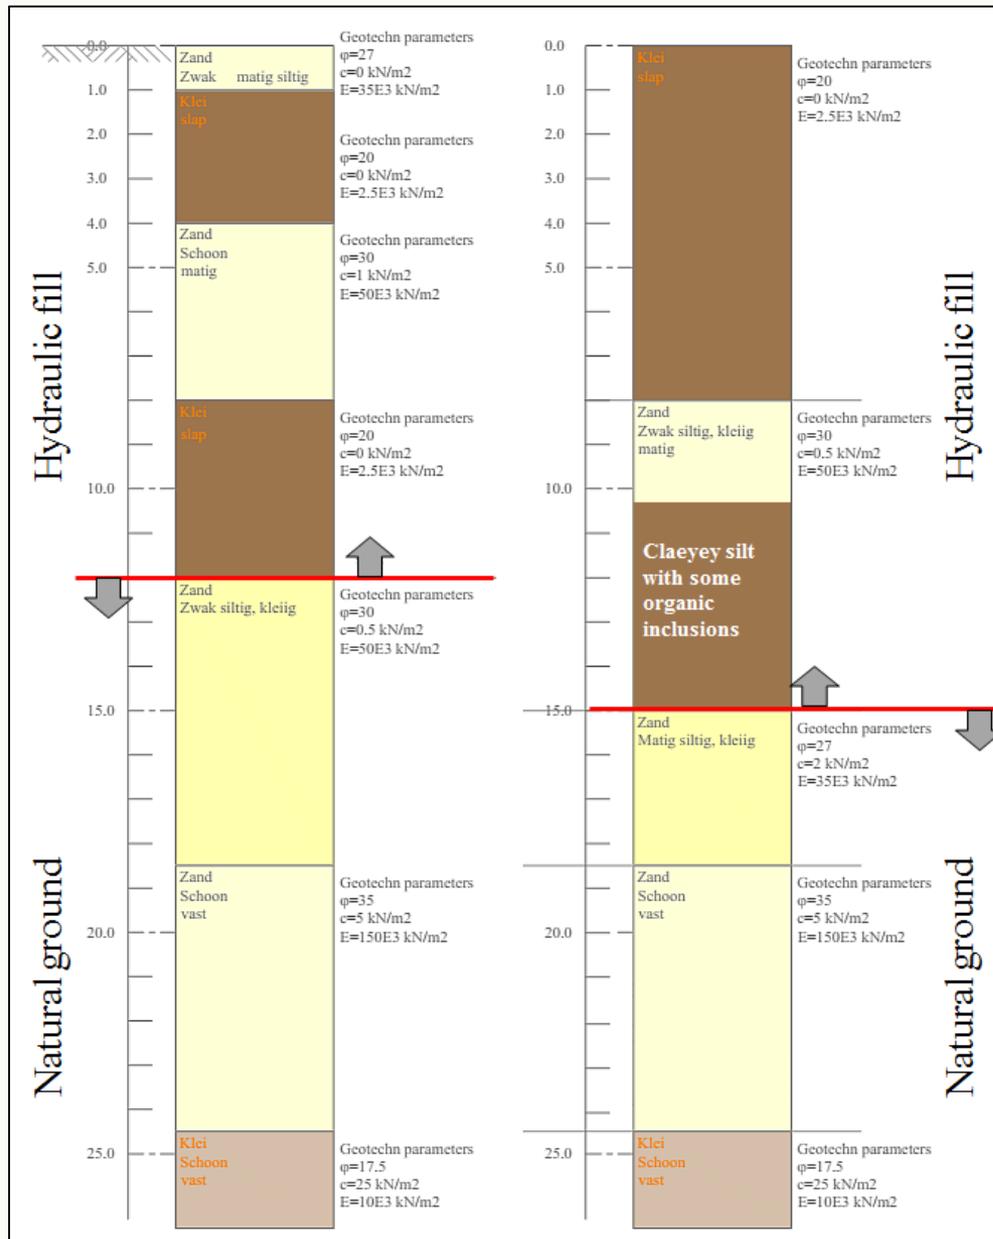
General pattern of the soil layering from large diameter borings and undisturbed sampling.

Until depths of about 15-17m; large differences, even at less than 50m interdistance, actually resulting from the 'man made' deposited layers over the last 25 years in this harbour/polder conditions

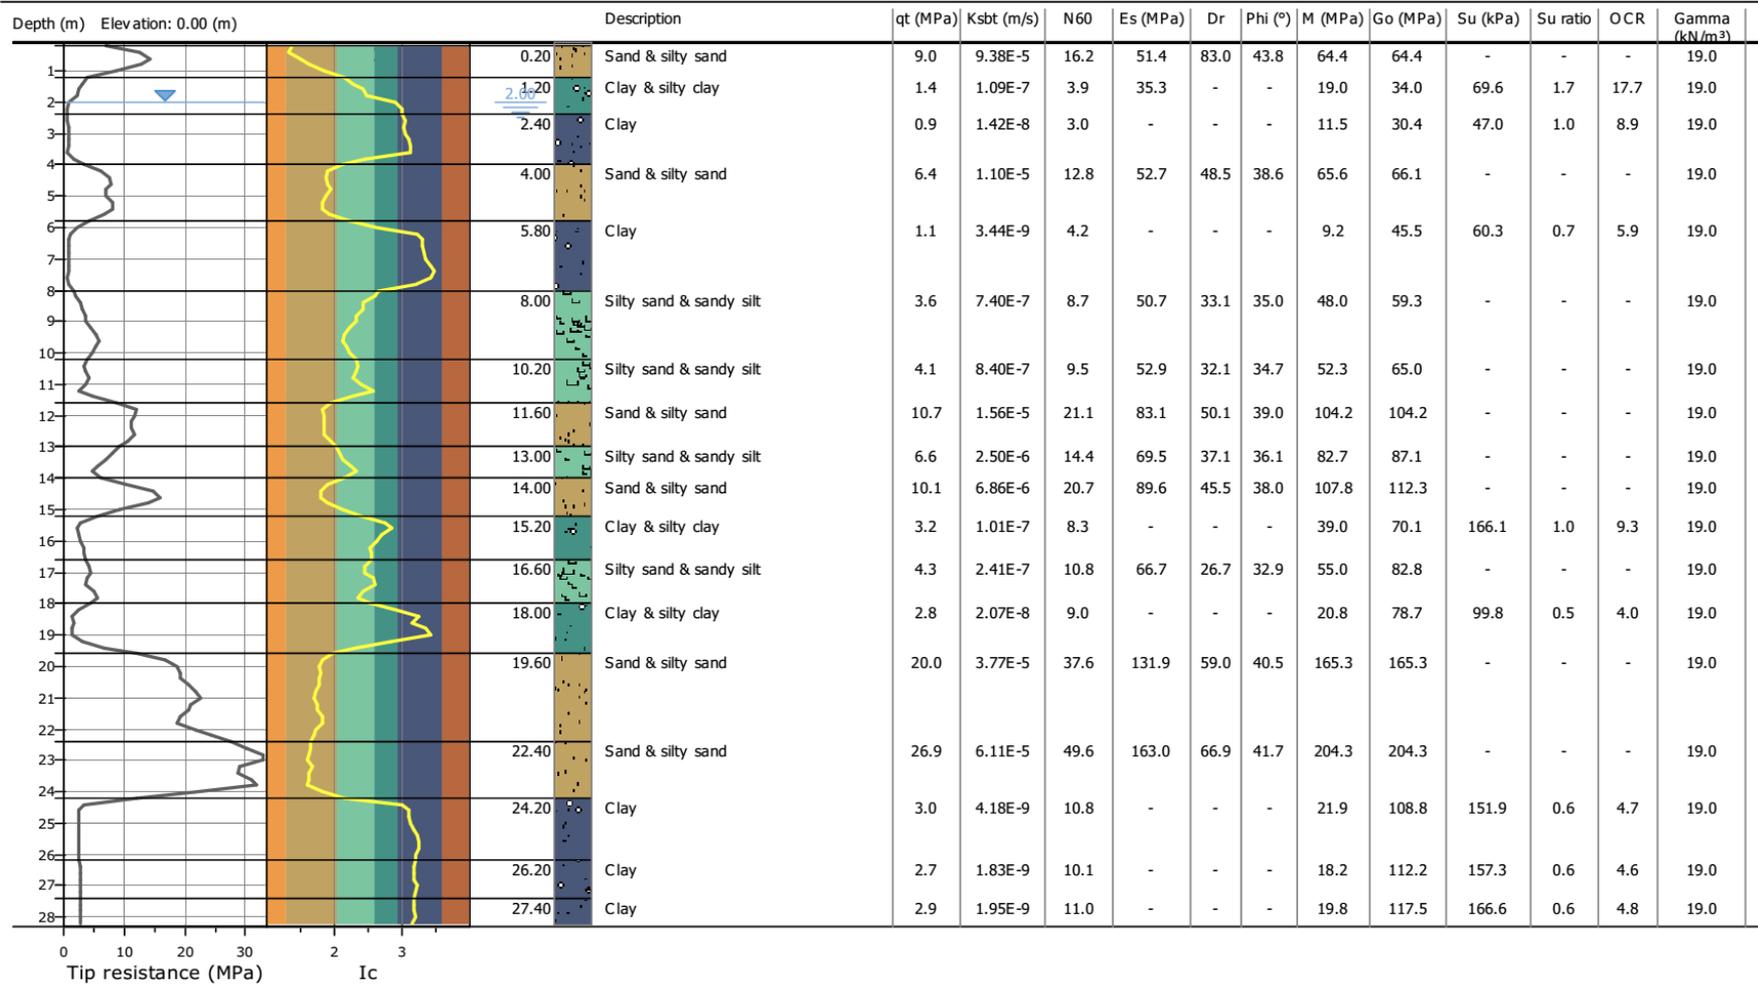
CPT: CPT-04 - Total depth: 28.20 (m)

Example of soil data estimation from CPT interpretation (Robertson 2010)

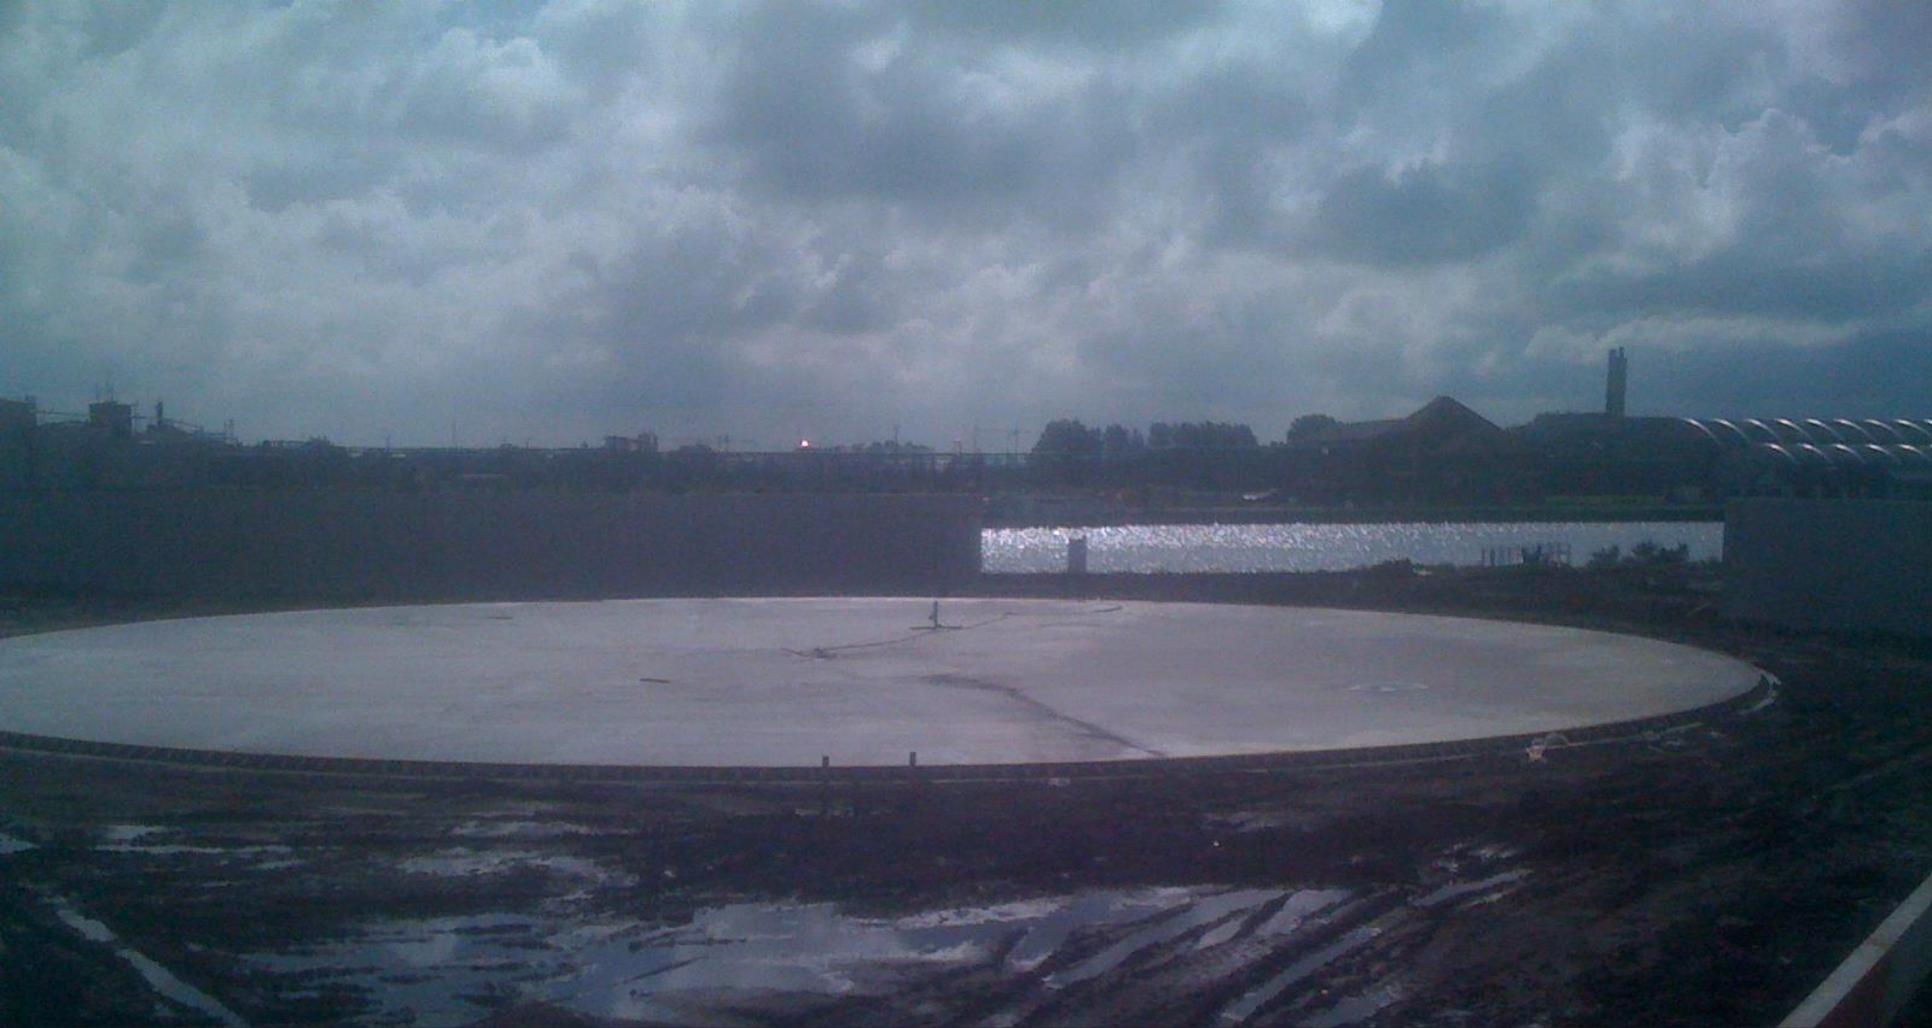
- 1800 small diameter mortar piles (vibratory installation) were supposed to handle the load bearing and deformation capacity of each of the tanks.
- The small diameter HSP piles (diam 180mm), were positioned in a grid of 1.1 x 1.1 m<sup>2</sup>; covered by a thin concrete sheet – 180 mm – as foundation slab.
- The small slender HSP piles were basically supposed in the design to work mainly as real deep foundation – tip load carrying piles

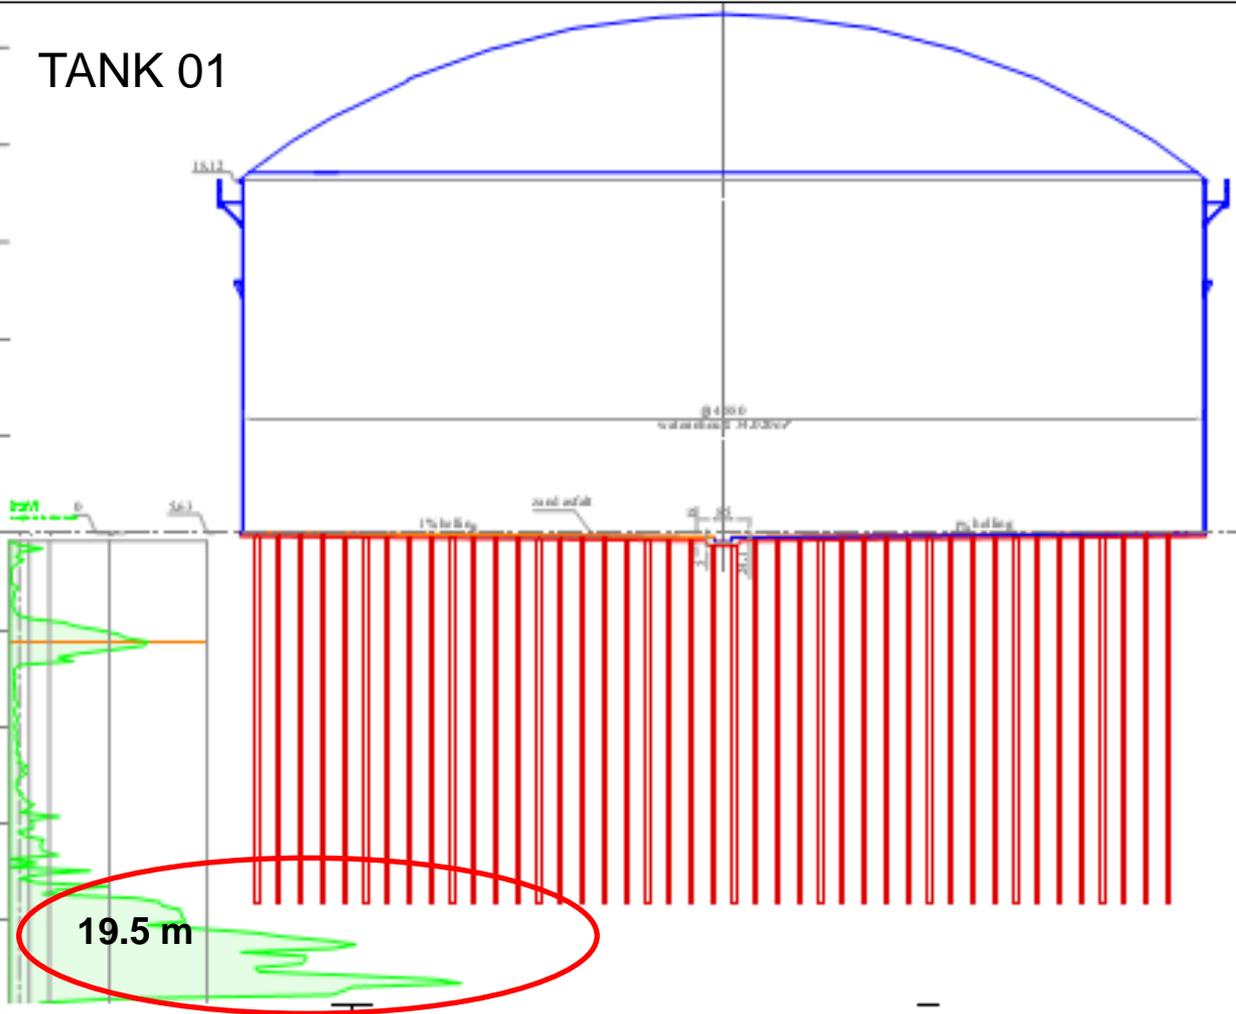
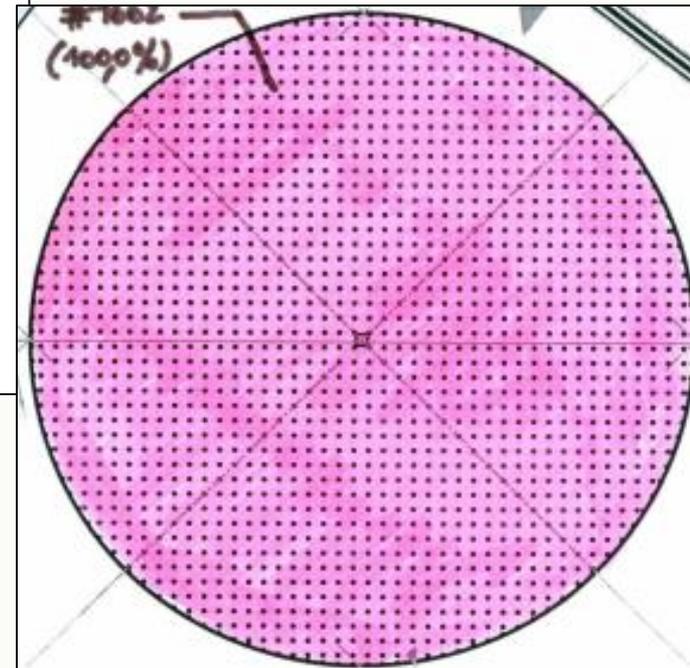
# TANK 01

In total : ~1800 small diameter (180 mm) piles, each with ~230 kN of load

This suggests a foundation concept of the tank **on end bearing (root)piles;**  
**however with a very thin slab on top;**  
**???group effect???**

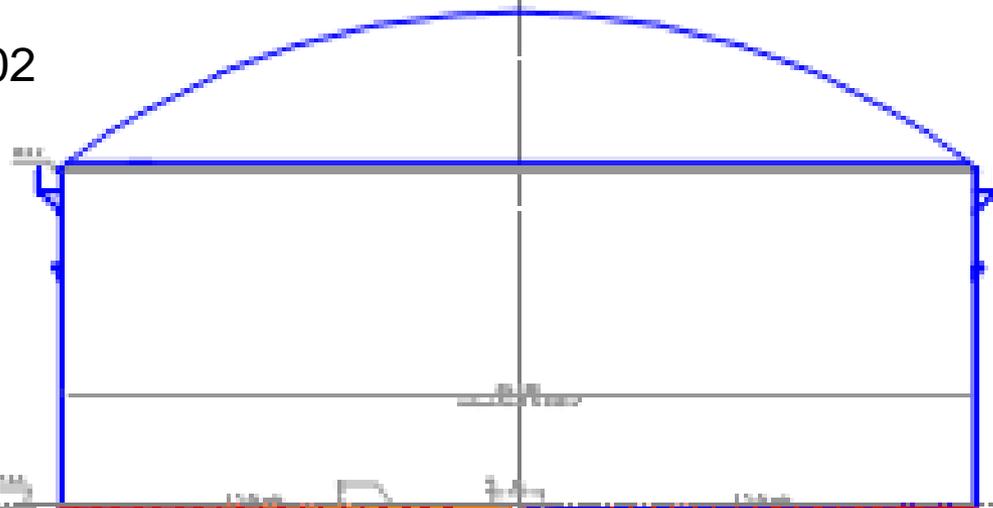
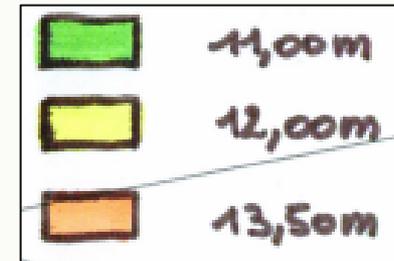
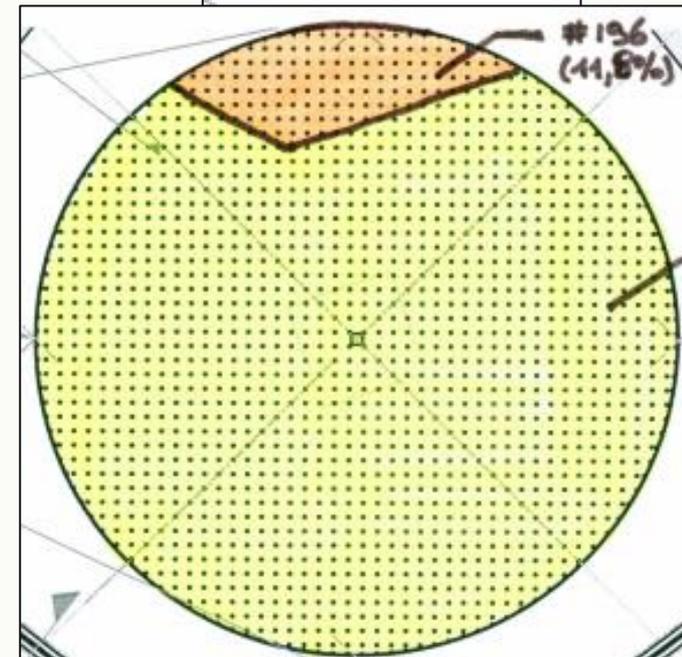
TANK 02

12m

Not deep enough  
considering the very large  
pile group and the CPT  
variations

This suggests an equivalent raft foundation of the tank **on (for almost the total pile amount) short (root) piles ???acting as settlement reducers???**;

incompatible with the design of end bearing piles with a very thin slab on top

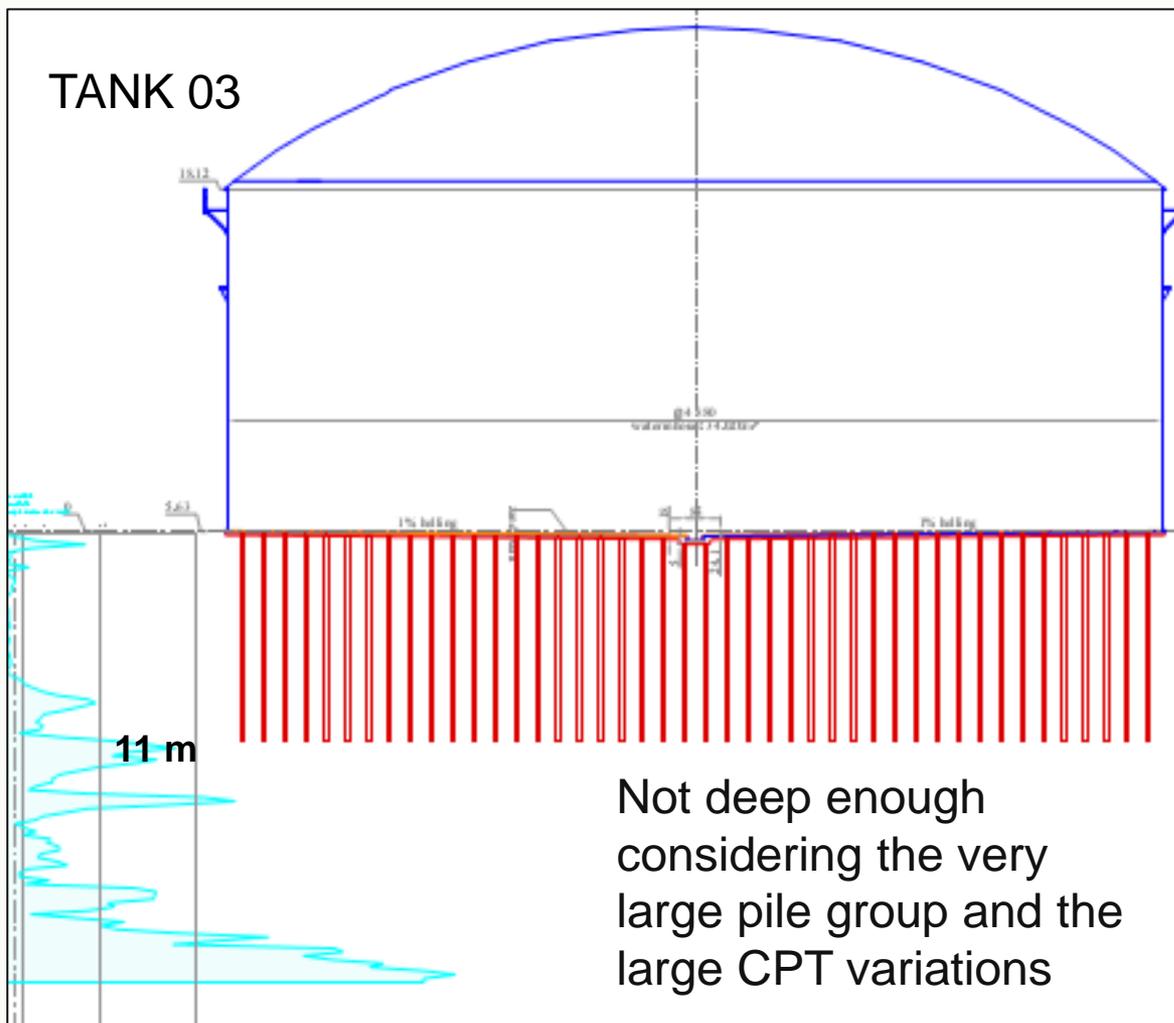
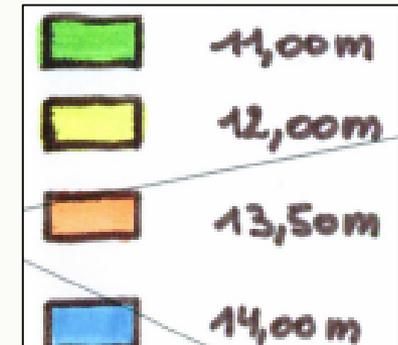
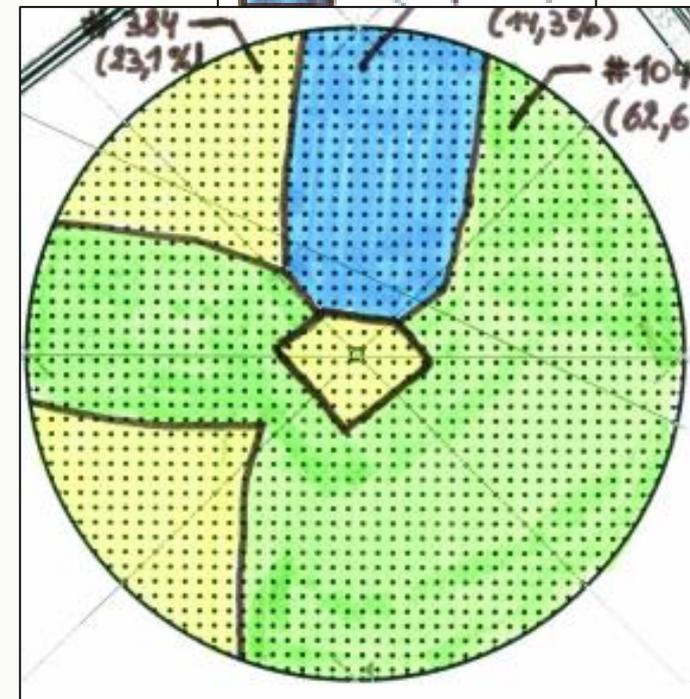
## TANK 03

In total : ~1800 small diameter (180 mm) piles, each with ~230 kN of load

This suggests an equivalent raft foundation of the tank on **very short (~root) piles ? short end bearing with sub-groups of piles at various depths?**

Incompatible with the design: an end bearing pile group concept

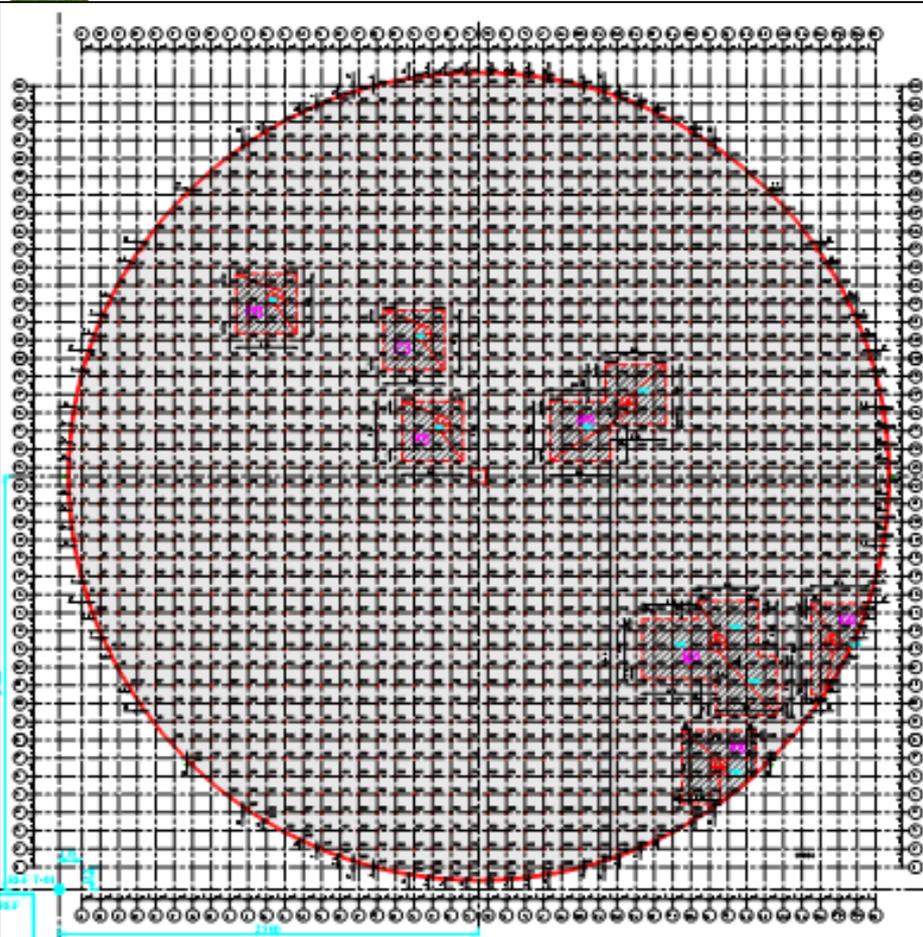
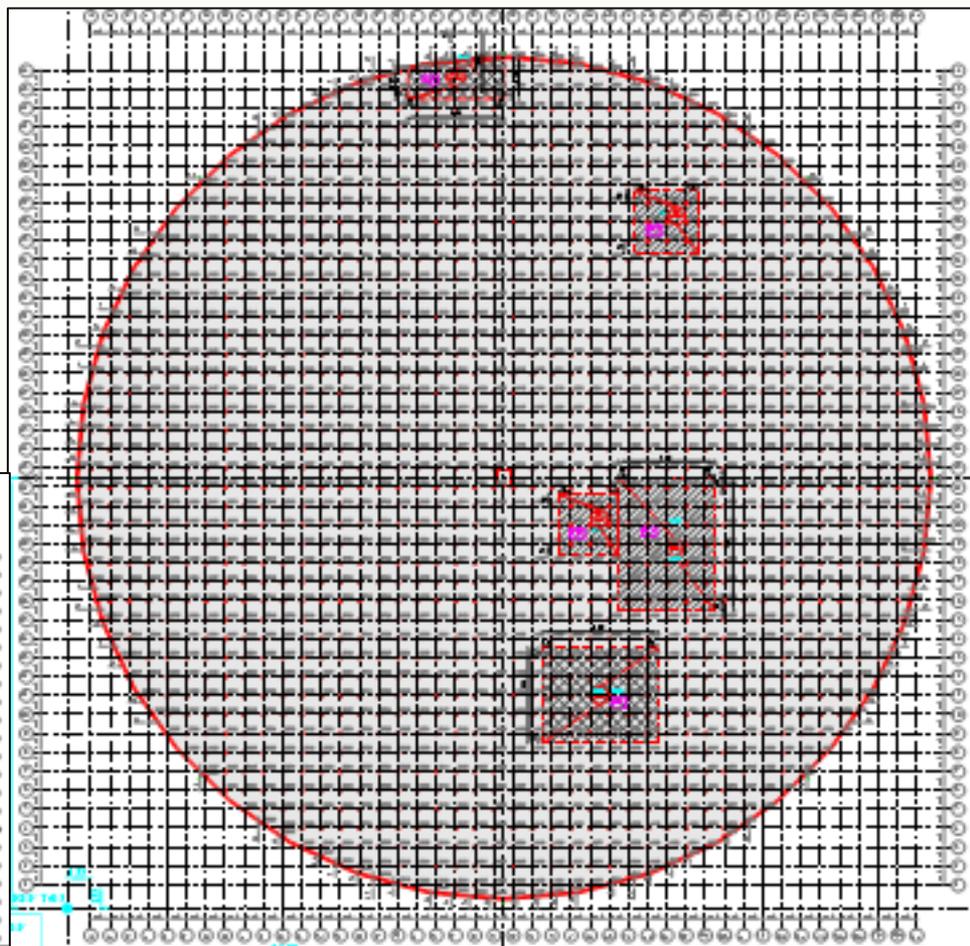
Tank 01 : small-diam pile deficiencies  
(upper ~2m)

It concerns mainly the **necking/interruption of the pile shaft** ( ideally here only 180mm ), as a result of the often high speed pile casing withdrawal and casting combined with the relatively high W/C ratio of the mortar.

**Deficiencies were observed near the pile top but one could expect that lower located deficiencies would appear and cannot be detected nor repaired.**

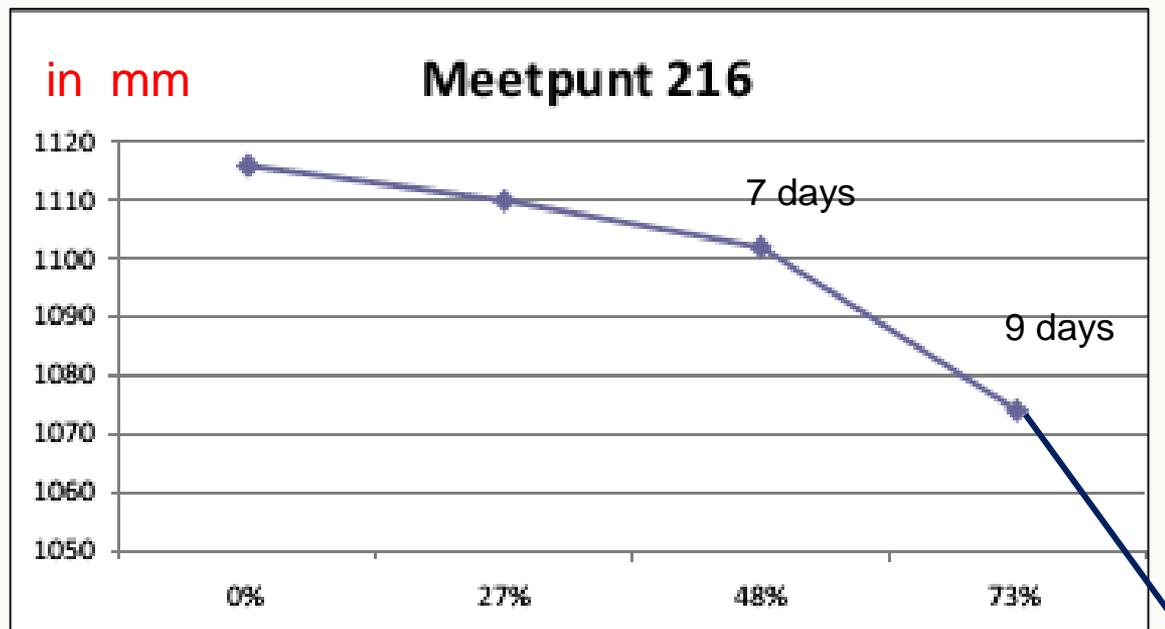
Differential settlements are measured at several points along the perimeter of tank 2 during the water test

Increasing deformation gradient starting at ~50% loading,

but fully uncontrolled increase of the settlements – initiating 2 to 12 days after reaching the 92% level of loading ;

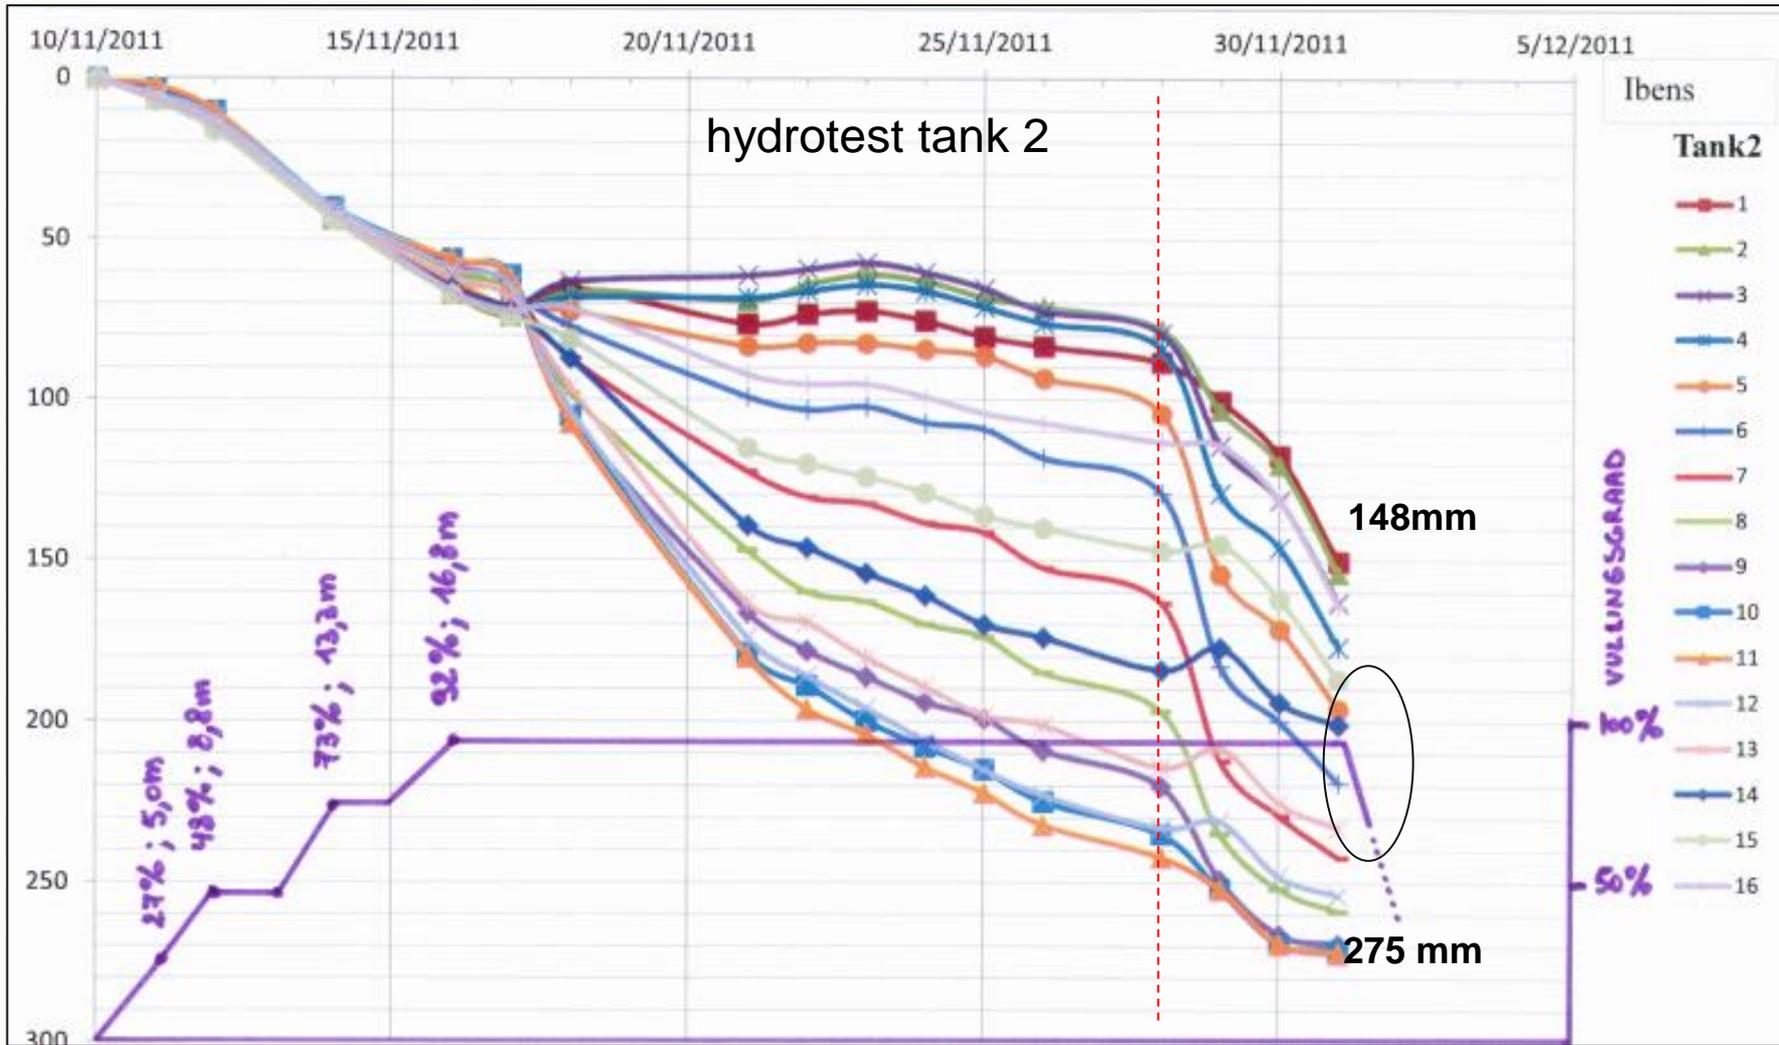
Increase in time of the settlements along the perimeter of tank 02, finally reaching the 92% loading level.

Rapid unloading required because of uncontrollable differential settlements at various perimeter points initiating 2 to 12 days after the 92% loading level.

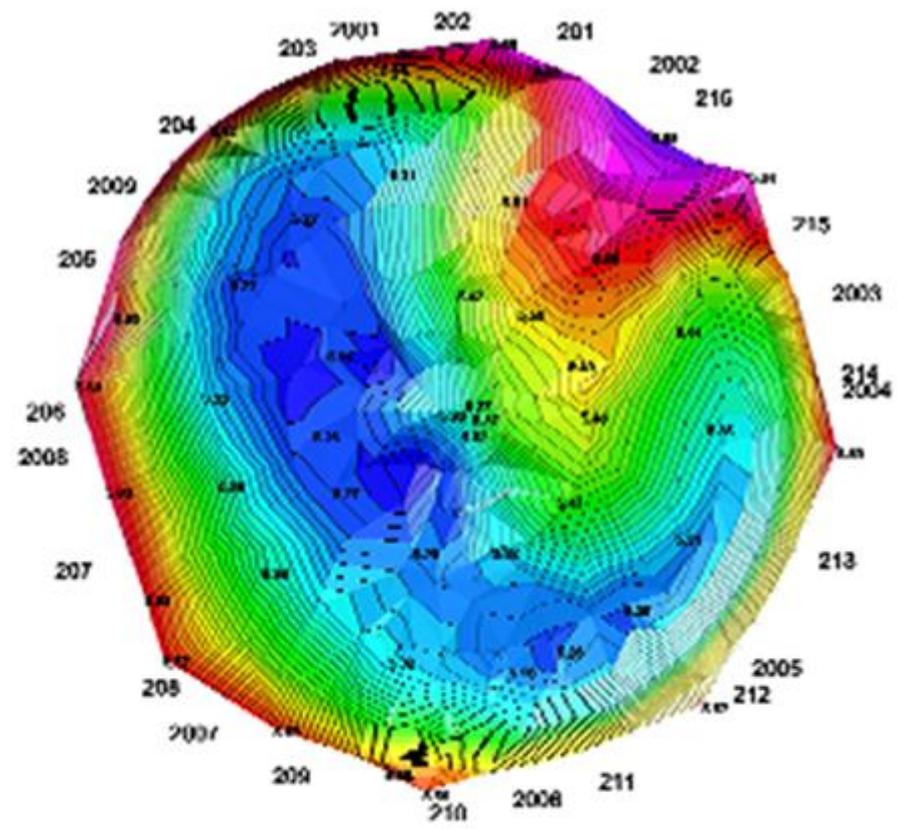
Oostende  
Bodem T2

3D zicht  
bovenaan

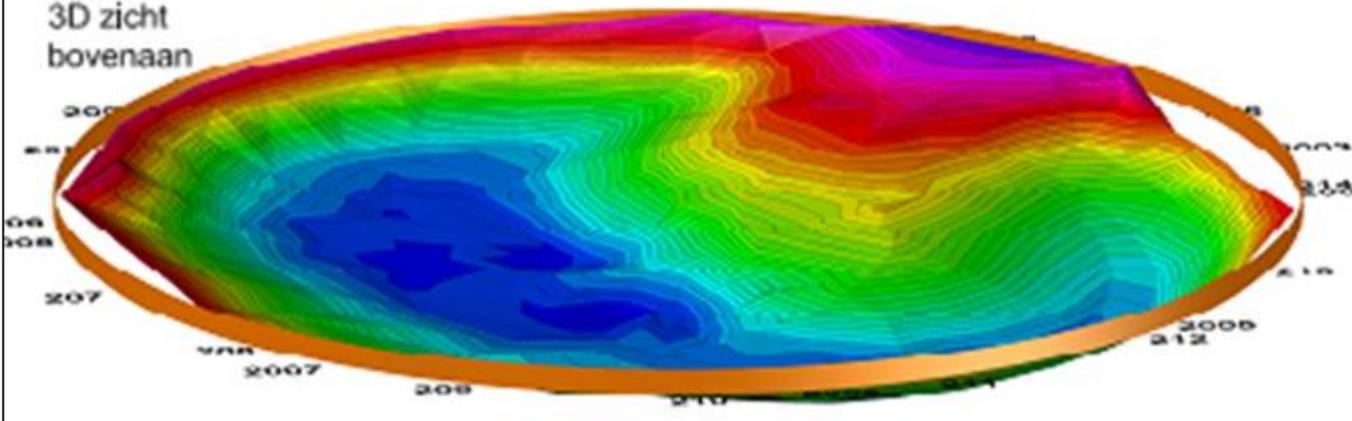
Shape of the deformed bottom plate of tank 02 after loading test

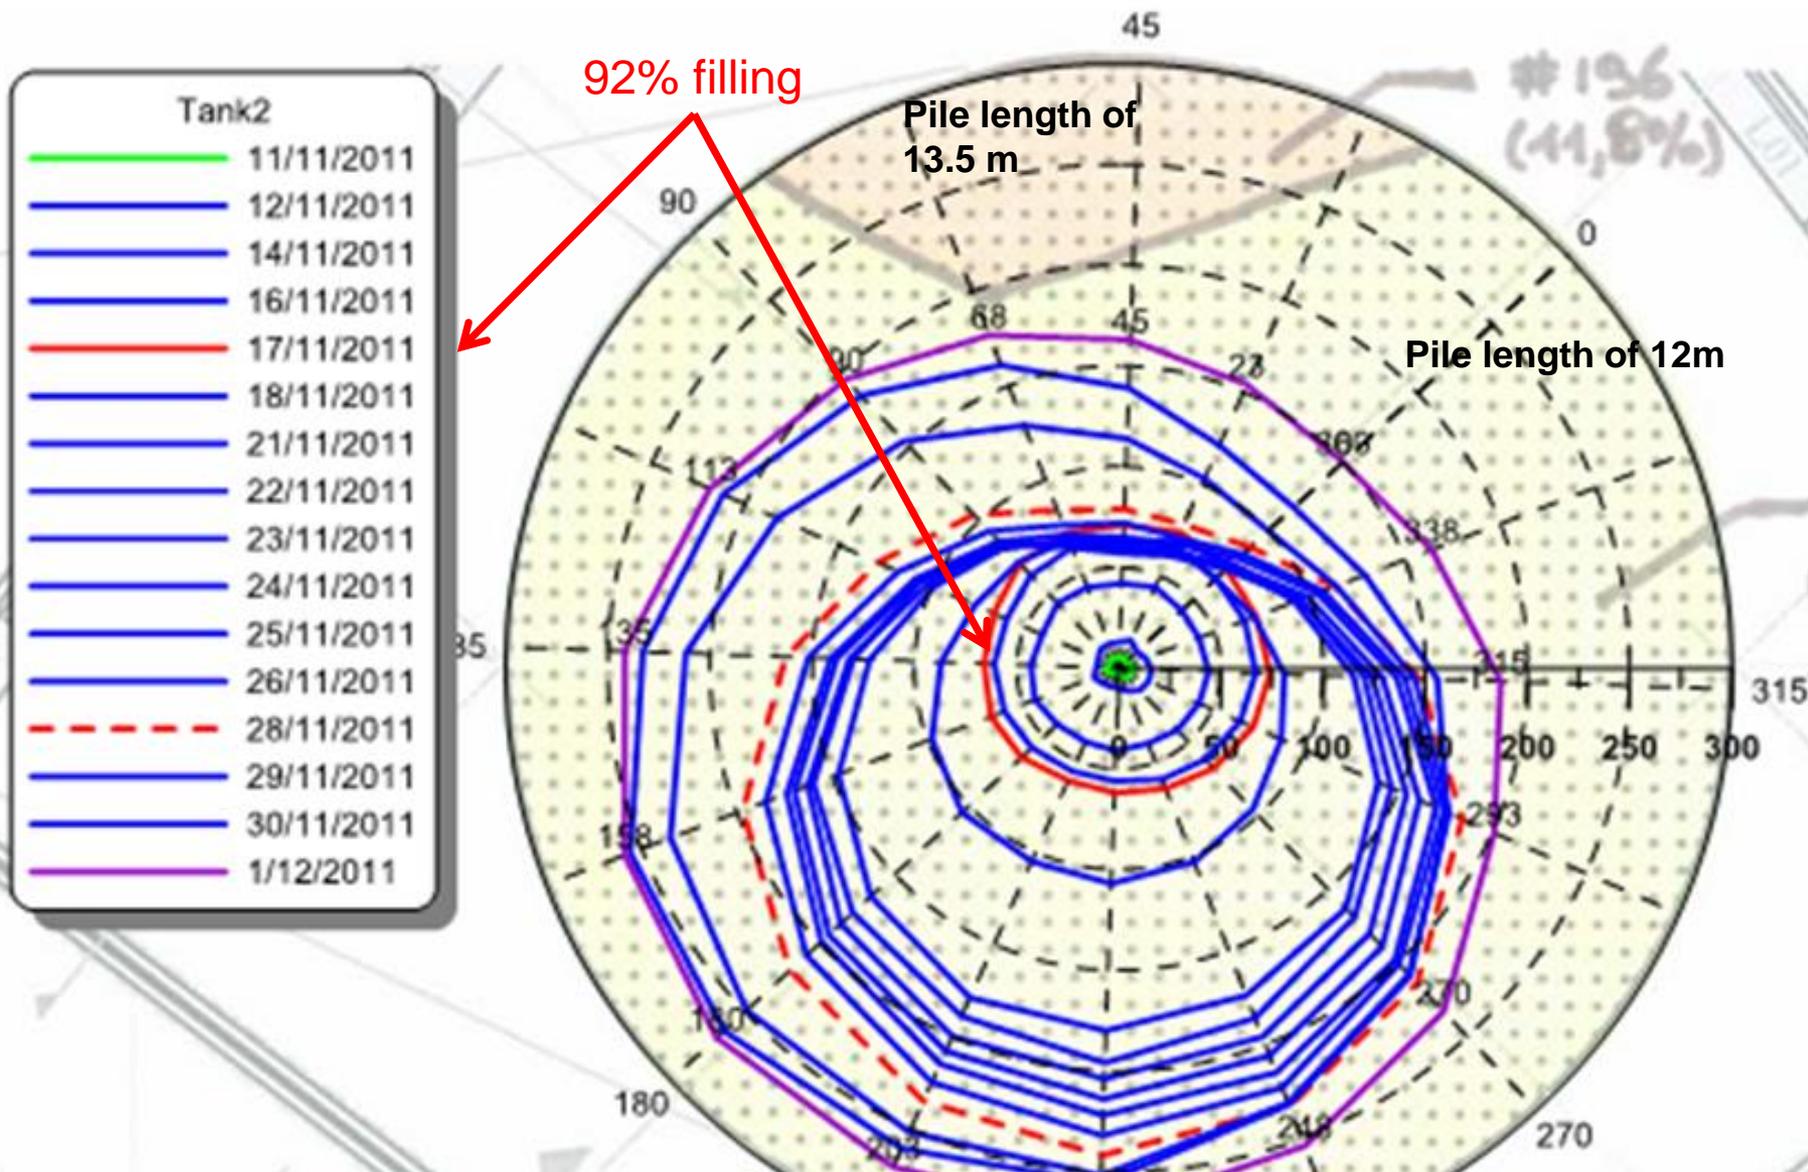
Measured increase of the differential settlements along the perimeter of the tank 02 during the hydro test and its evolution until 01/12/2011
