Symposium:  
"Pile design and displacements"  
May 27th, 2016  
The Hague

# A case study of large screw pile groups behavior

Em. Prof. Dr.ir. William Van Impe  
Presented by ir Maurice Bottiau

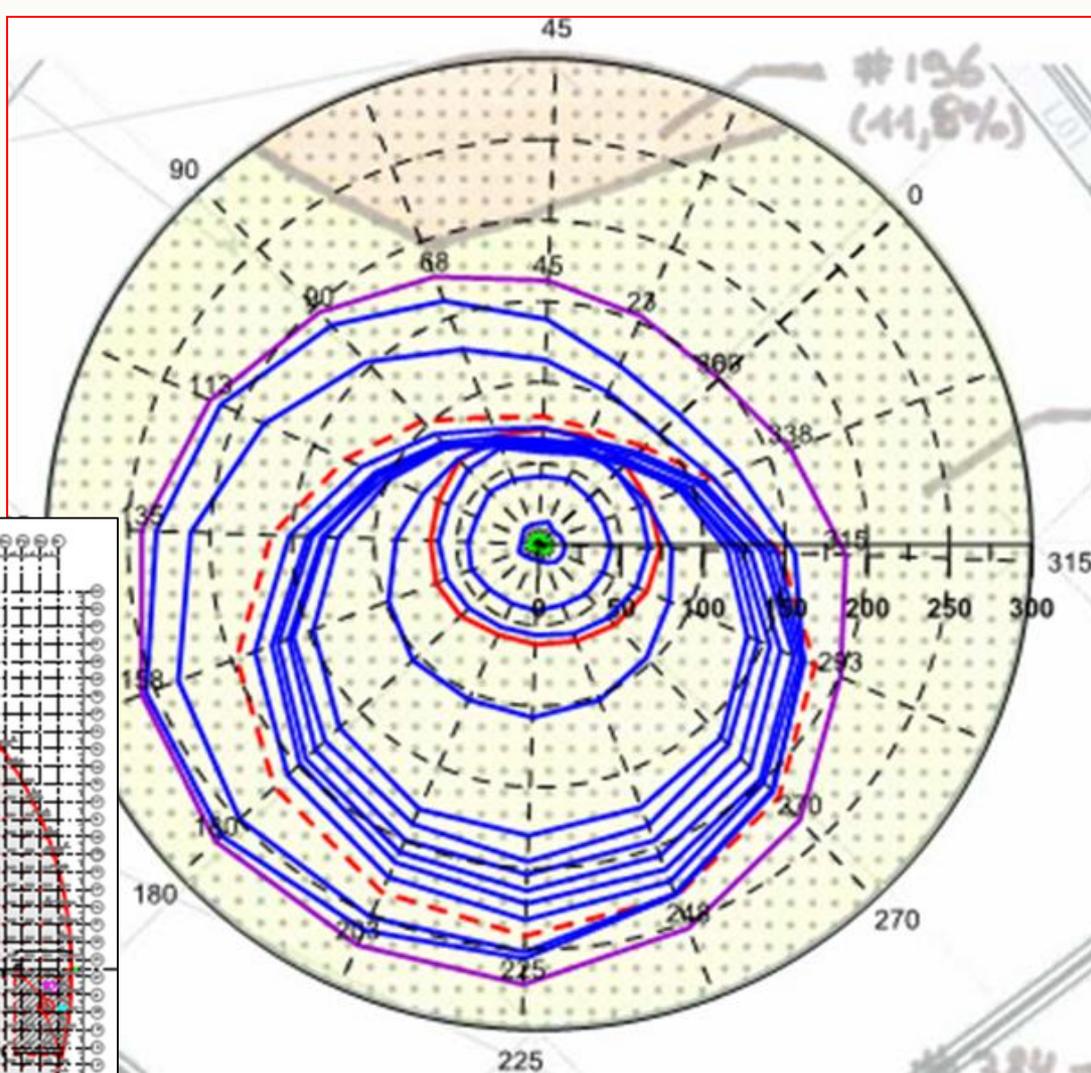
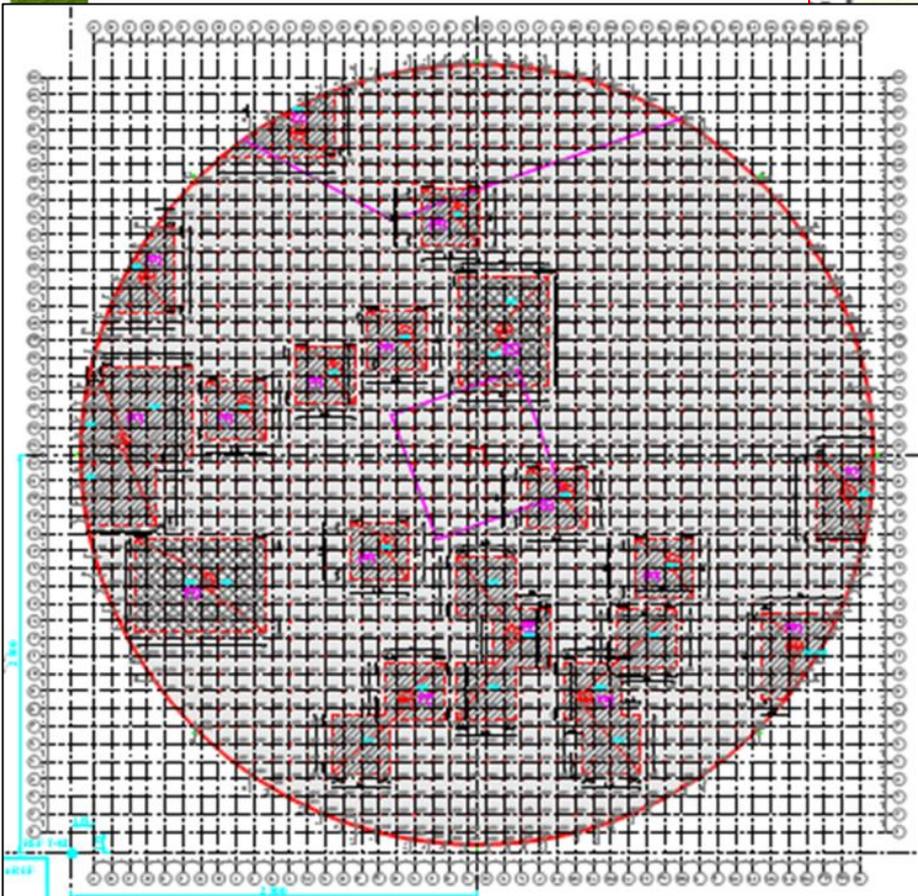
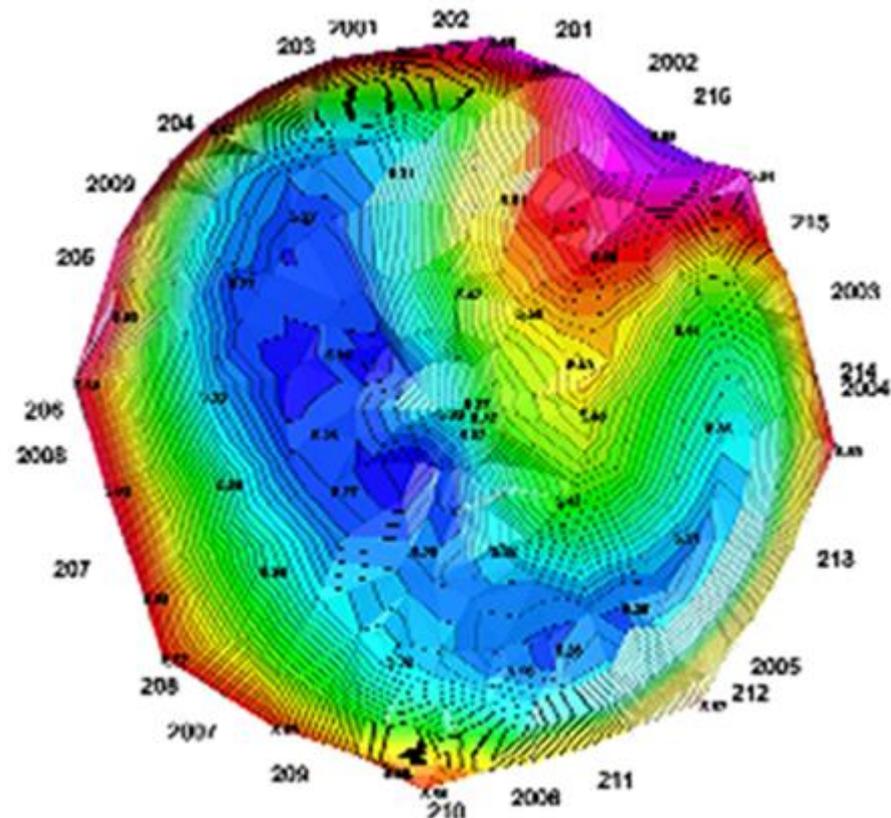
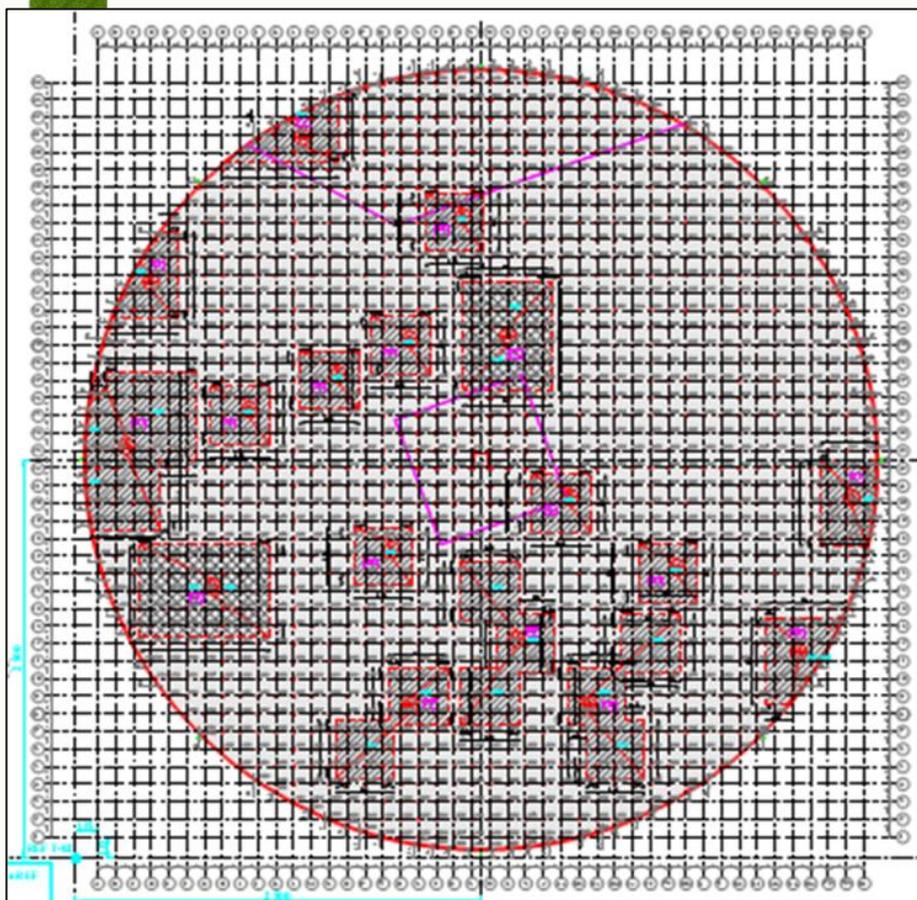
Differential settlements due to local « failure conditions » is obviously asymmetrically distributed, however not following fully the top deficiencies (also deeper defic. are influencing)

The supporting small diameter piles, being of questionable quality in many zones, « collapsed » one after another, from 17/11/2011 on, creating a **domino effect on the overall capacity failure** – with some squeezing failure of the soft soil under the tank bottom (cfr the upheave in some zones around).

1. **Incorrect pile length** mostly under tanks 2 and 3, even with best possible pile type
2. **No group effects possible** ( pile diameter too small, inter-distance too large, pile too slender, pile raft too thin)
3. **Different pile lengths under one and the same tank**
4. **End bearing pile-concept** of foundation engineering actually **impossible with this pile type**; such piles can only serve as ground reinforcement in another design type
5. **Unadapted foundation concept**

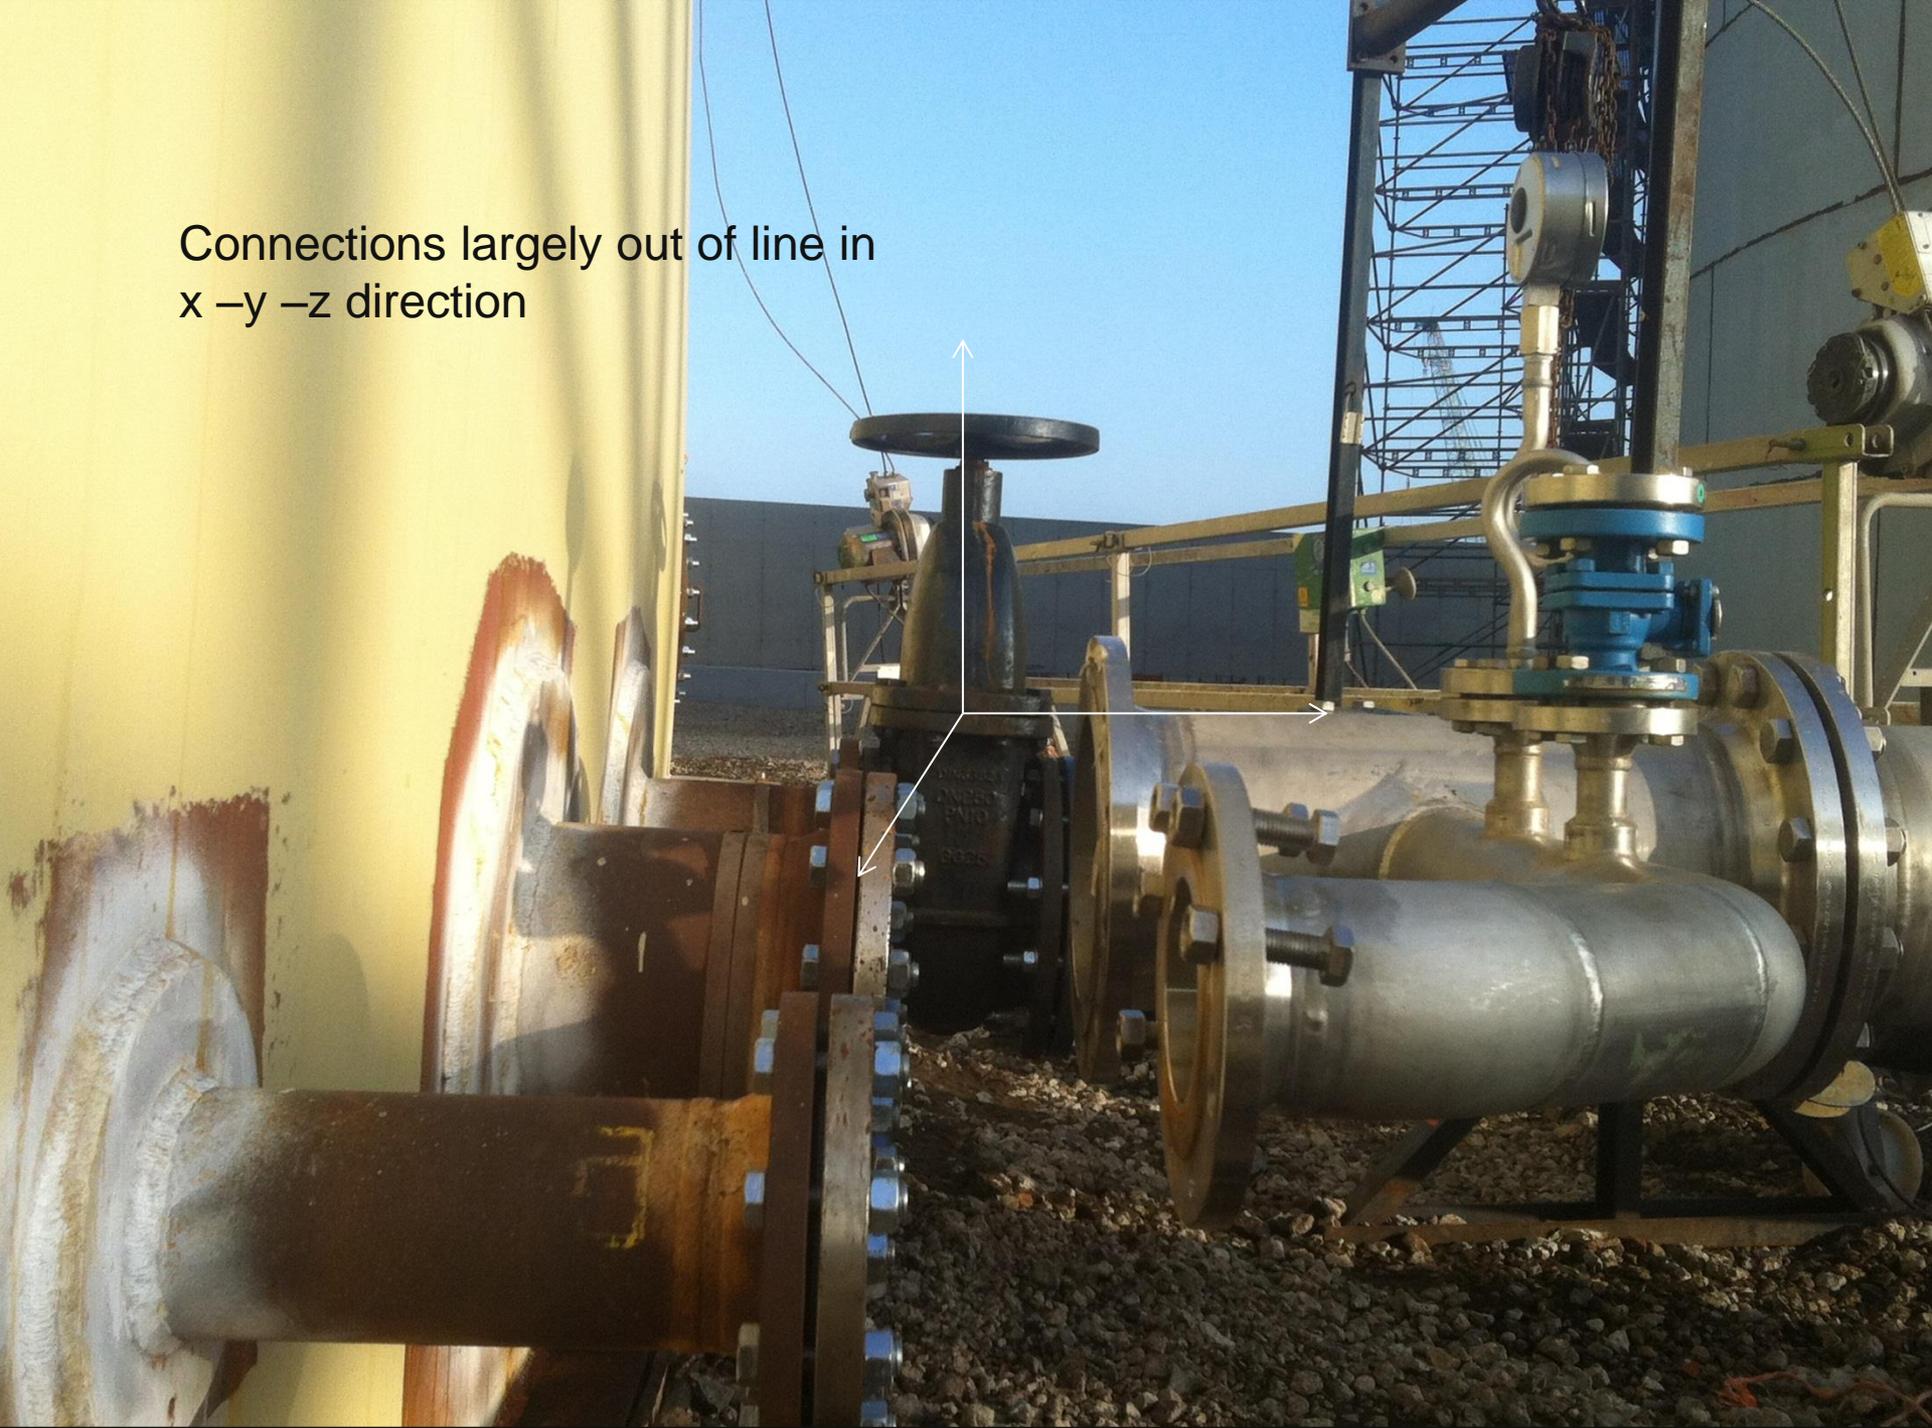
Connections largely out of line in  
x -y -z direction

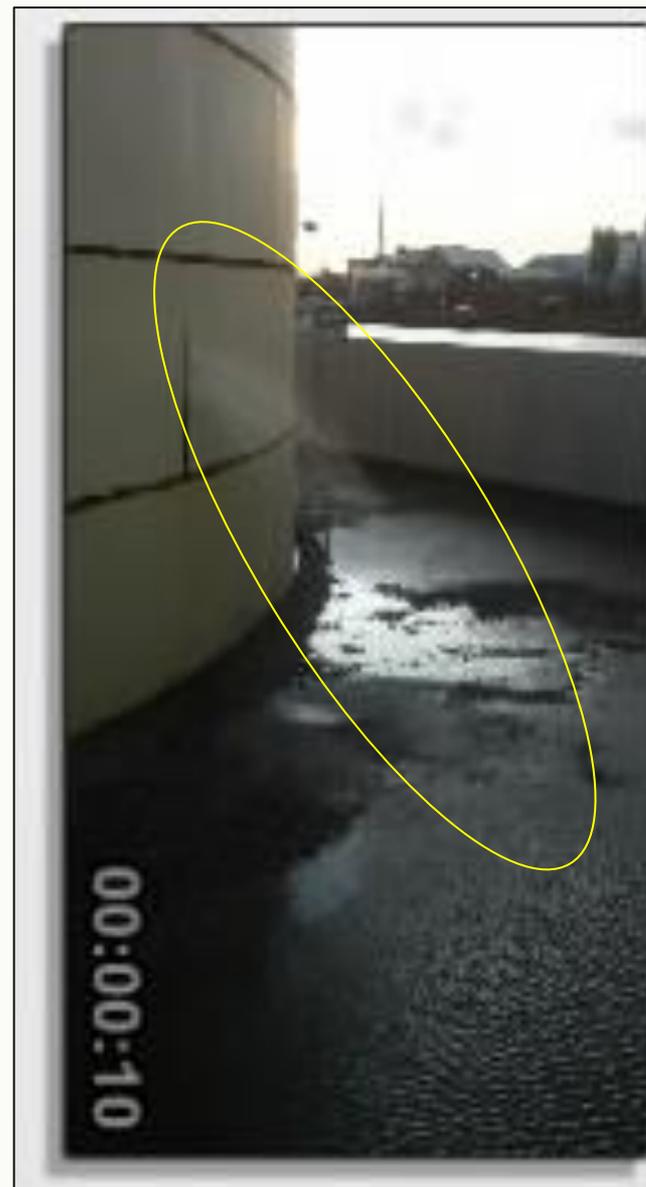
Starting fissuring failure of tank 01  
during the water test filling

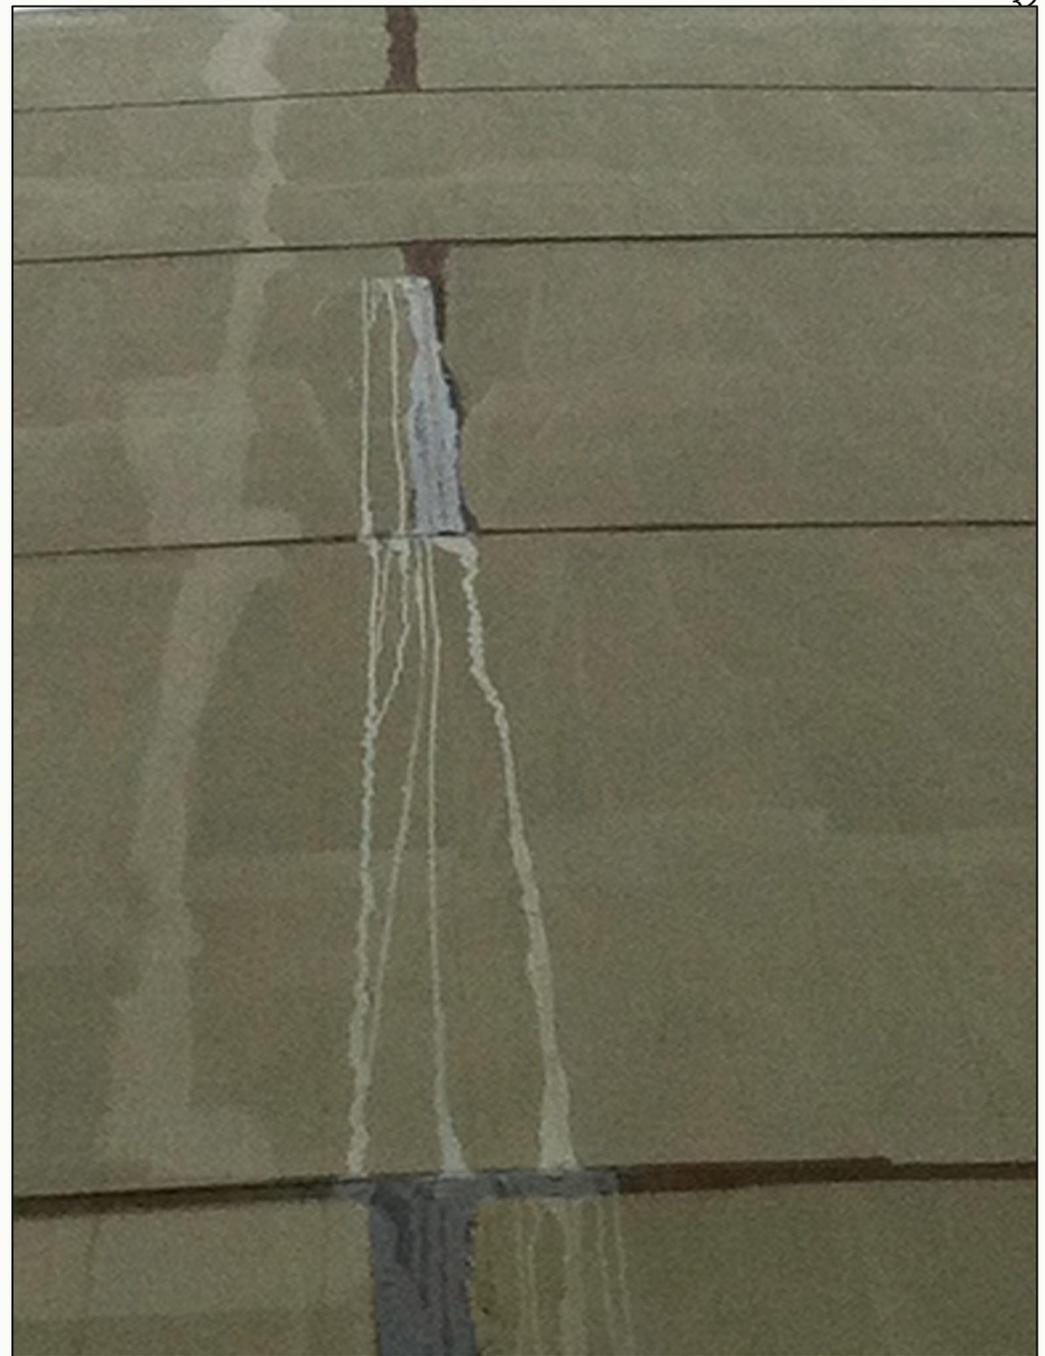
Failure of tank 02 during the water test filling

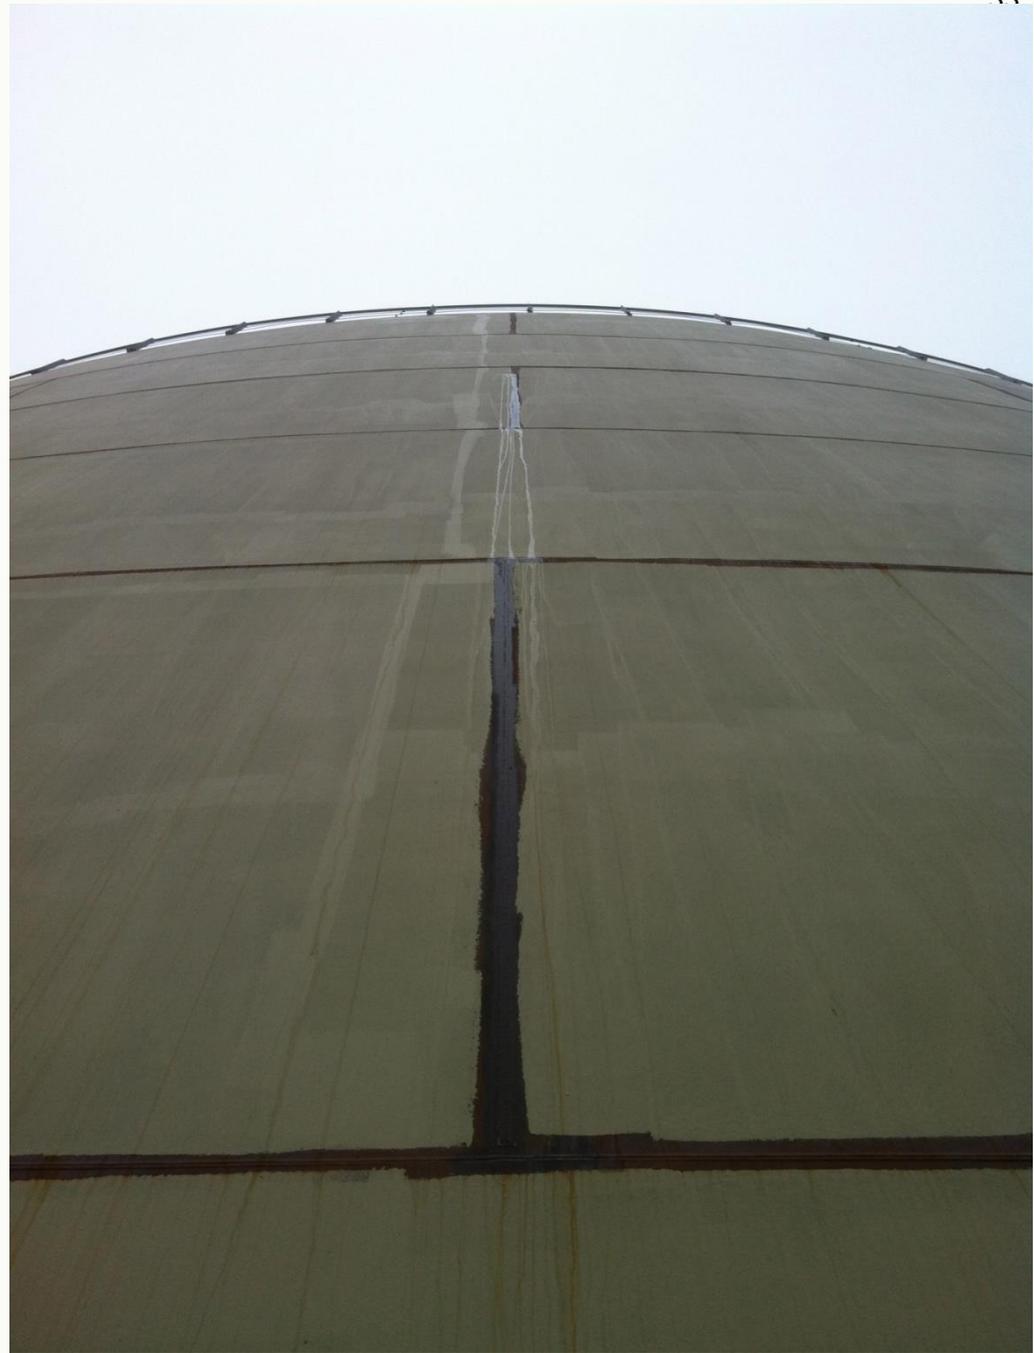
Failure of tank 02 during the  
water test filling

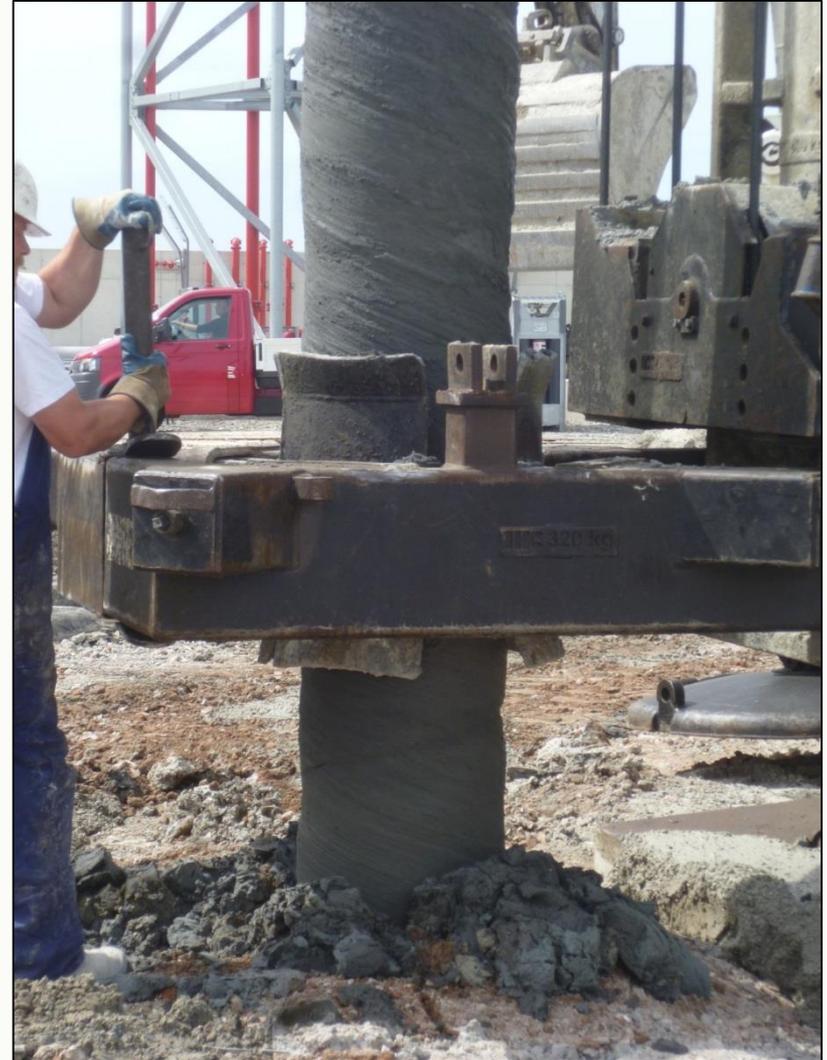
- foundation on a large group of ~ 420 end bearing displacement screw piles per tank, based in the dense tertiary dense sand at ~ 22m of depth
- 460mm diameter Franki Omega pile type designed (at an overall safety factor of >2) to allowable load of 1000 kN/pile (negative skin friction included); pile installation sequence from outer to inner rings

*Omega screw pile installation*

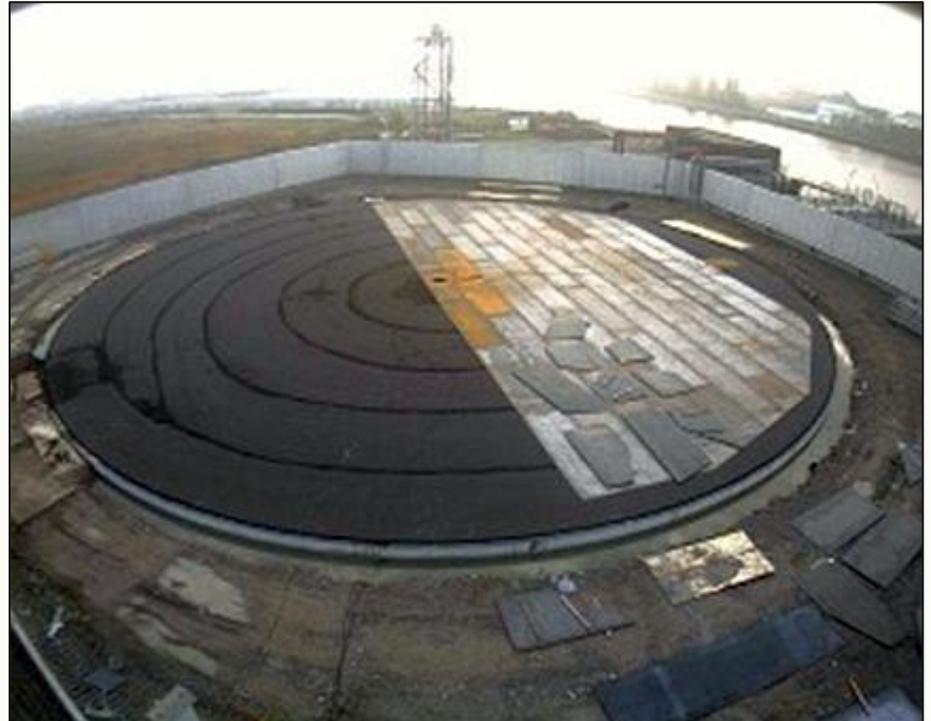
A 600mm thick reinforced concrete raft on top; connecting all displacement reinforced Omega screw piles of 460mm diameter + an asphalt layer cover

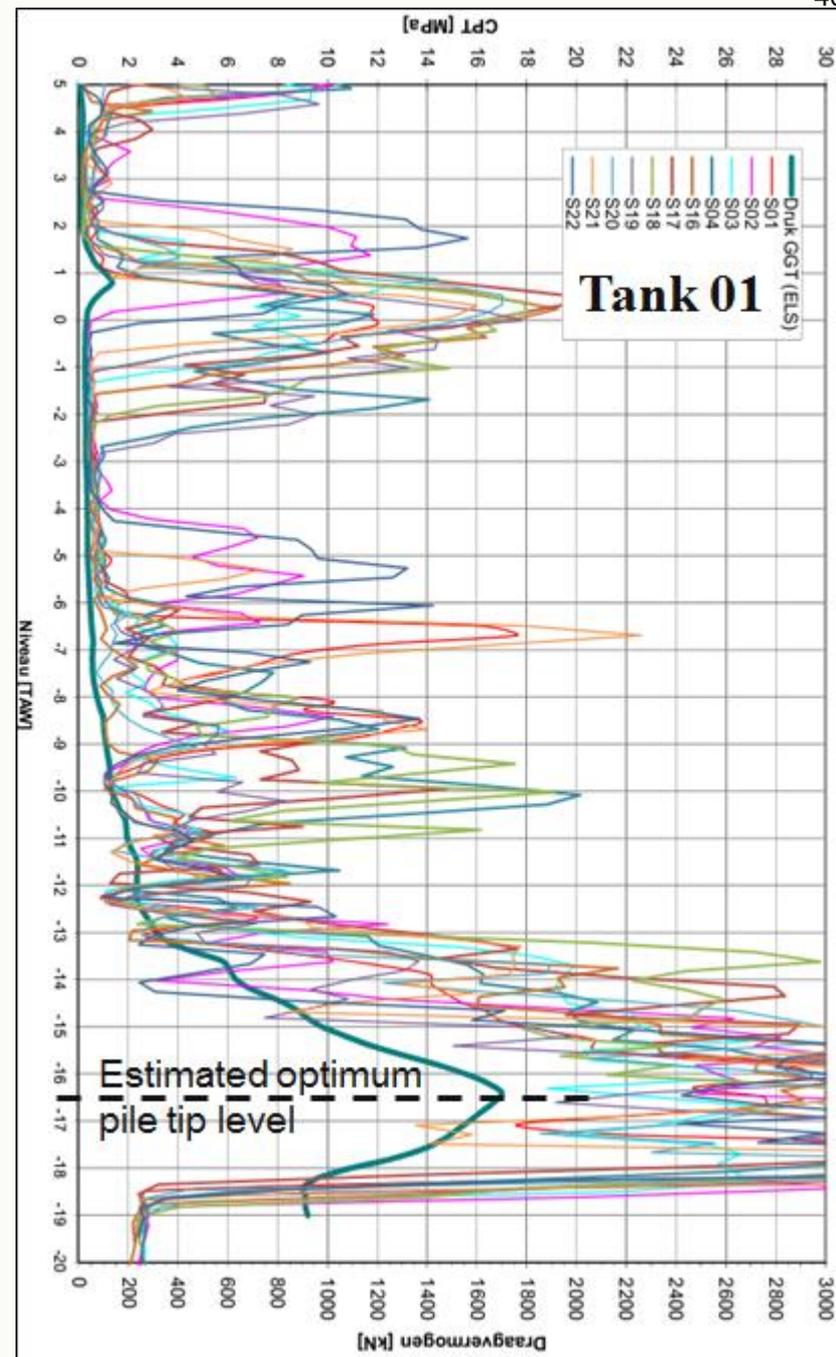
Ultimate unit pile tip resistance of a displacement pile of 460mm diameter, as a function of depth, using all CPT results relevant to tank 01 using the adapted Van Impe - De Beer method (ISC Orlando-1986)

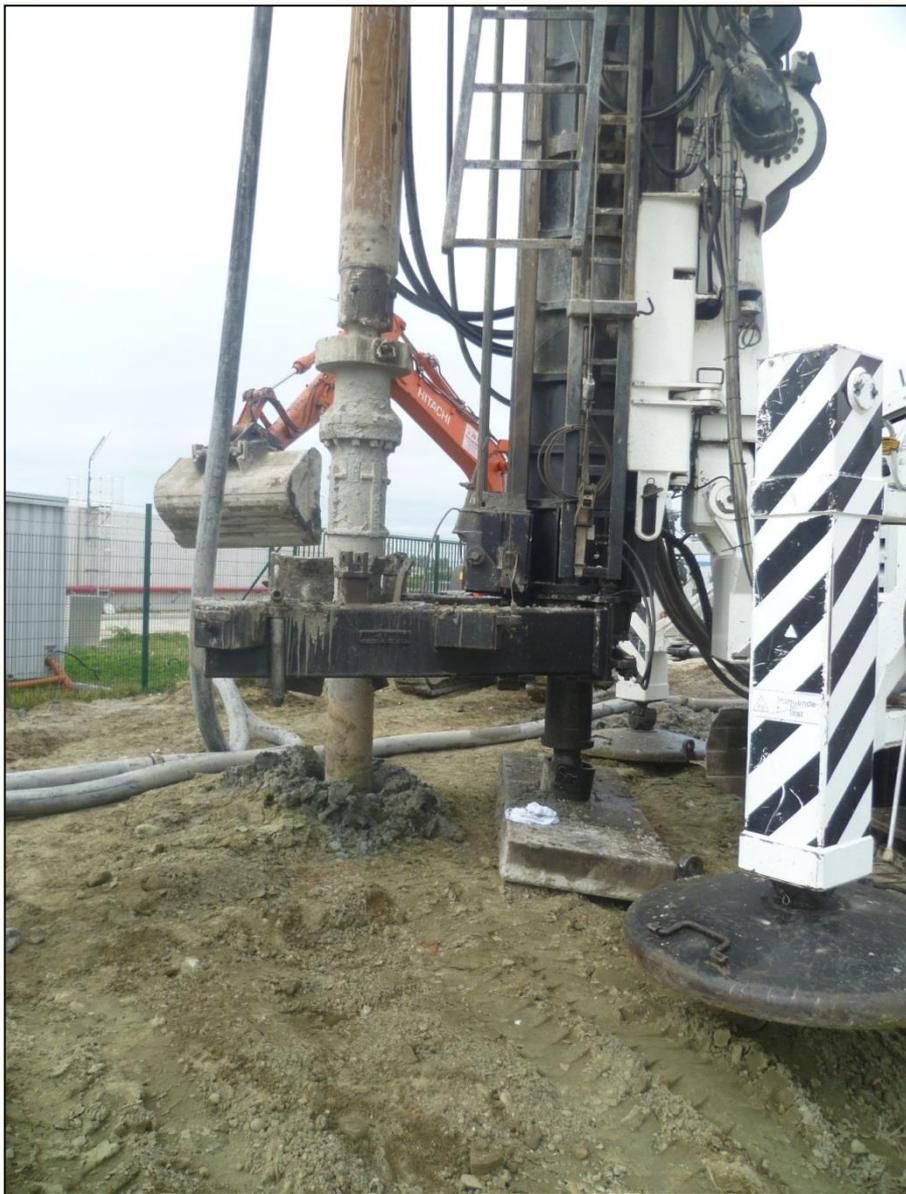
Test pile for fully (extensometer) instrumented pile test until complete 'failure' was being set-up in the neighbourhood of the tanks 2 and 3

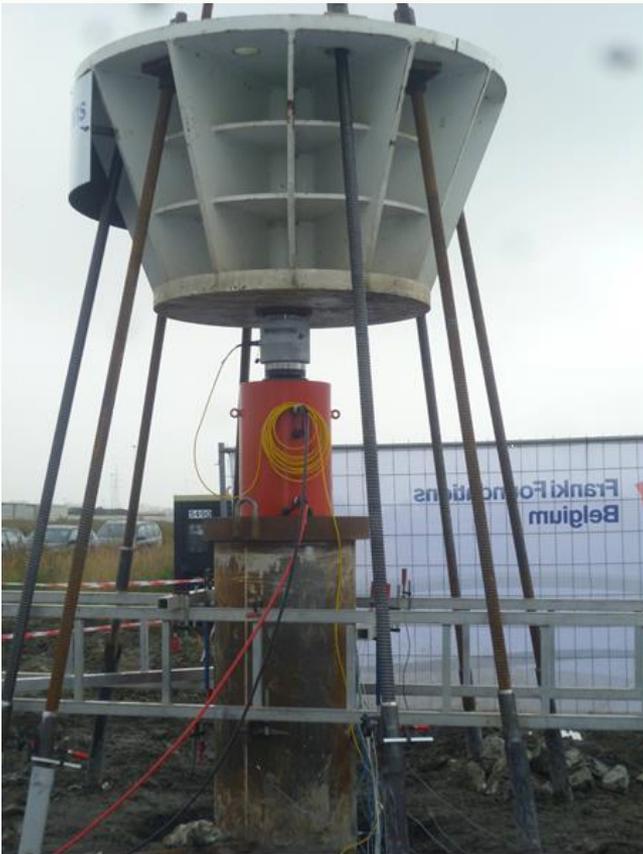
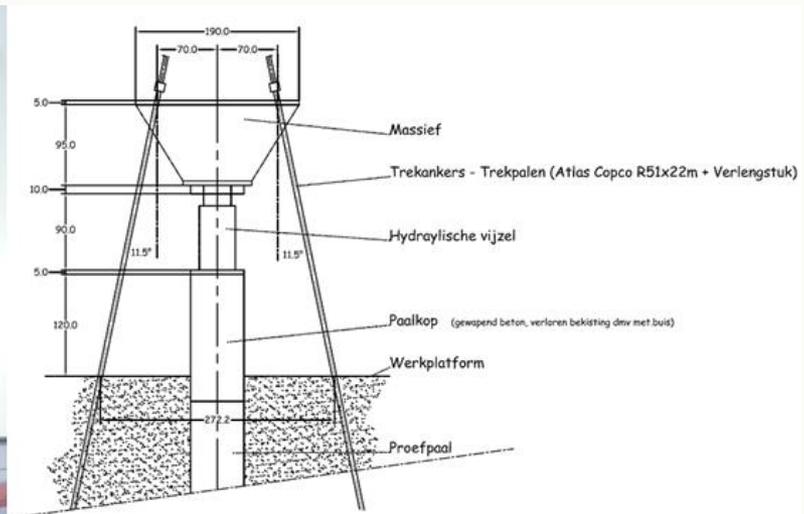
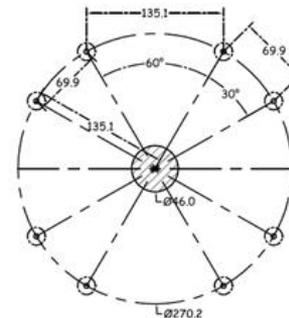
Oostende GFS  
Proefpaal omega 460  
Proefopstelling

Fully instrumented test pile (to be loaded up to a pile base settlement of 10% of pile diameter)

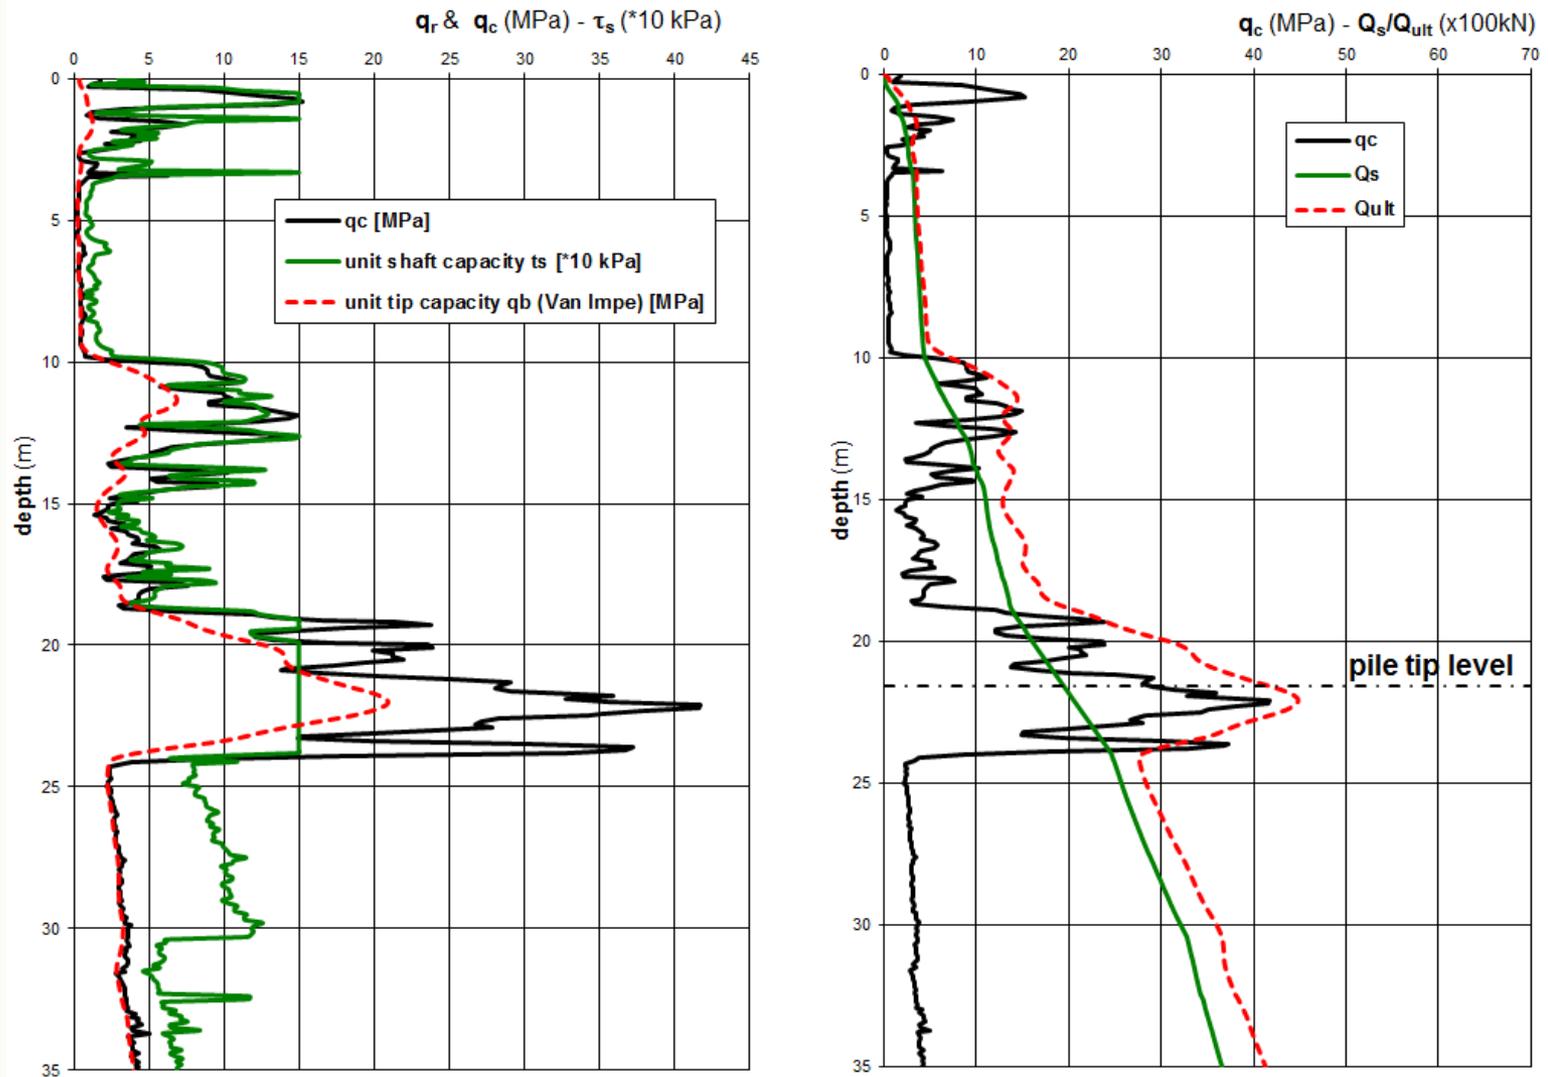
On the left: the unit pile tip and unit pile shaft values; on the right: the total ultimate pile capacity  $Q_{ult}$  vs depth at the location of the test pile axis

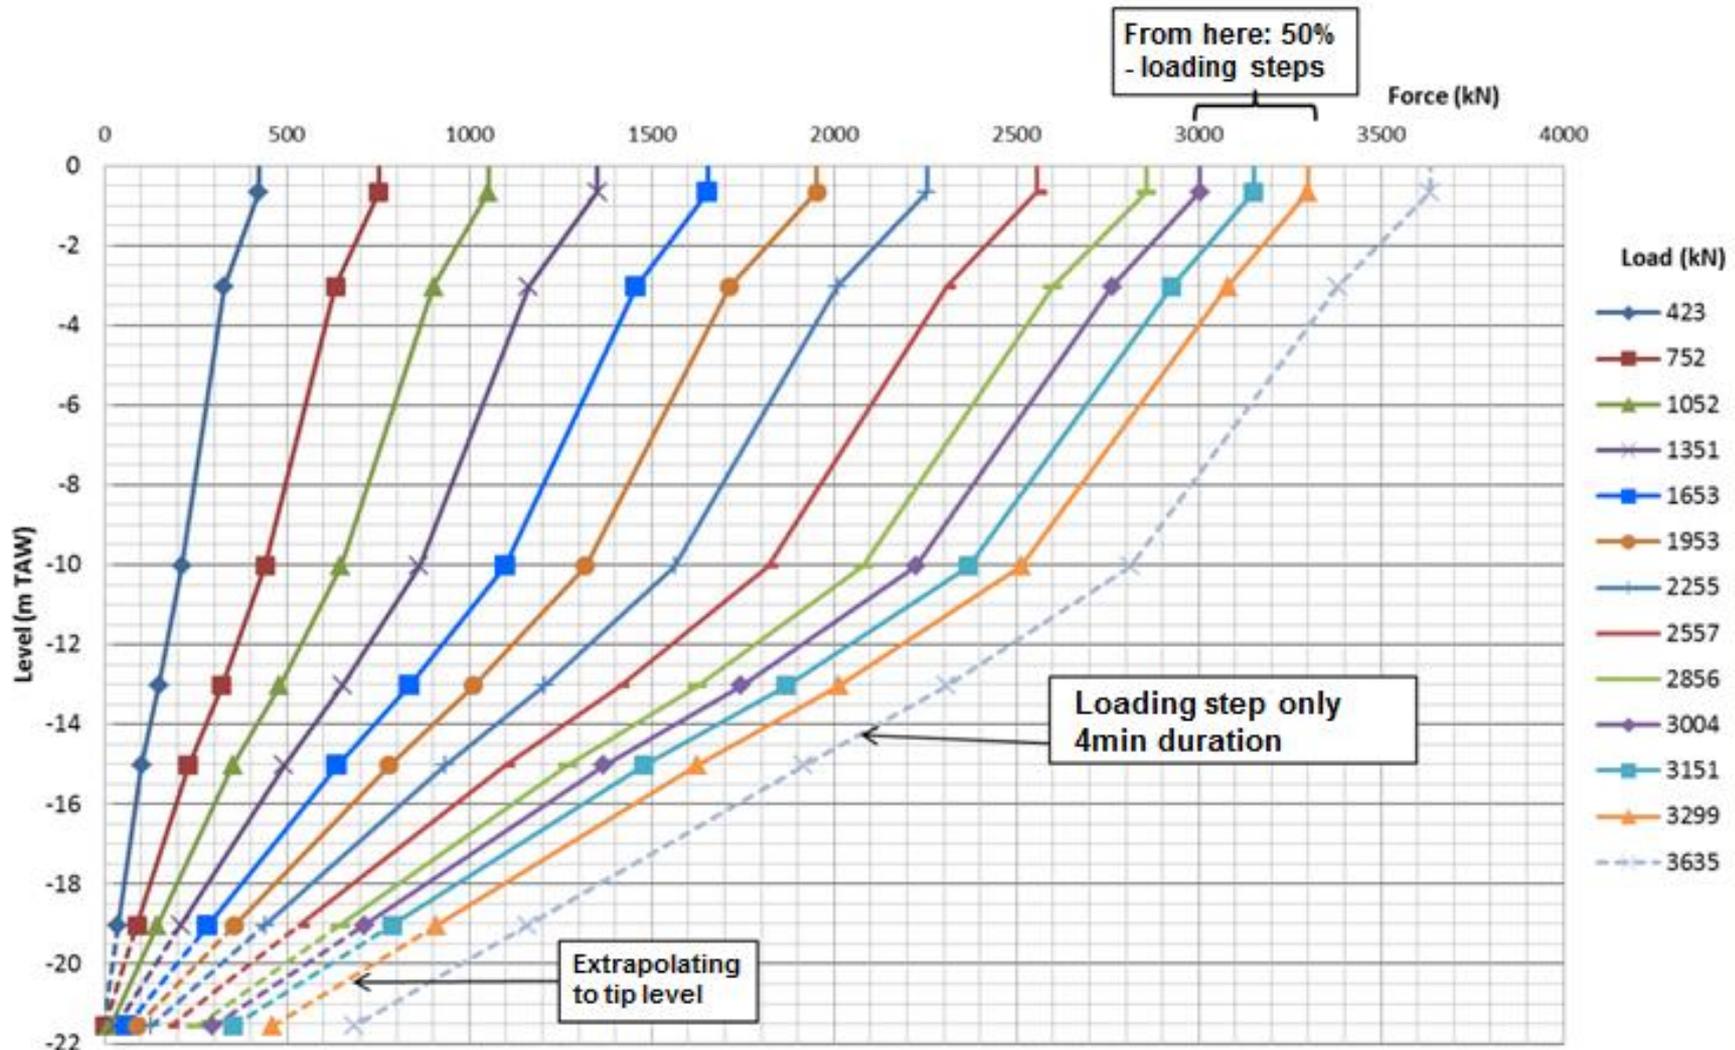
Pile head loads, as transferred to the various pile section levels (extensometer levels)

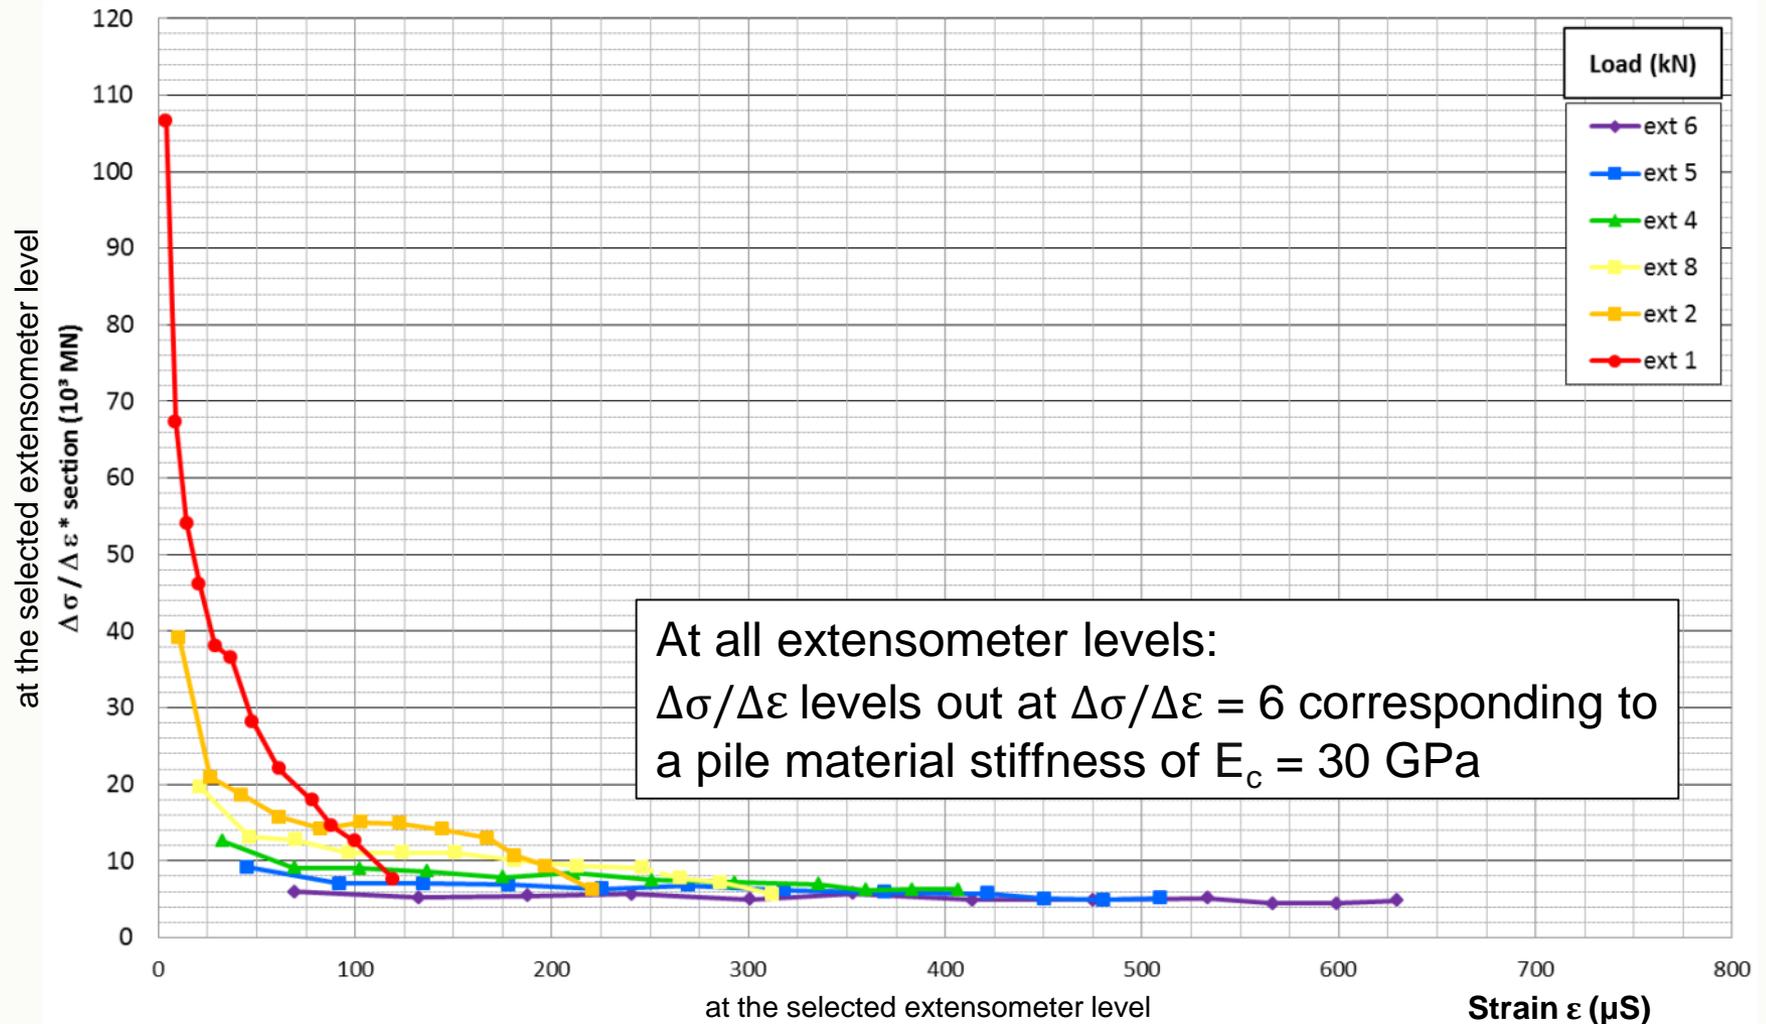
Stiffness evaluation of the test pile material during loading – at the various levels of the extensometers (adapted Fellenius 2001 method)

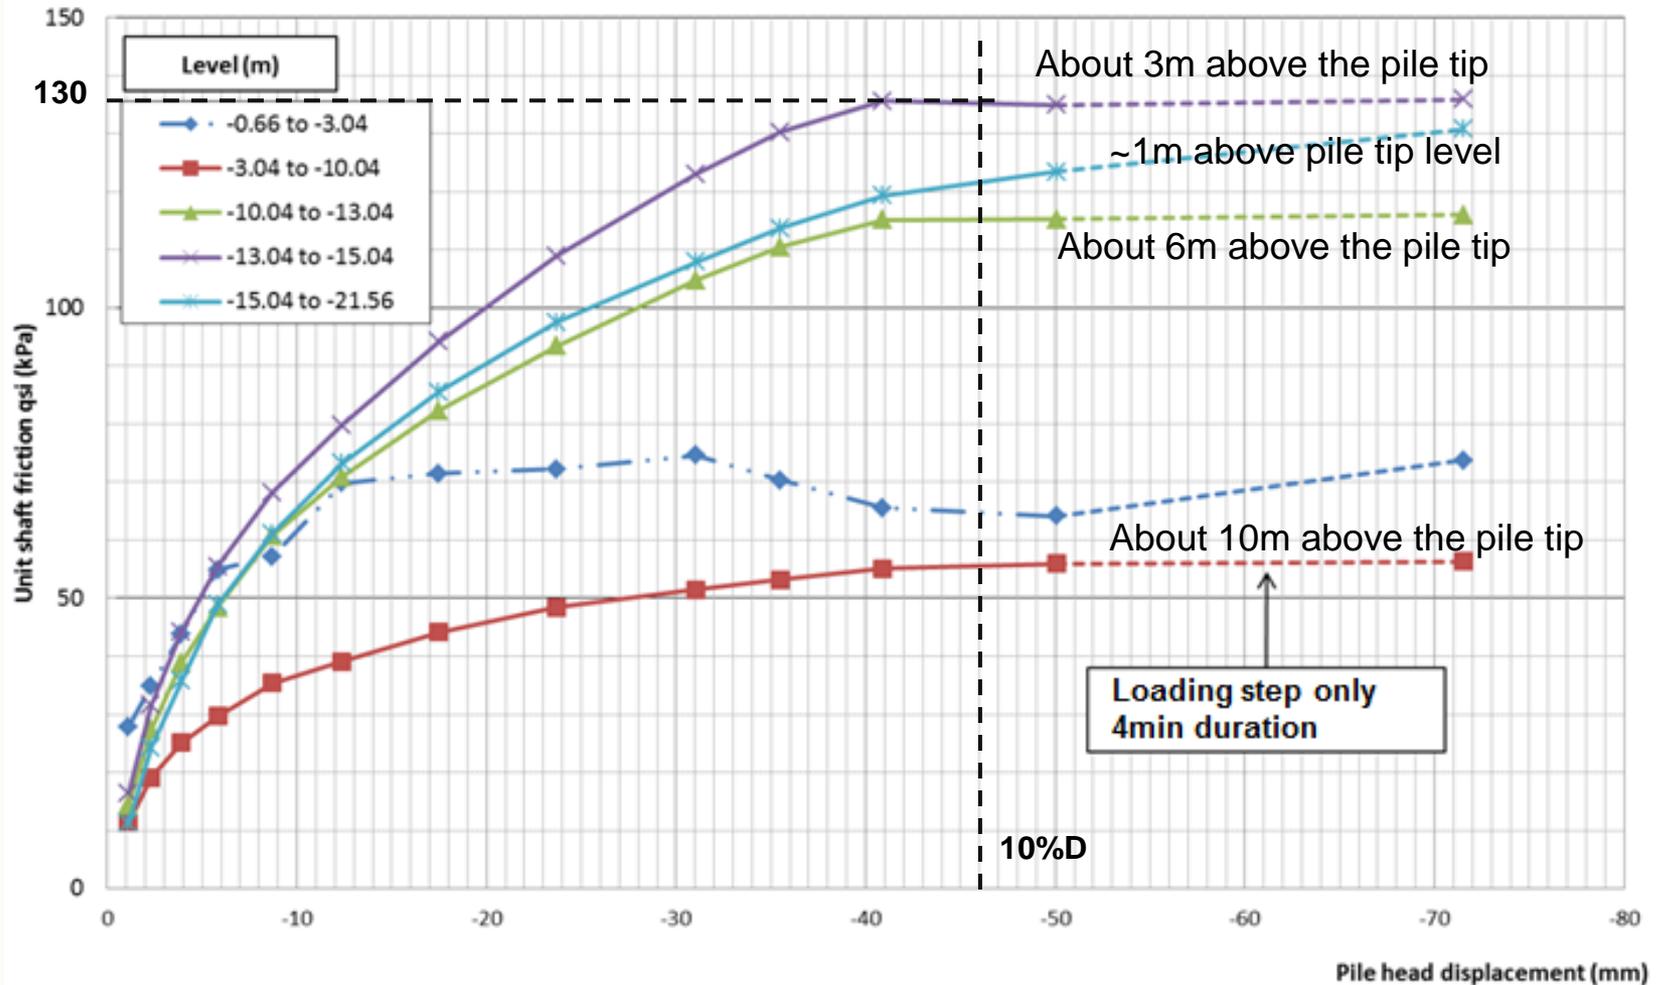
Mobilizing the pile shaft capacity at increasing pile deformations, in the sections in between the extensometer levels.
