Symposium:  
"Pile design and displacements"  
May 27th, 2016  
The Hague

# A case study of large screw pile groups behavior

Em. Prof. Dr.ir. William Van Impe  
Presented by ir Maurice Bottiau

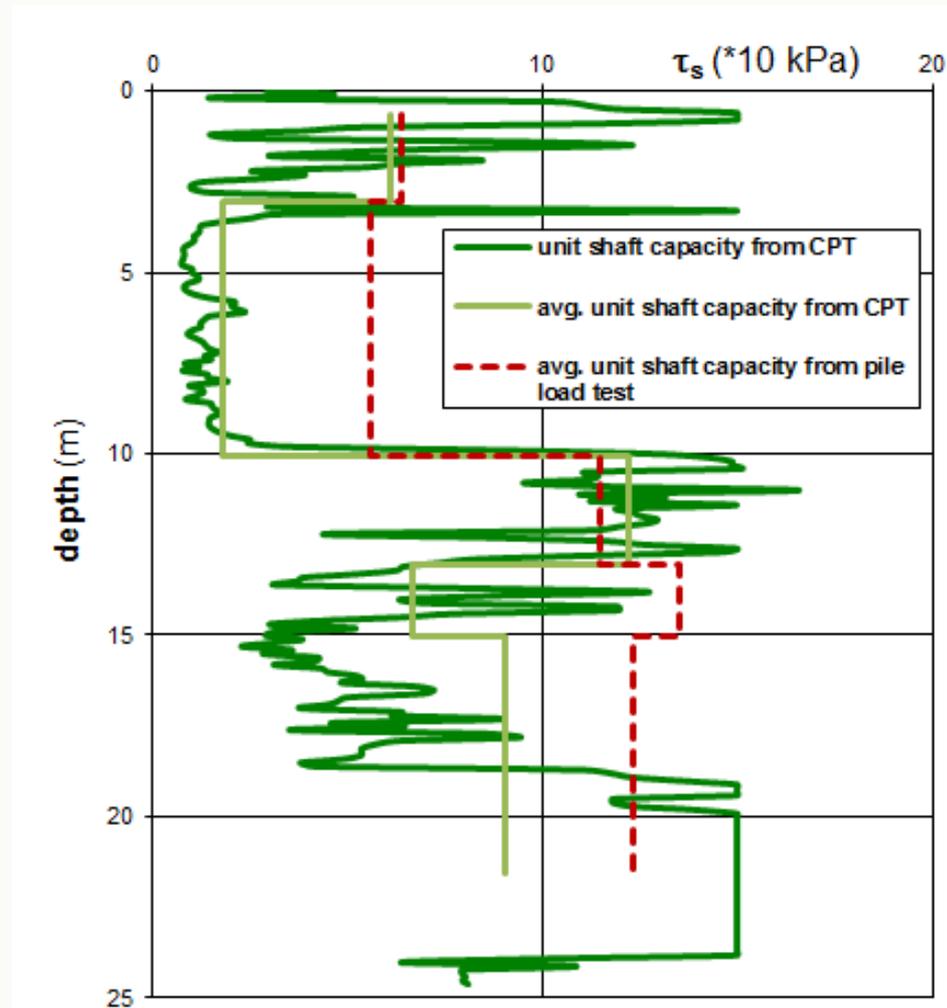
Comparison of the mobilized unit shaft friction along the test pile shaft: CPT based predicted mobilized friction versus the measured values during the load test

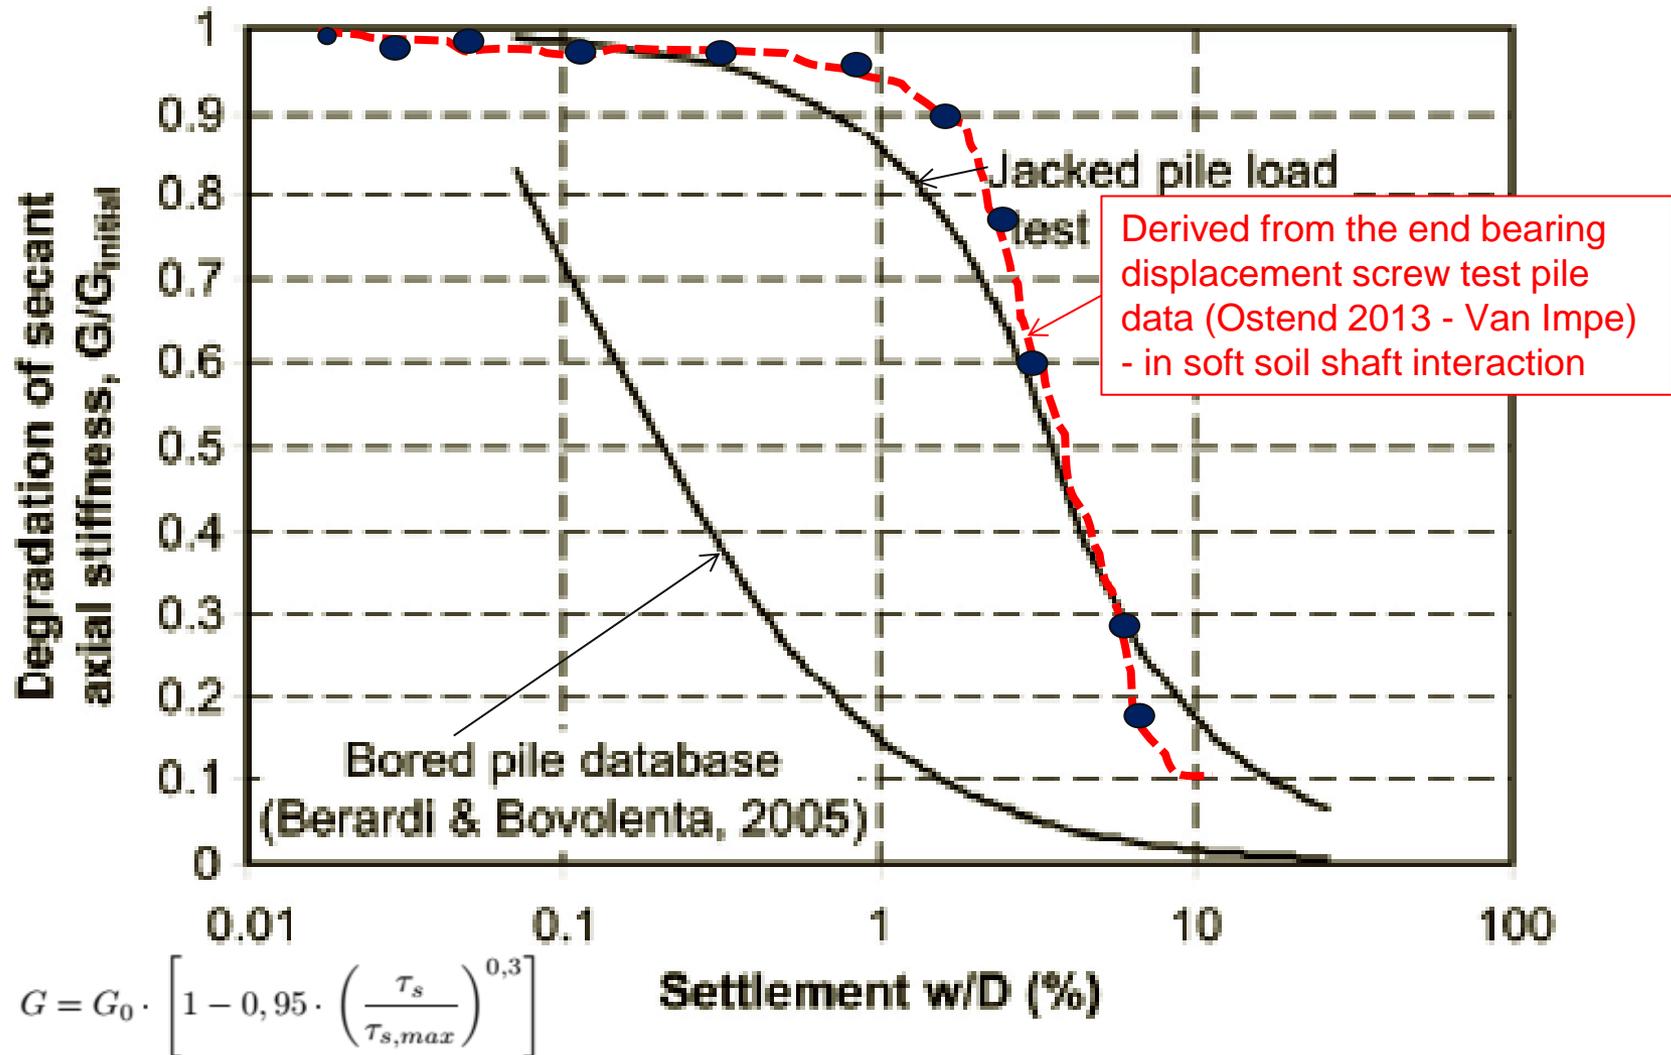
The strain level dependency varies with installation method because of the very different nature of failure pattern

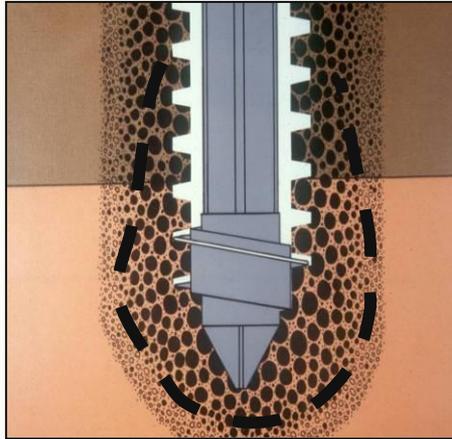
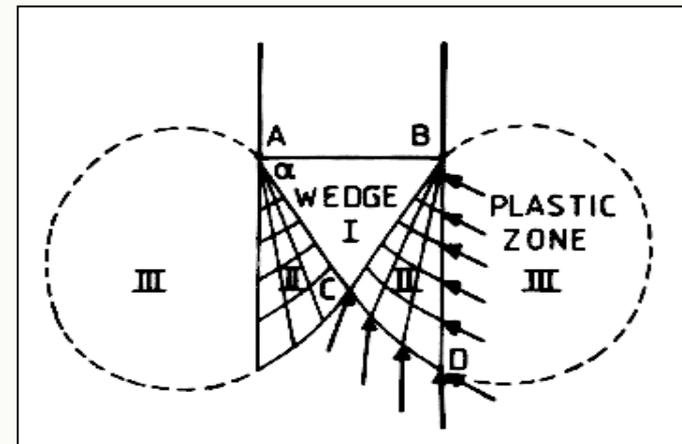
## Driven piles

- very high level of curvature
- very progressive failure
- larger interaction displacement allowable up to failure

## Displacement screw piles

- less curvature of failure surface
- so, less progressive failure

Displacement screw piles do show a by far less curved potential shear surface in the same type of soil, due to a less pronounced tip-soil interaction + a greater (installation governed) disturbed “soil paste zone” along the shaft (and so an easier and more pronounced upward soil movement along the tip/shaft)

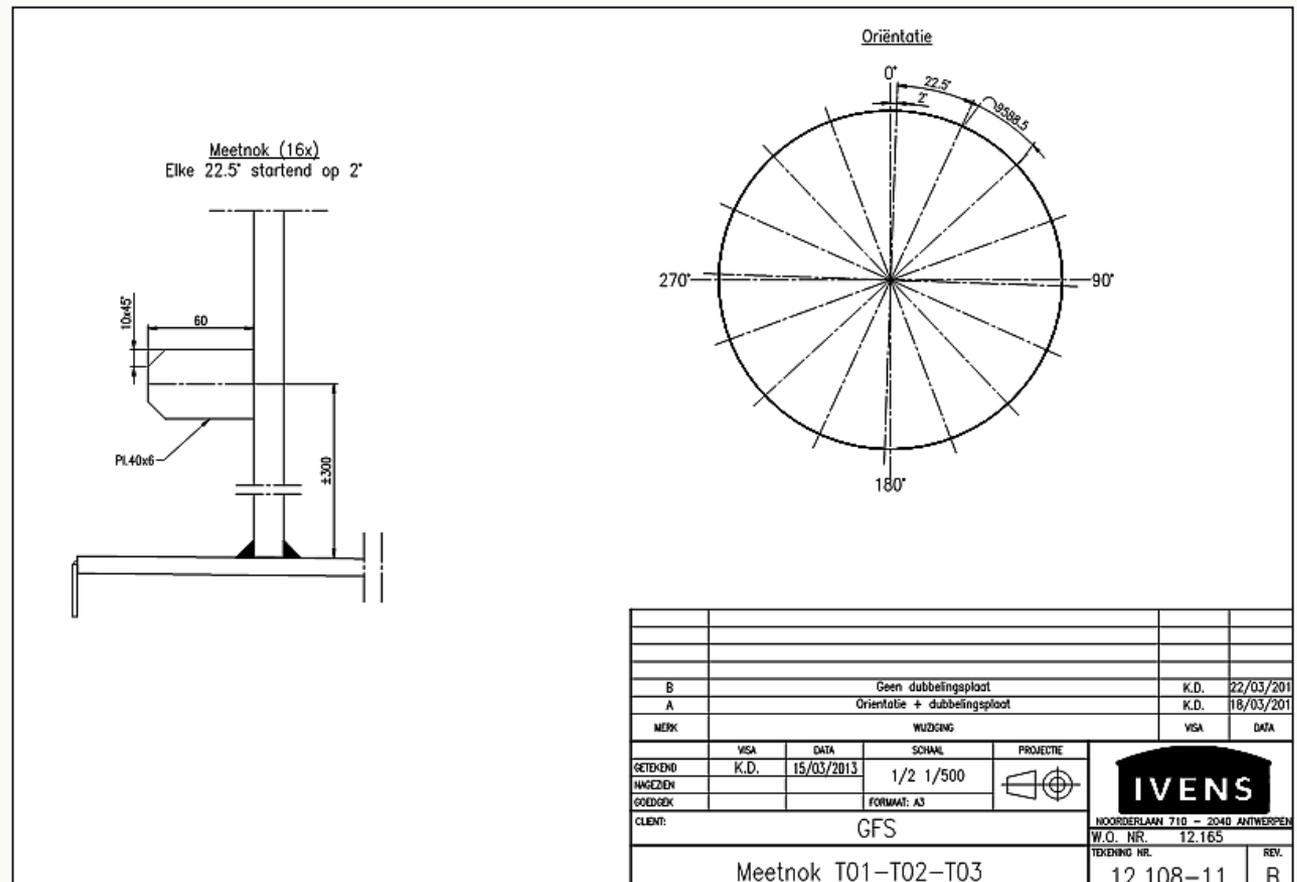
16 points along tank's perimeter, equally divided at a center angle of  $22.5^\circ$  from each other

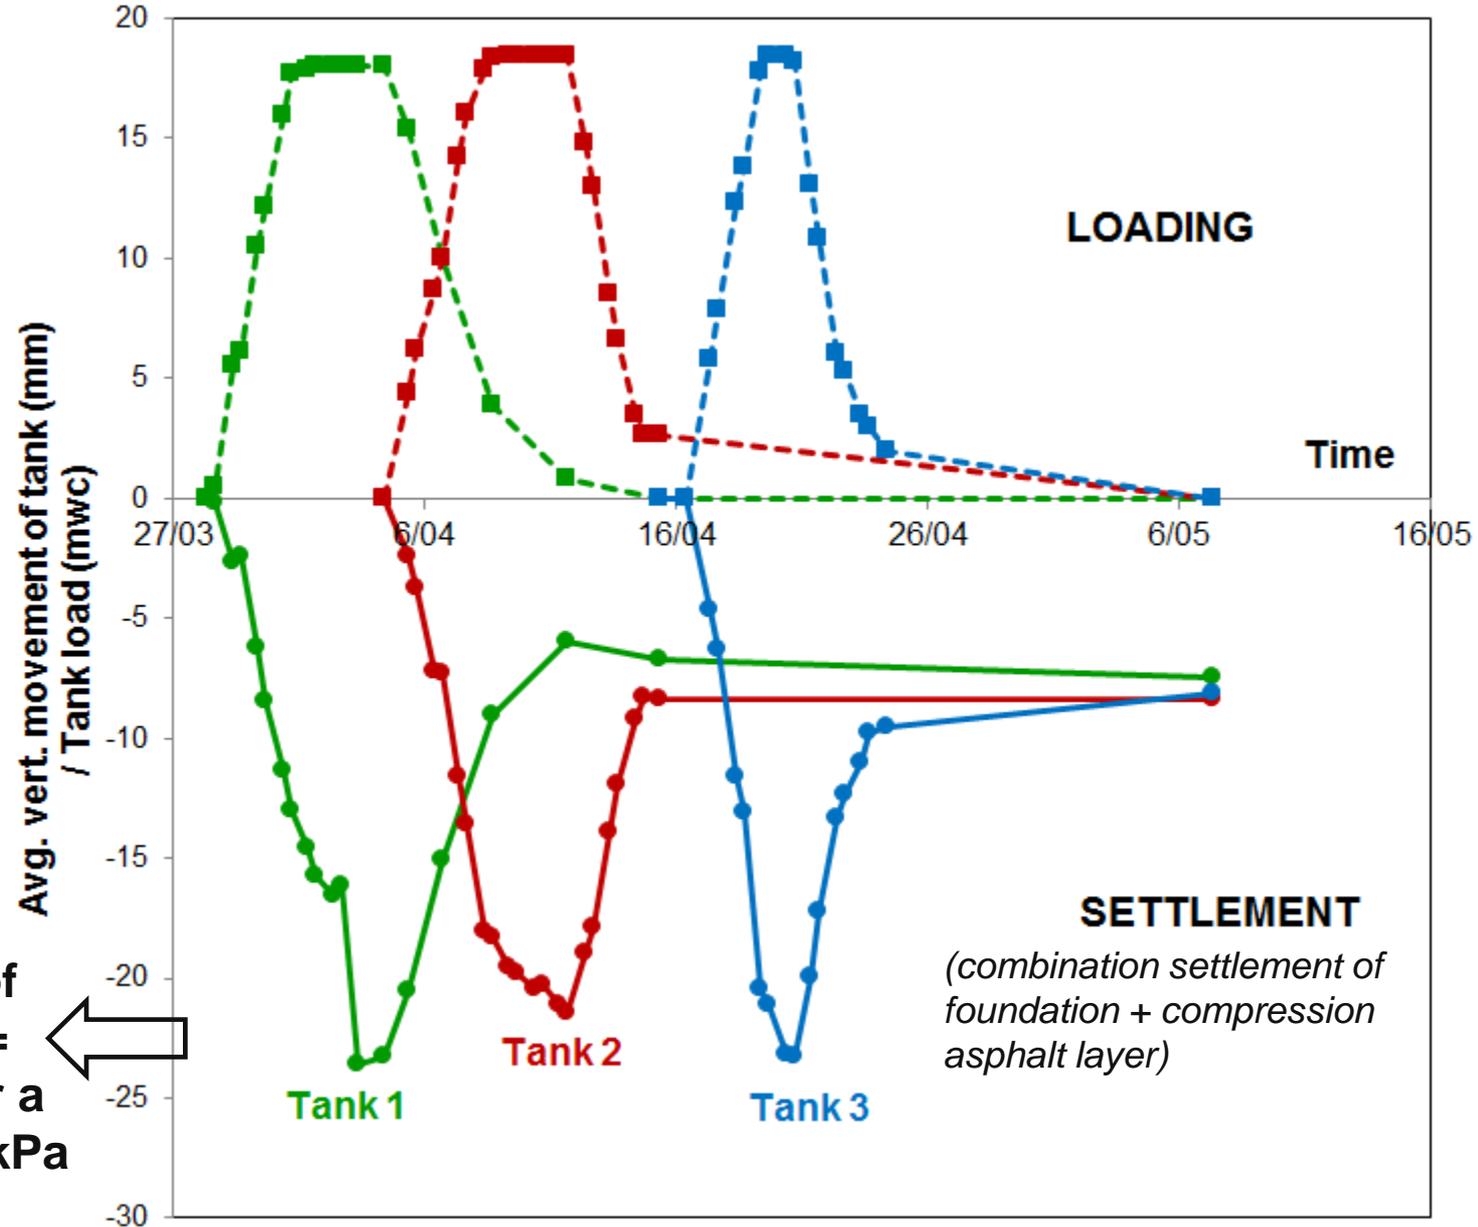
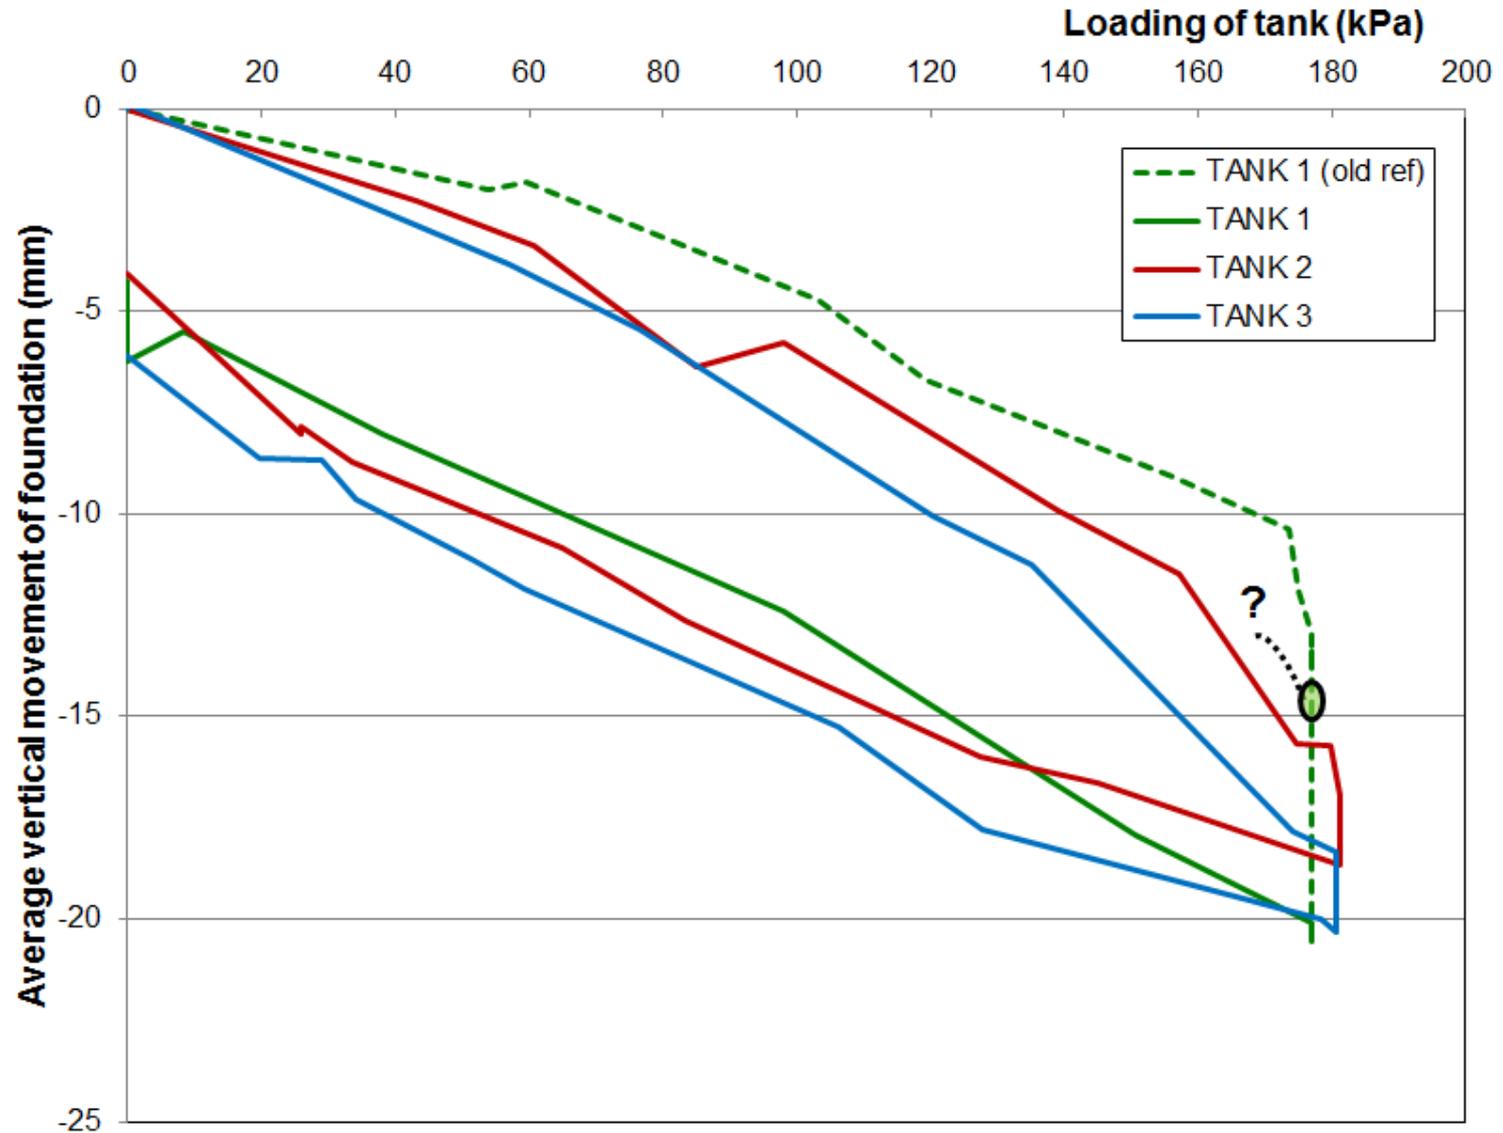
- As each tank was tested separately and for a very short period, the impact of the load is presumably limited to the immediate response of the stiff sand layer and the upper part of the underlying silty clay layer
- no real interaction between tanks  
= limited tilt of the tanks (2-3mm)
- residual average deformation at the end of hydro-test  
~ 8mm for all tanks

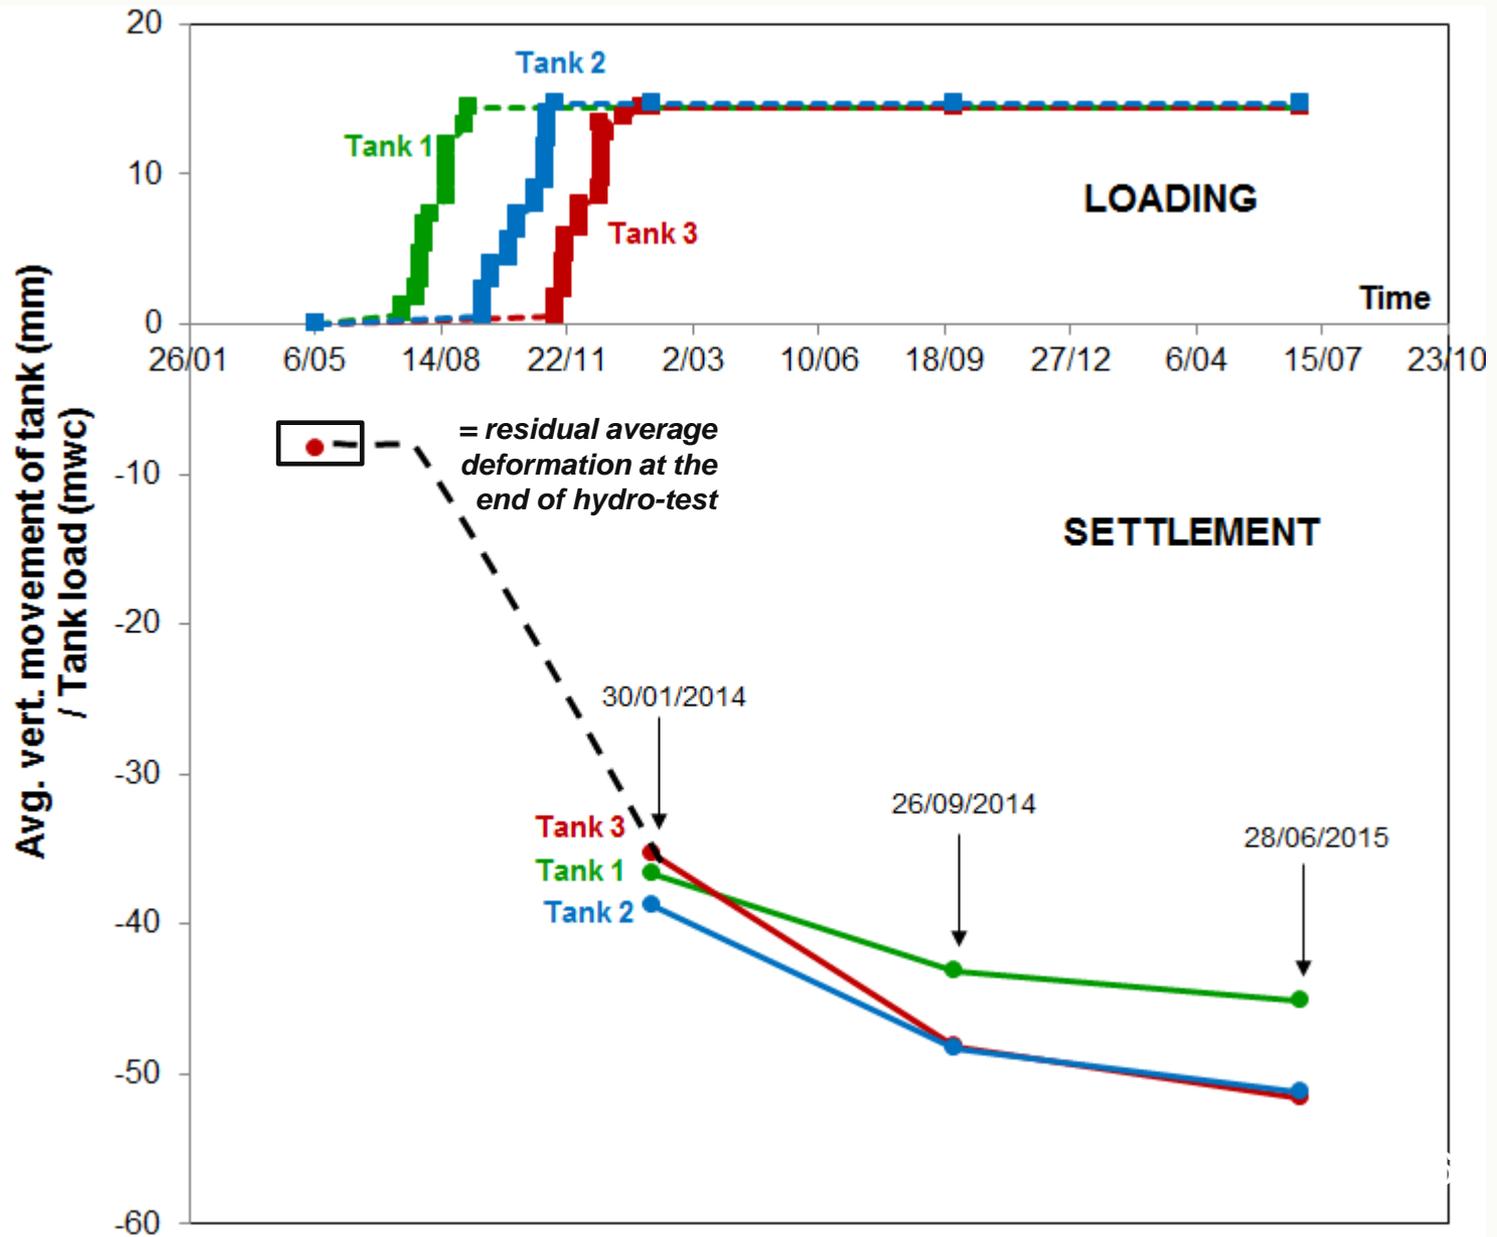
- additional average settlement at this point has reached values of 34 to 40mm
- higher value of the tilt (compared to hydro-test) as expected due to interaction of different loads
- values of average settlement, tilt and distortion still far below critical values

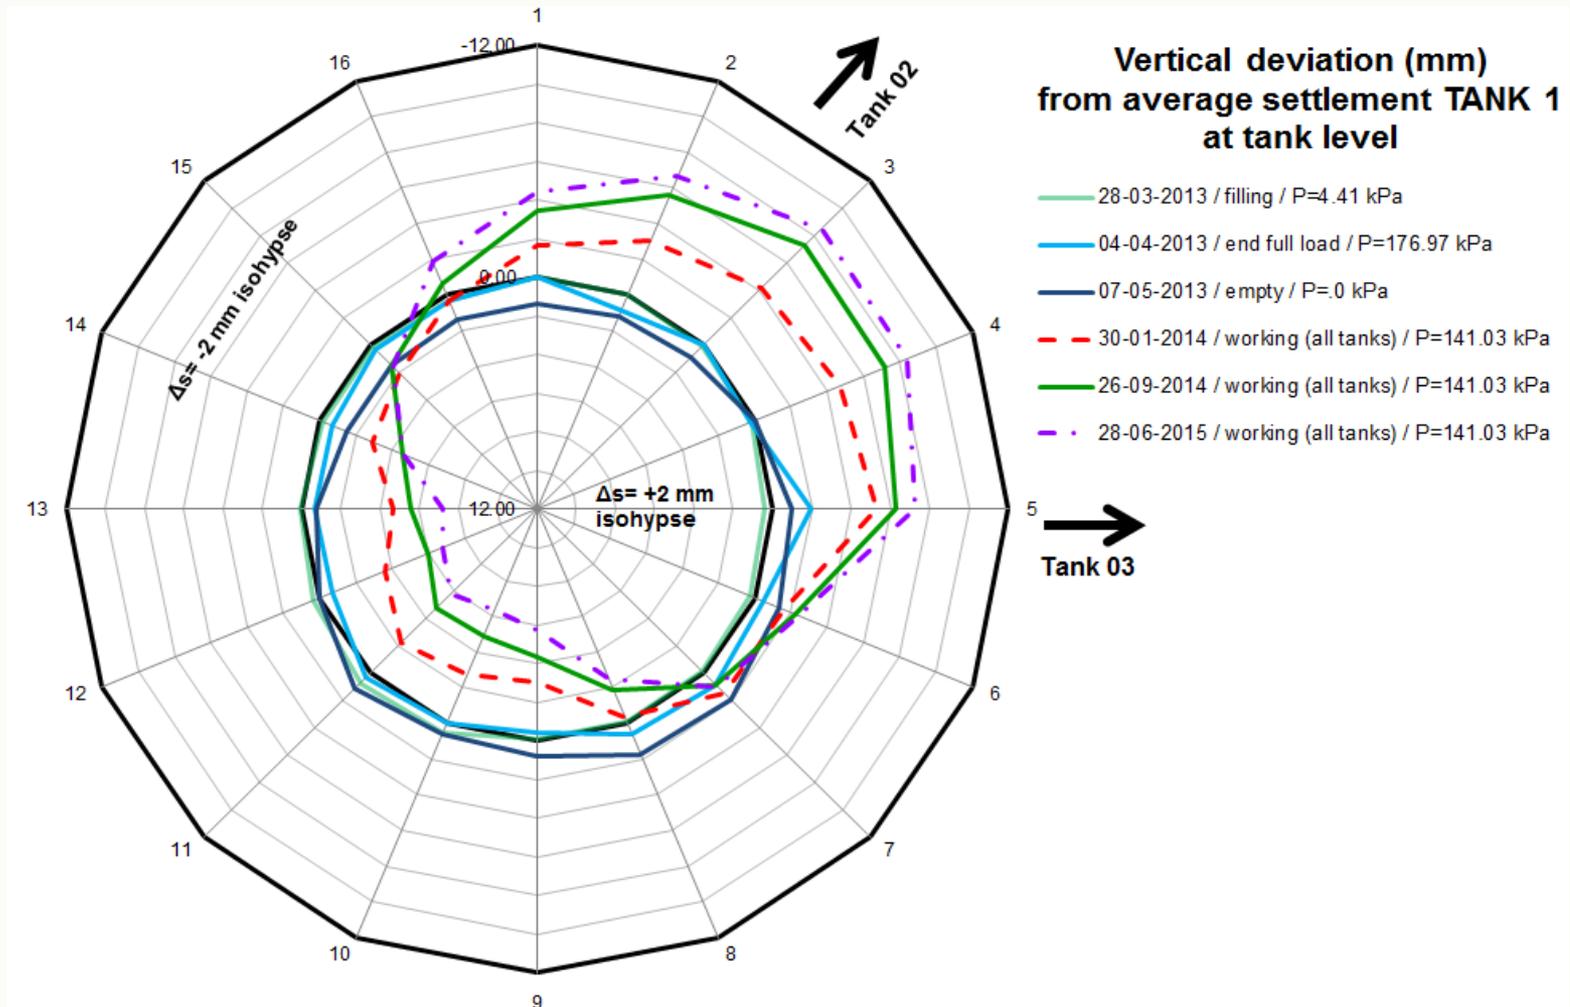
# Vertical deviation from average settlement (mm) of Tank 1 - during hydro test and during operation

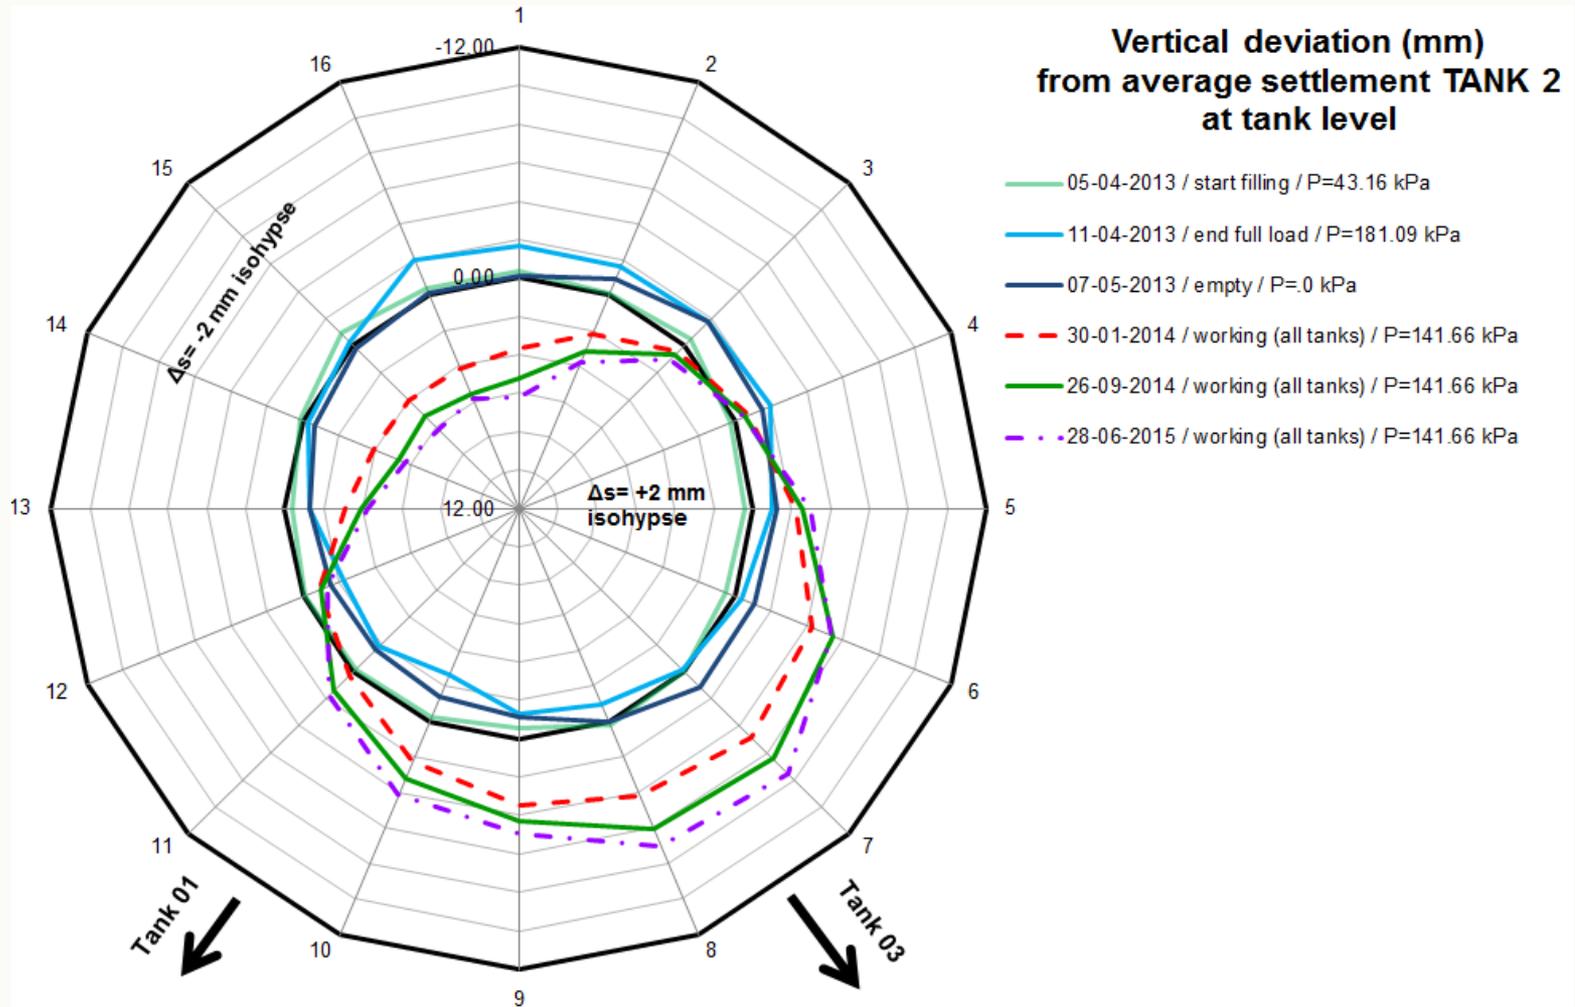
# Vertical deviation from average settlement (mm) of Tank 2 - during hydro test and during operation

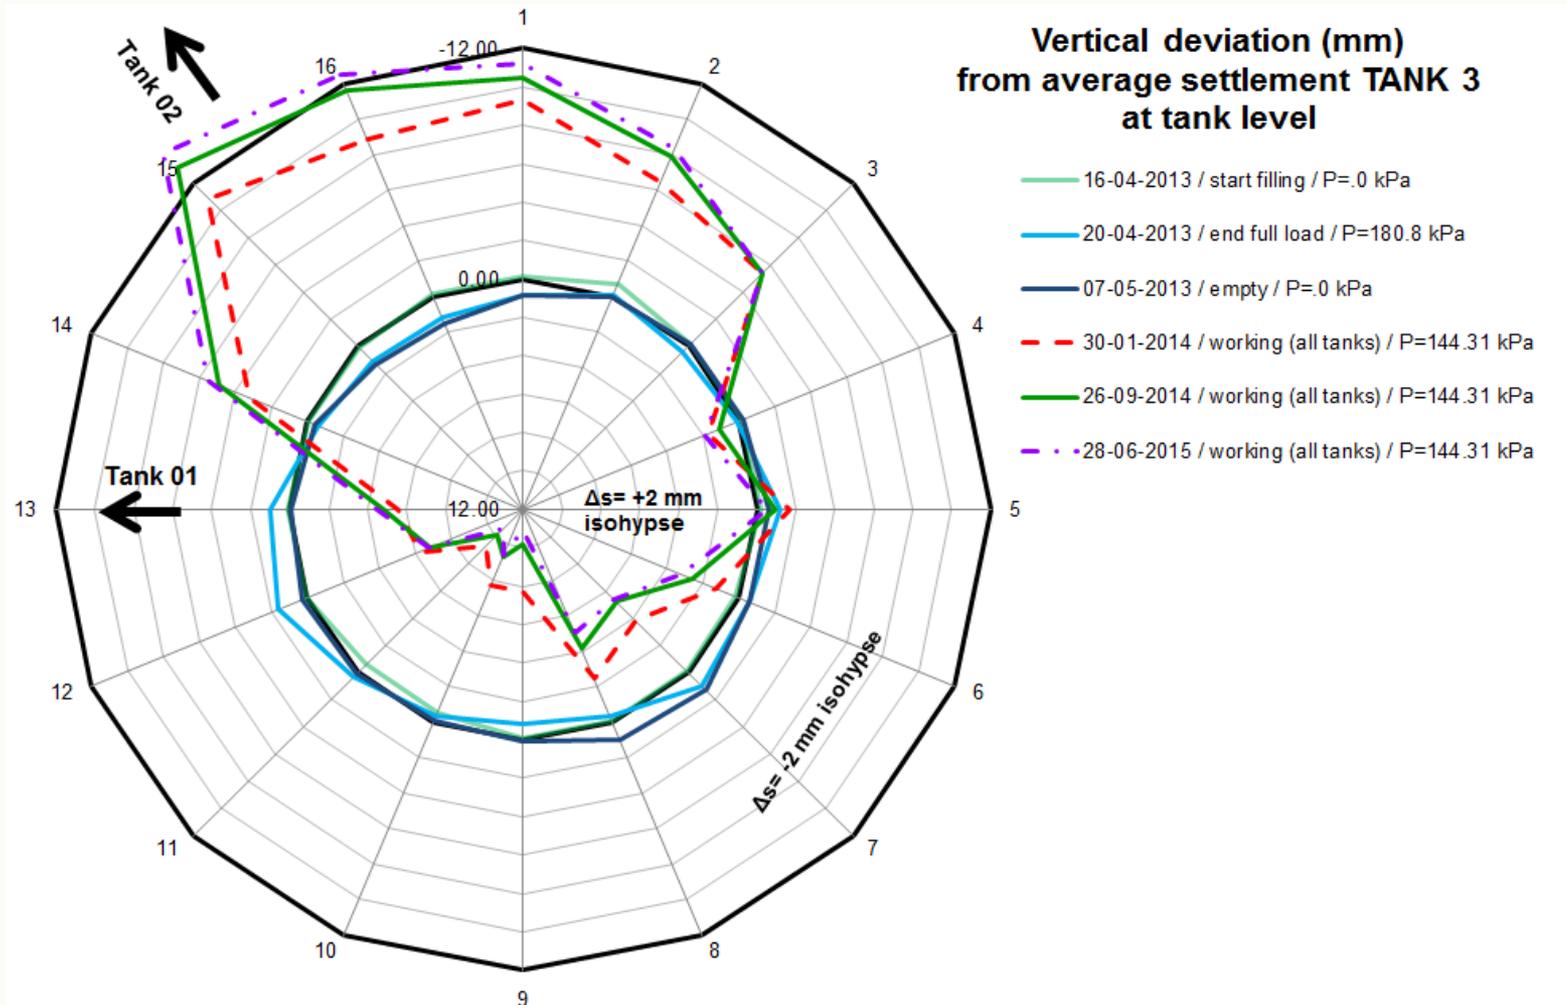
# Vertical deviation from average settlement (mm) of Tank 3 - during hydro test and during operation

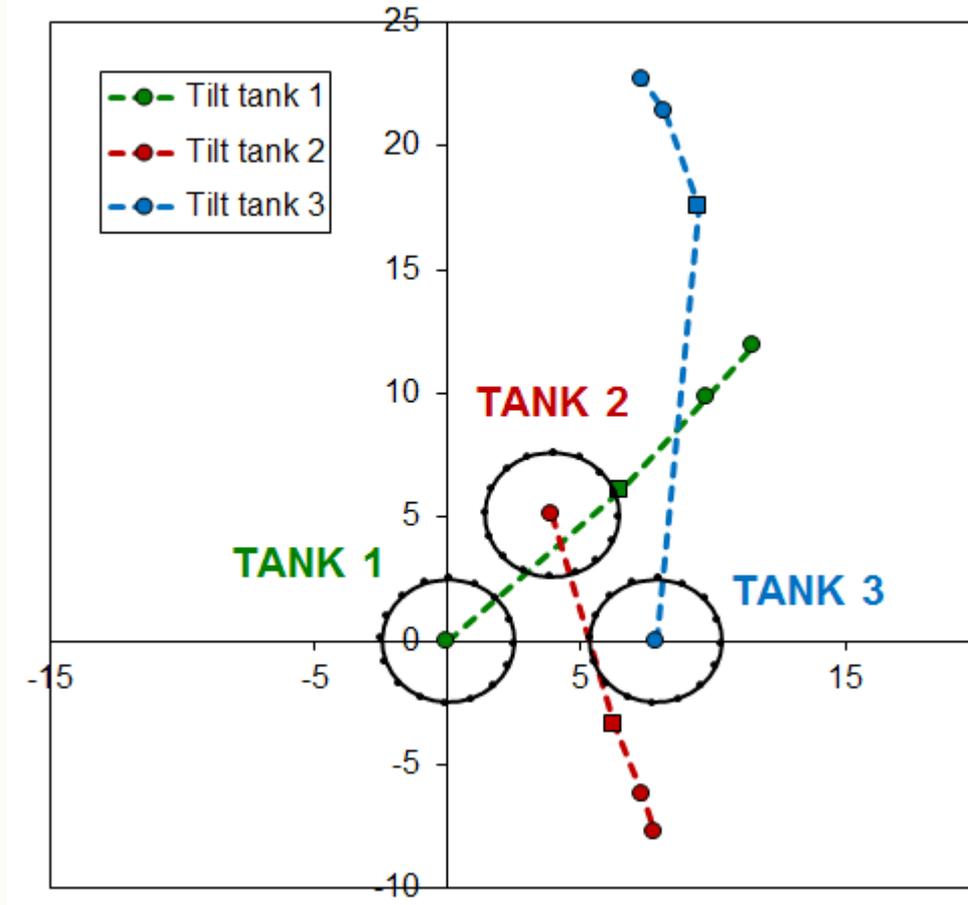
## Direction and size (mm) of tilt of the tanks during operation

Both **tank 1** and **2** exhibit about 15 mm of nearly perfectly planar tilt ( $0.00031$  m/m) towards the central area in-between the tanks, while **tank 3** tilts almost directly north for about 22 mm ( $0.00046$  m/m)

**!!!! local subsoil heterogeneities below tank 3**

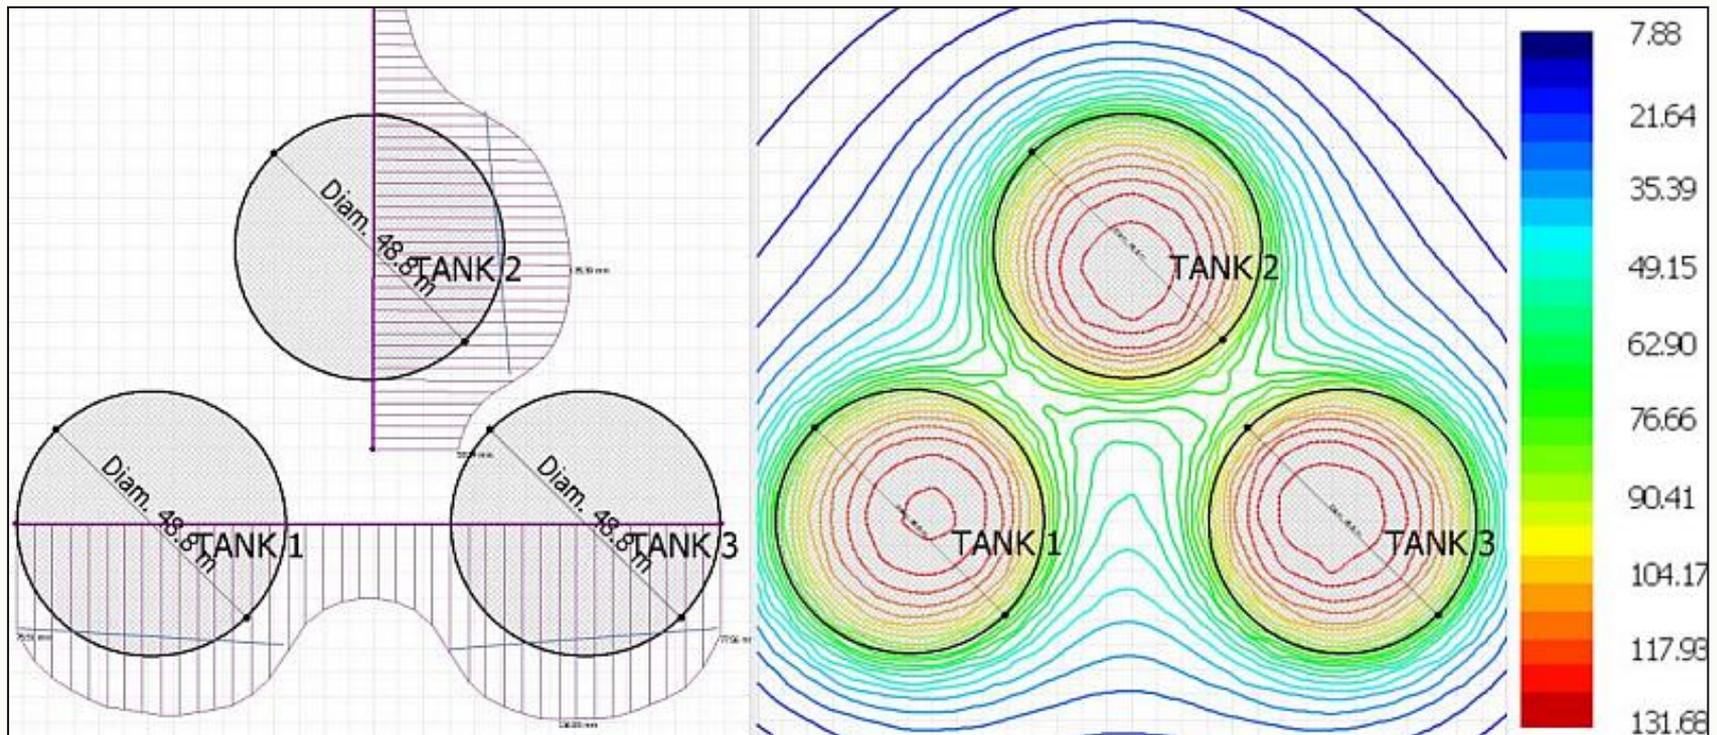
Based on the compressibility parameters from CPT + hydro-testing, a single value of  $c_v$  for the silty clay was found to get the best fit between predicted and measured average settlements

(SteinP 3DT program)

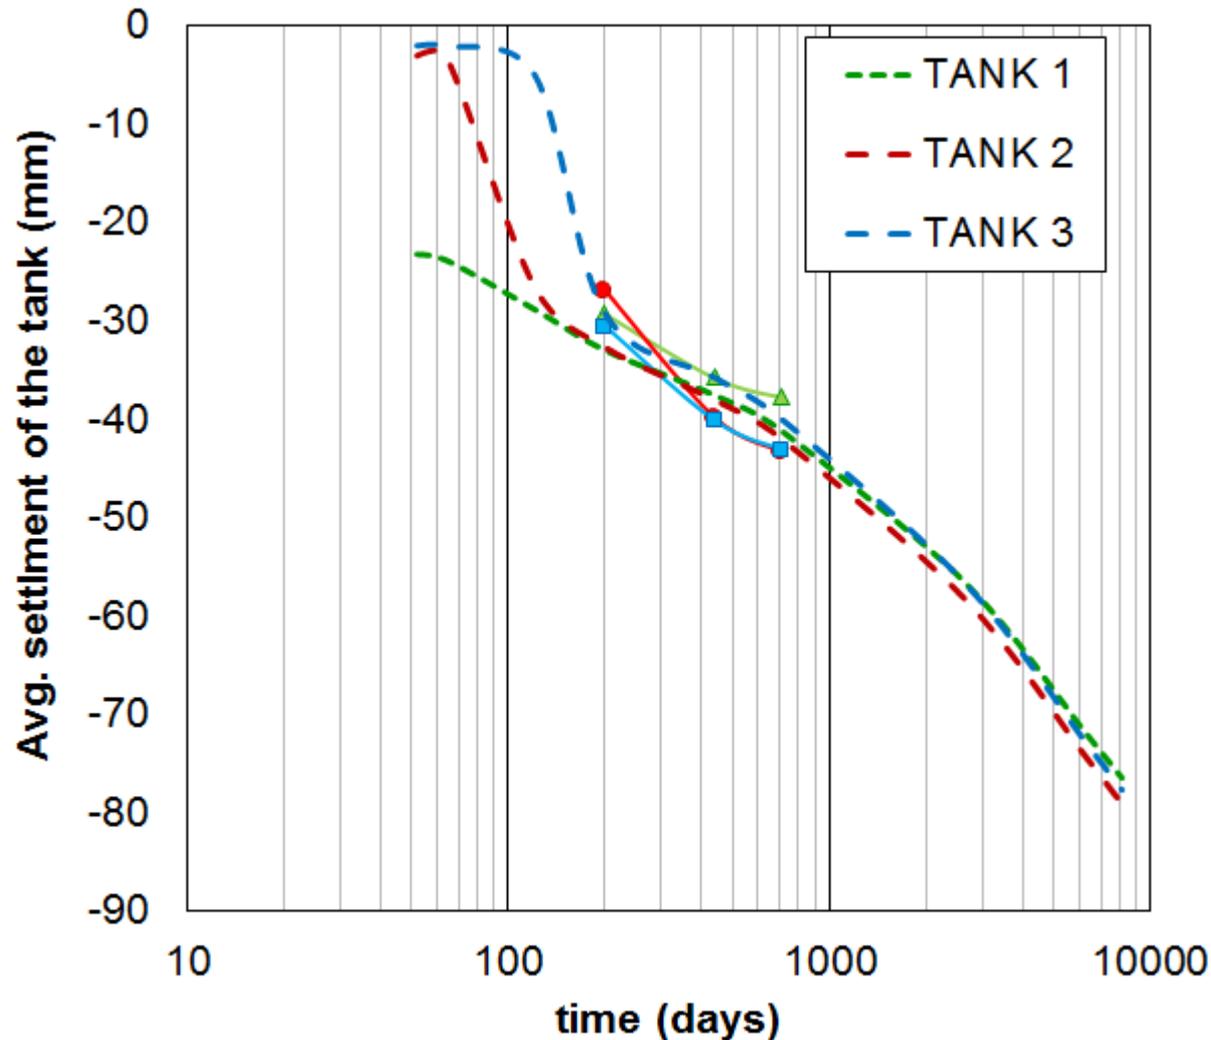
# Analysis of the time settlement behavior – Predicted (lines) vs measured (dots) average settlement

Fitting done on the basis of  $c_v/d^2$  (also the drainage path length is indeed unknown!!!)

This leads so far to a value of the time factor  $c_v/d^2 = 0.0023 \text{ month}^{-1}$

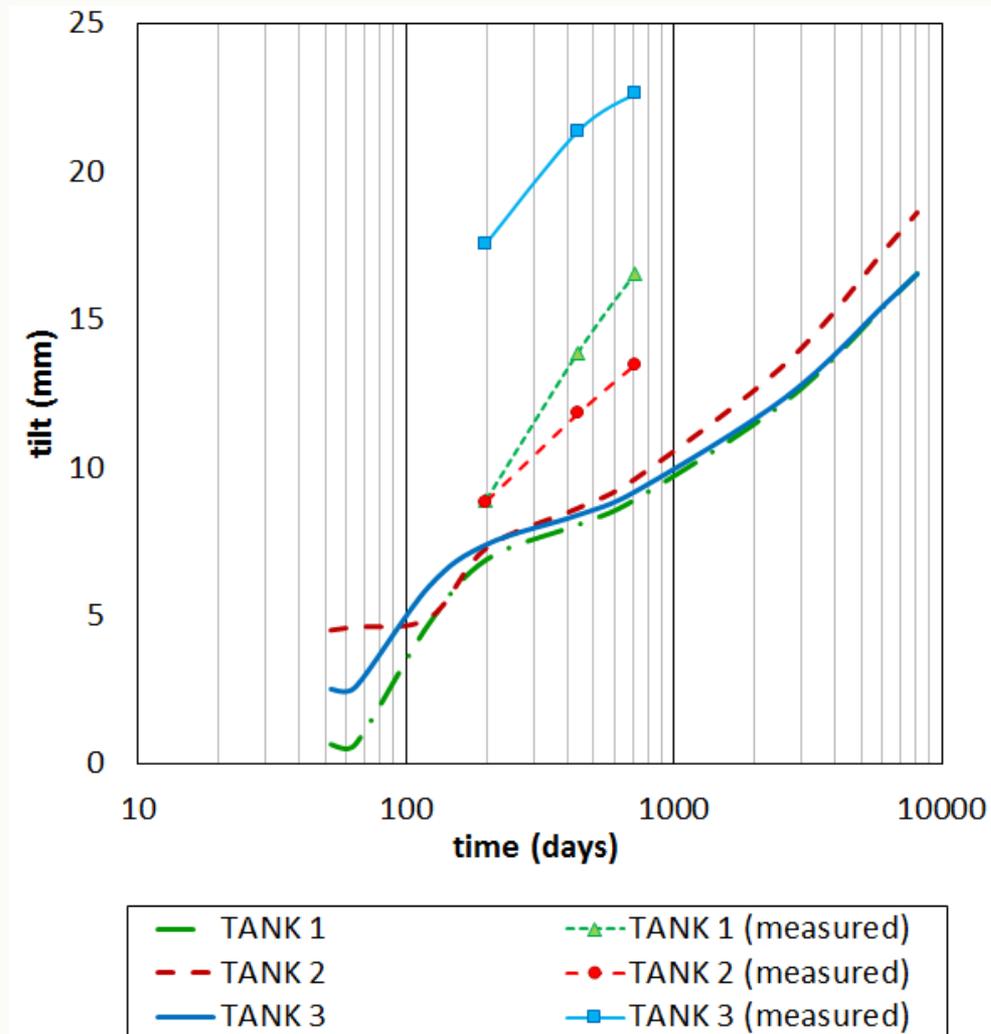
# Analysis of the time settlement behavior – Predicted (lines) vs measured (dots) tilt of the tanks under operational load
