Wick Drains and Piling for Cai Mep Container Port, Vietnam, and the true cost of 5 cent per foot

Bengt H. Fellenius

May 27, 2016

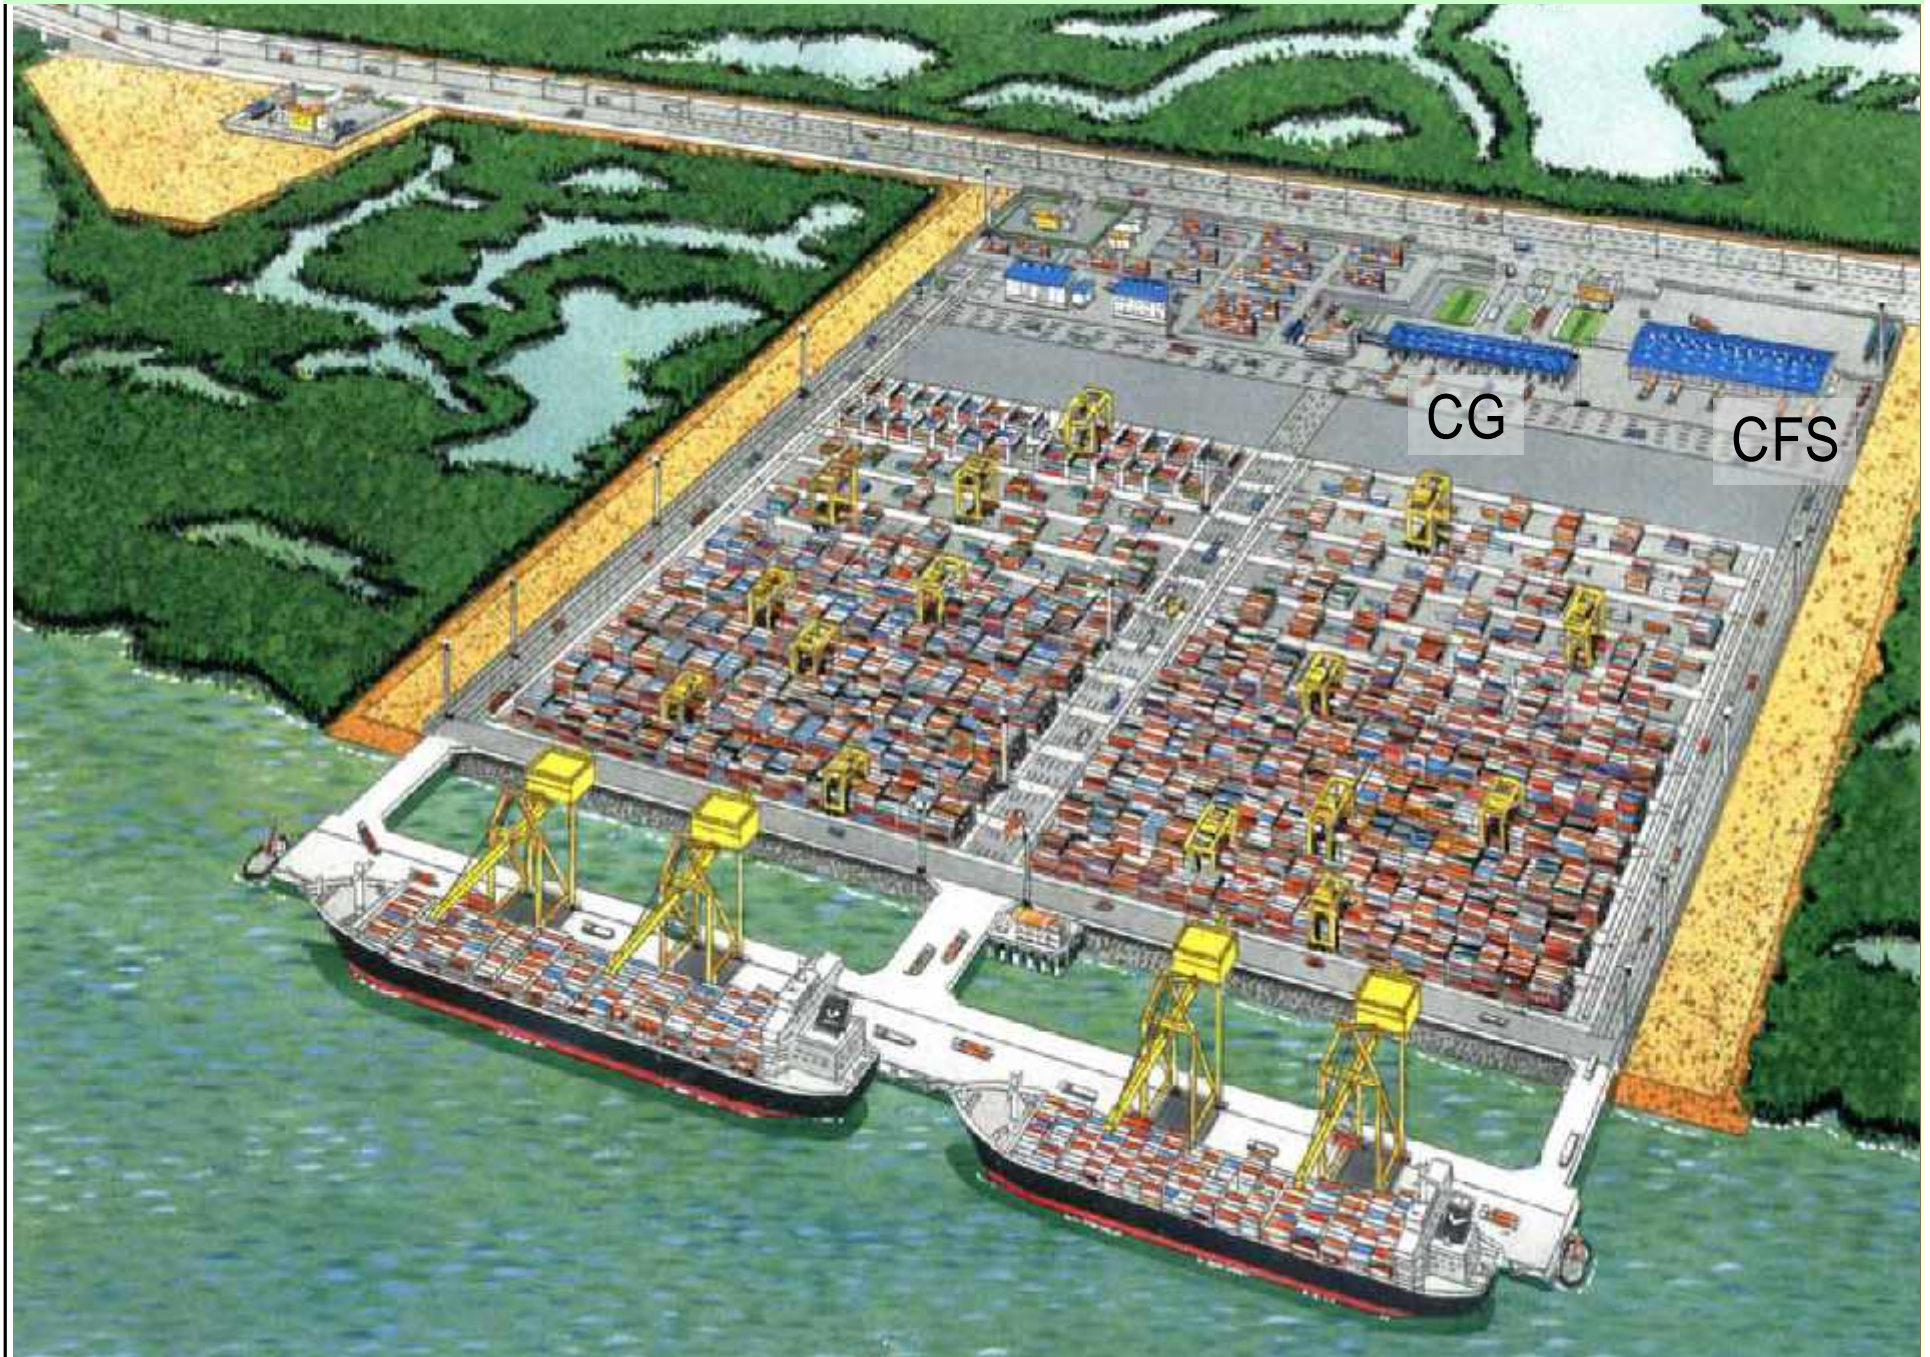
The site of the new container facility extends over an 800 m by 600 m area along the Thi Vai River

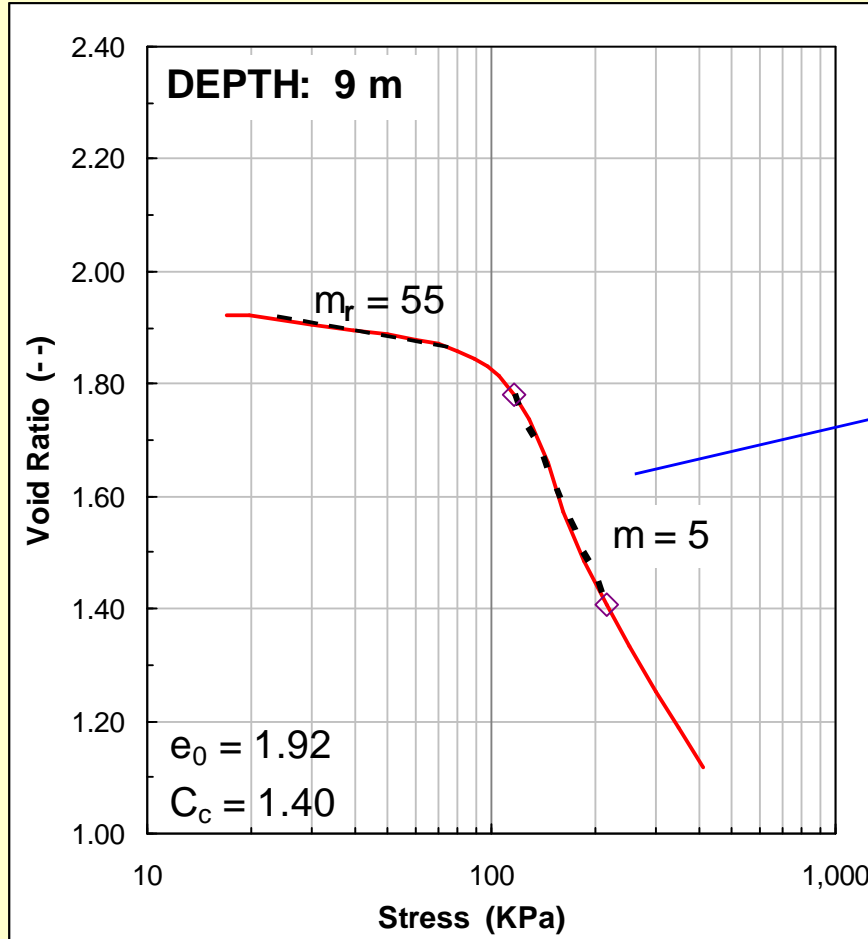
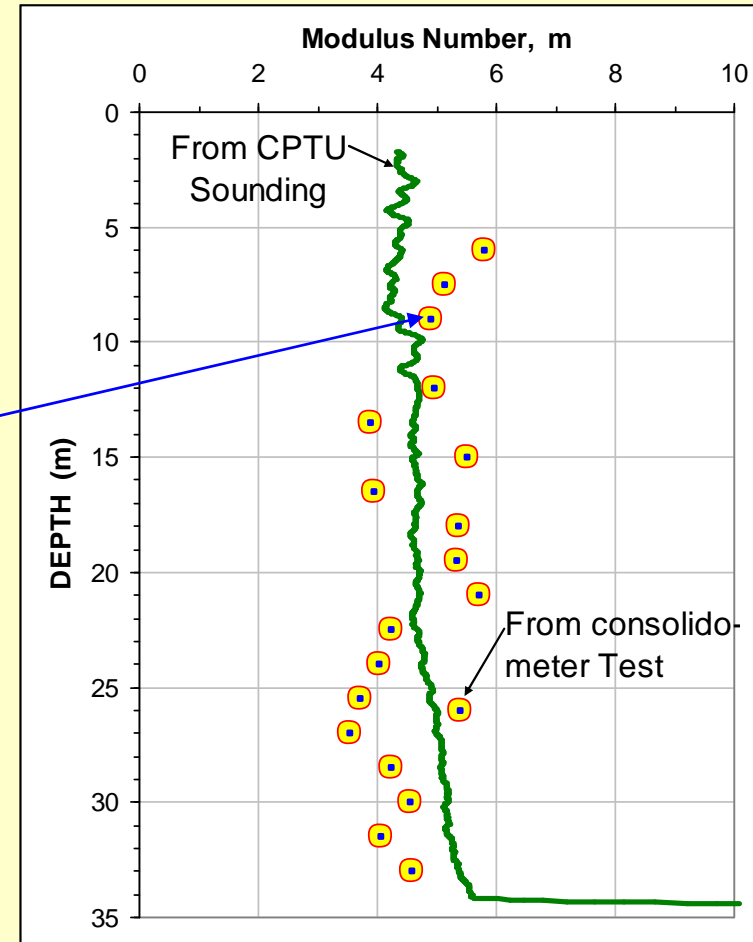
Results from a large series of consolidation tests show the soil to be very compressible, normally consolidated

Typical example of results

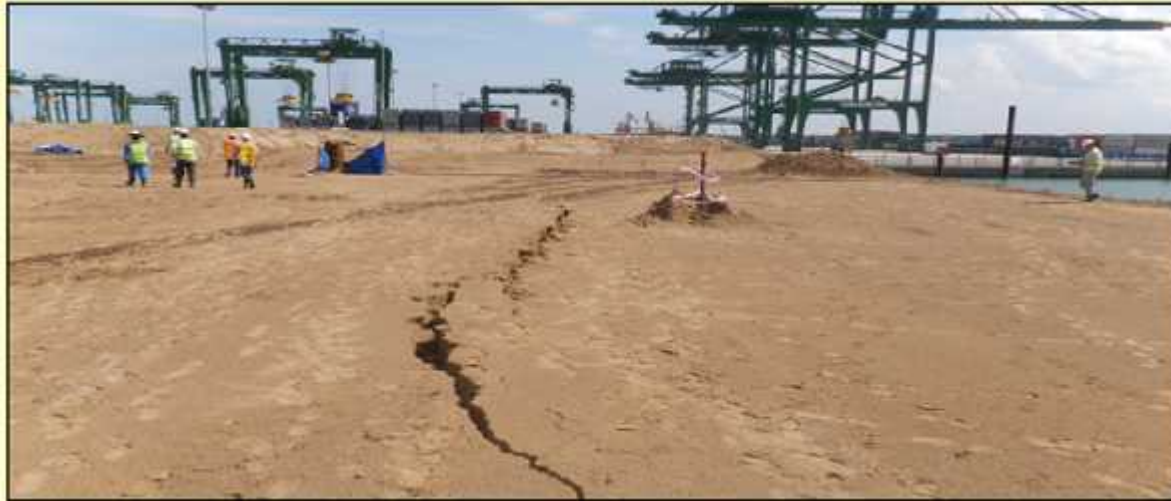
Downstream view of the first cracks that appeared at Thi Vai site along the riverbank (April 5, 2010)

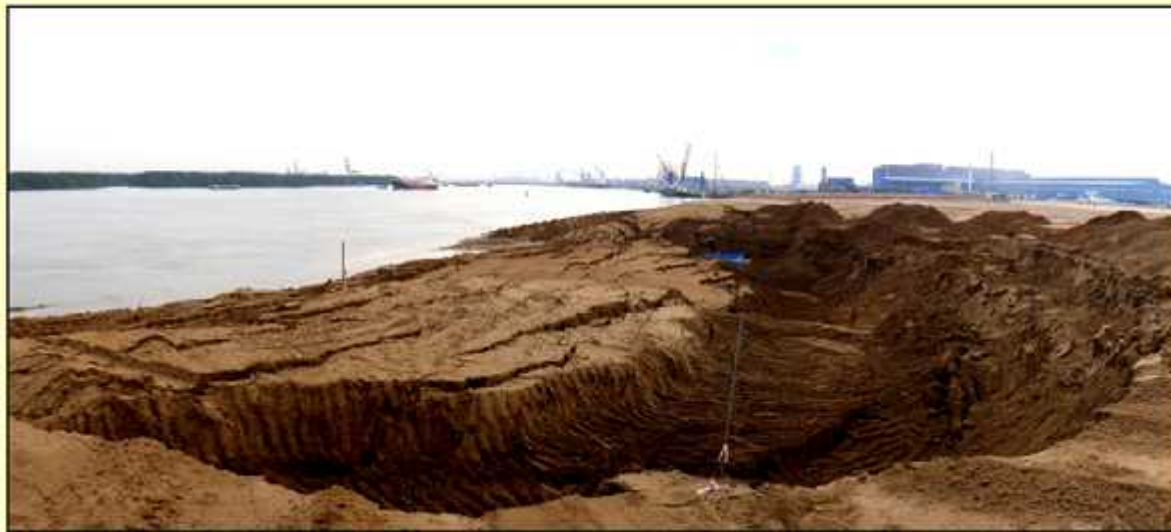
Slope failure on July 12, 2010, viewed upstream

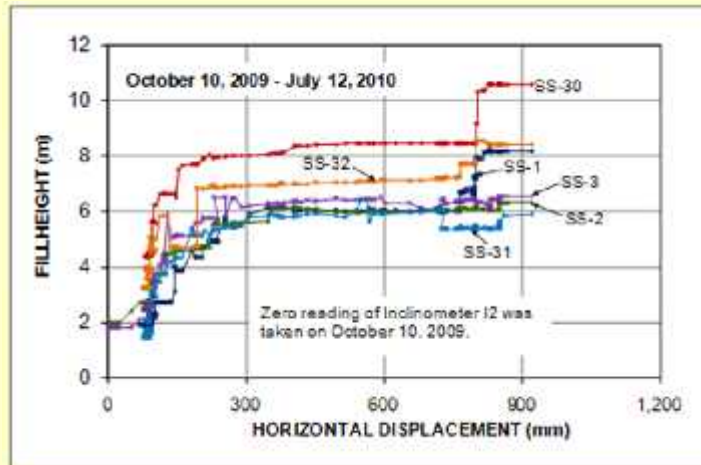
Fill Height vs. Horizontal Displacement

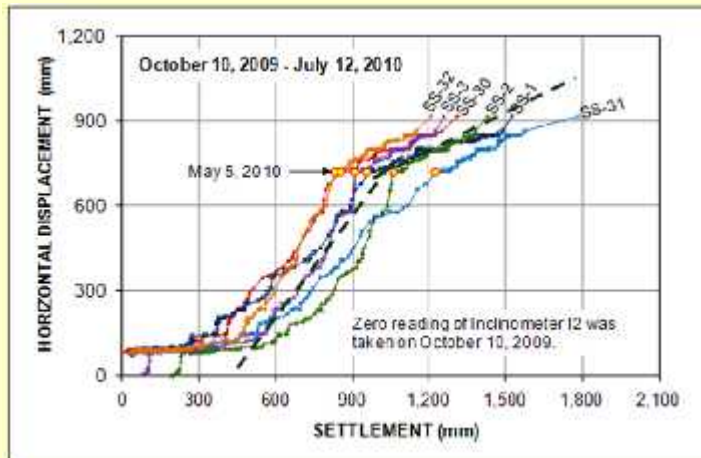
Horizontal Displacement vs. Surface Settlement

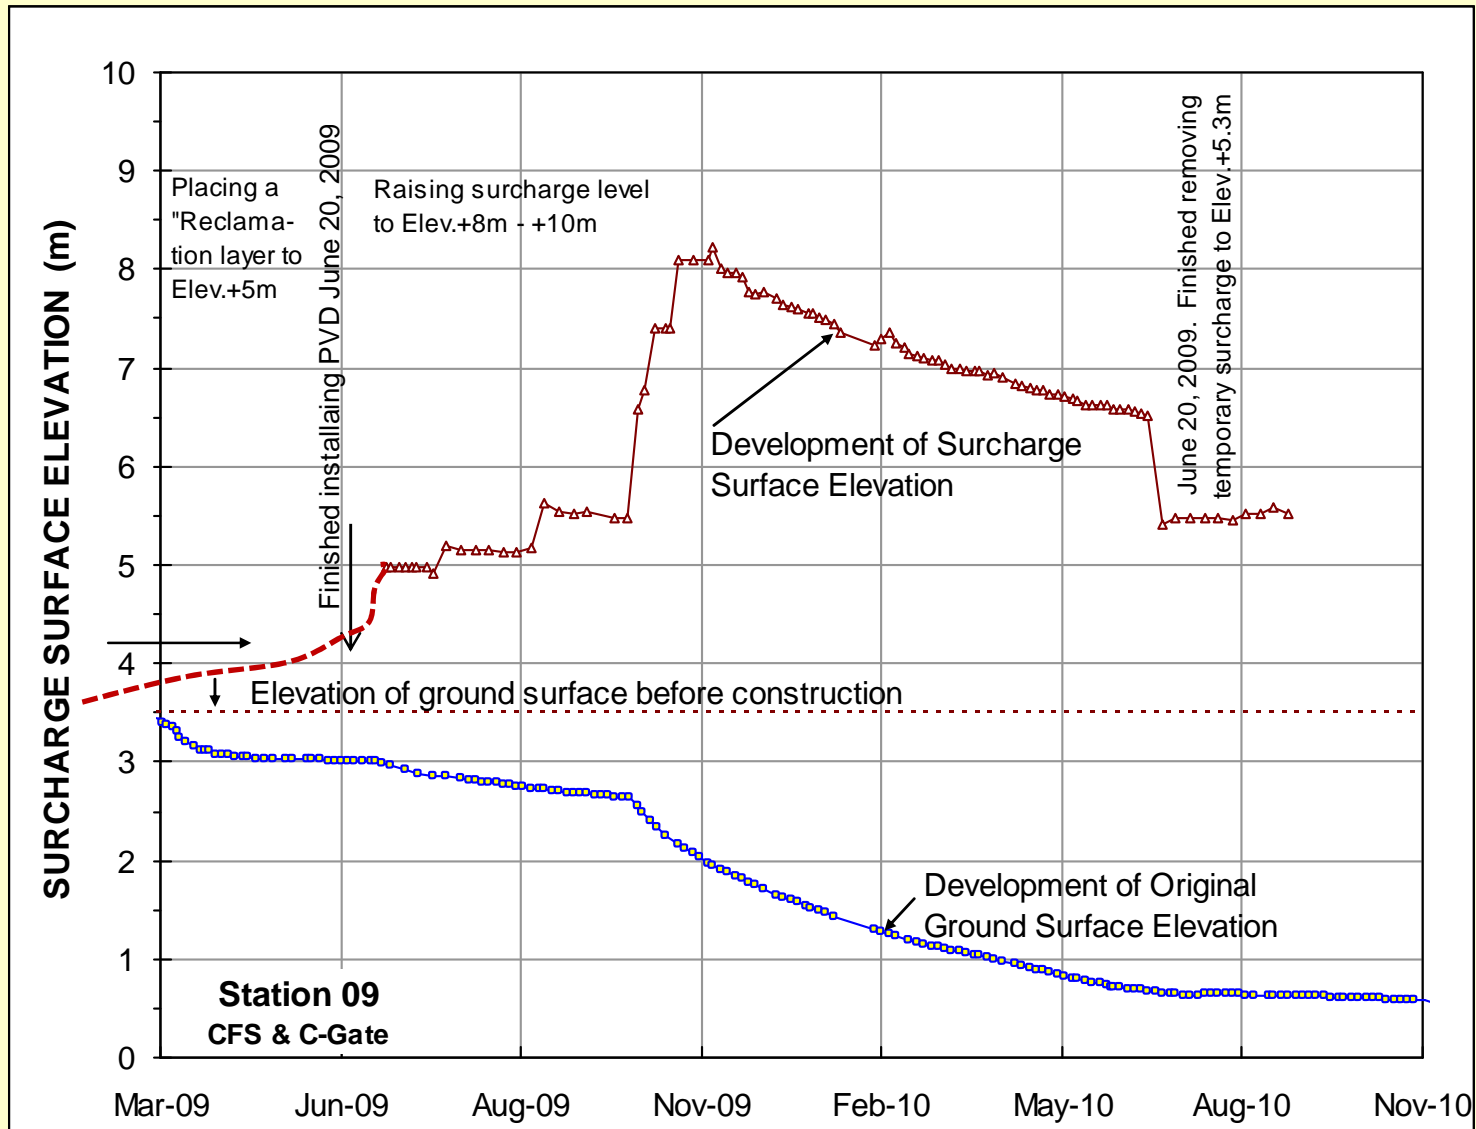
Fill height and pore pressures measured June 24, 2009, through September 17, 2010 (Days -527 and -77) at the CFS building

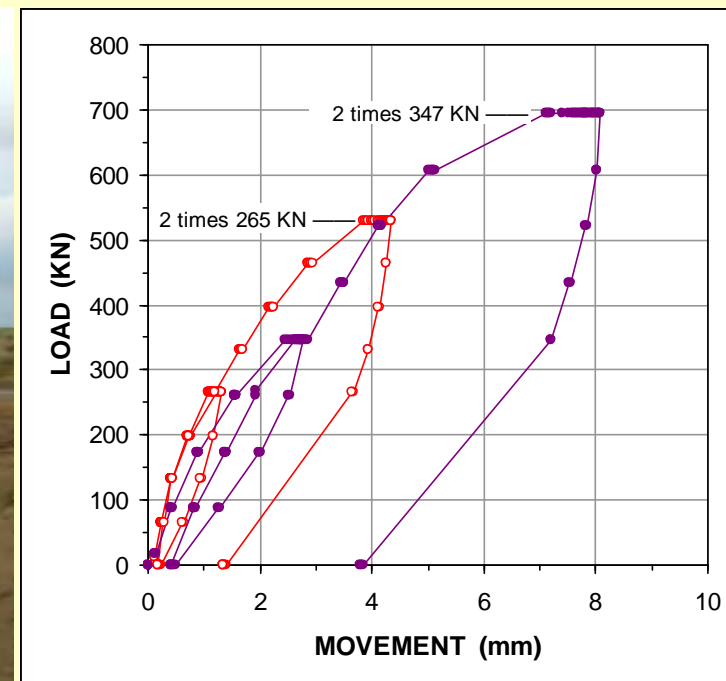
The static loading tests (CFS and CG) were carried out in September 2010, nine months after pile driving

Load-movement curves from static loading tests at CFS and CG buildings

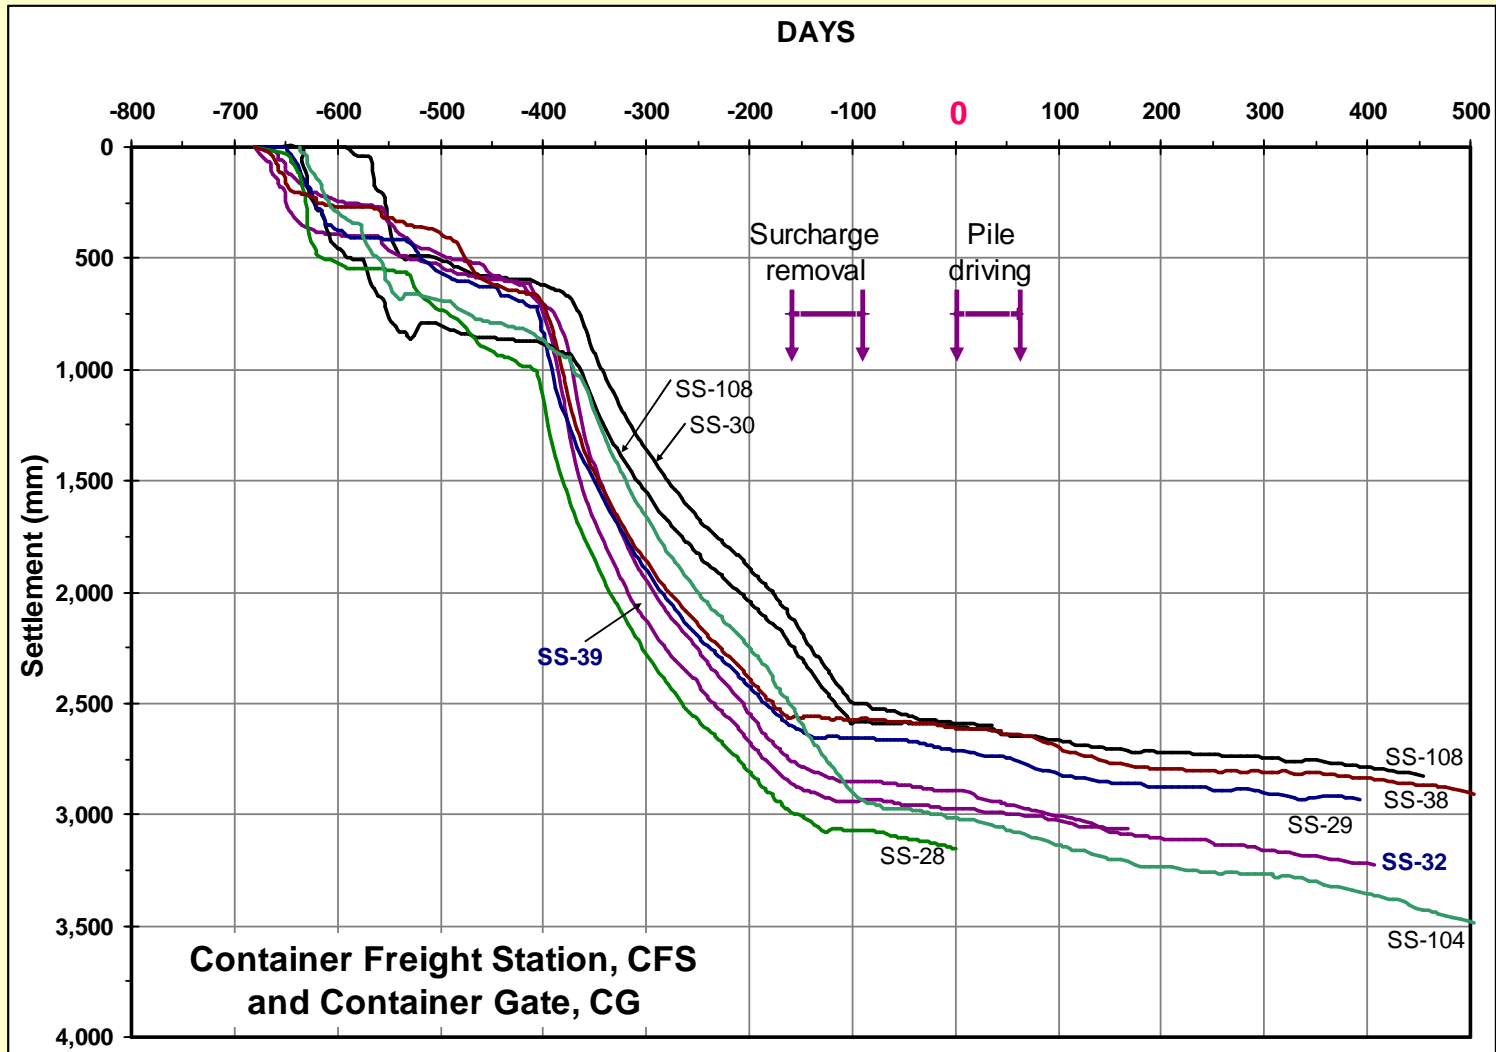
The below figure shows the settlements measured by the SS-plates at or near the buildings until November 15, 2011. The zero date is December 1, 2010, the day of the start of the pile driving for the CGS building. Driving was completed on January 24 at the CG building.

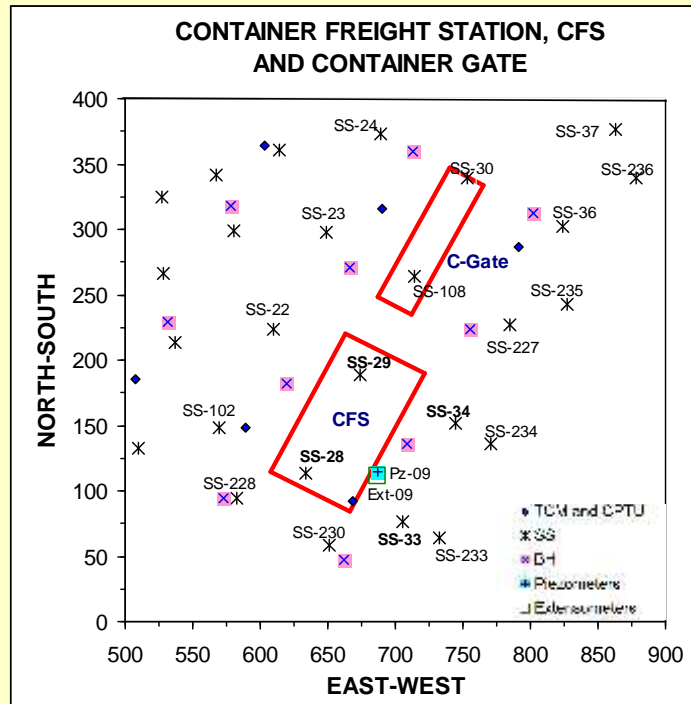
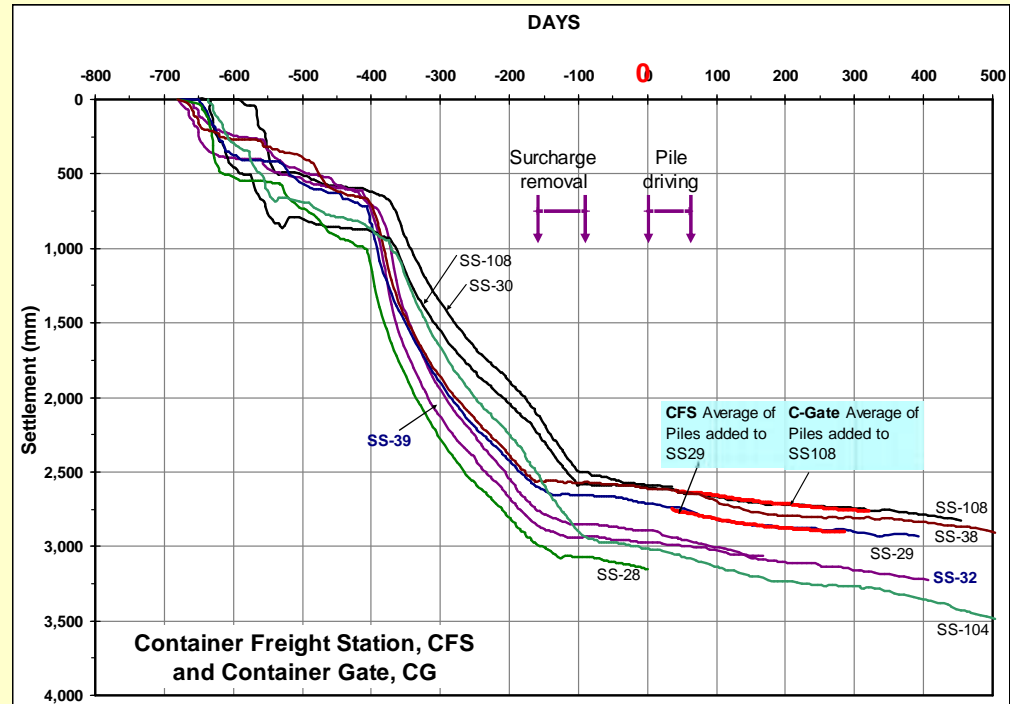
Container Freight Station (CFS) and Container Gate (CG)

Settlements of ground surface and pile heads

Settlements measured for SS-plates and 28 m long piles at the CFS and CG buildings until November 15, 2011

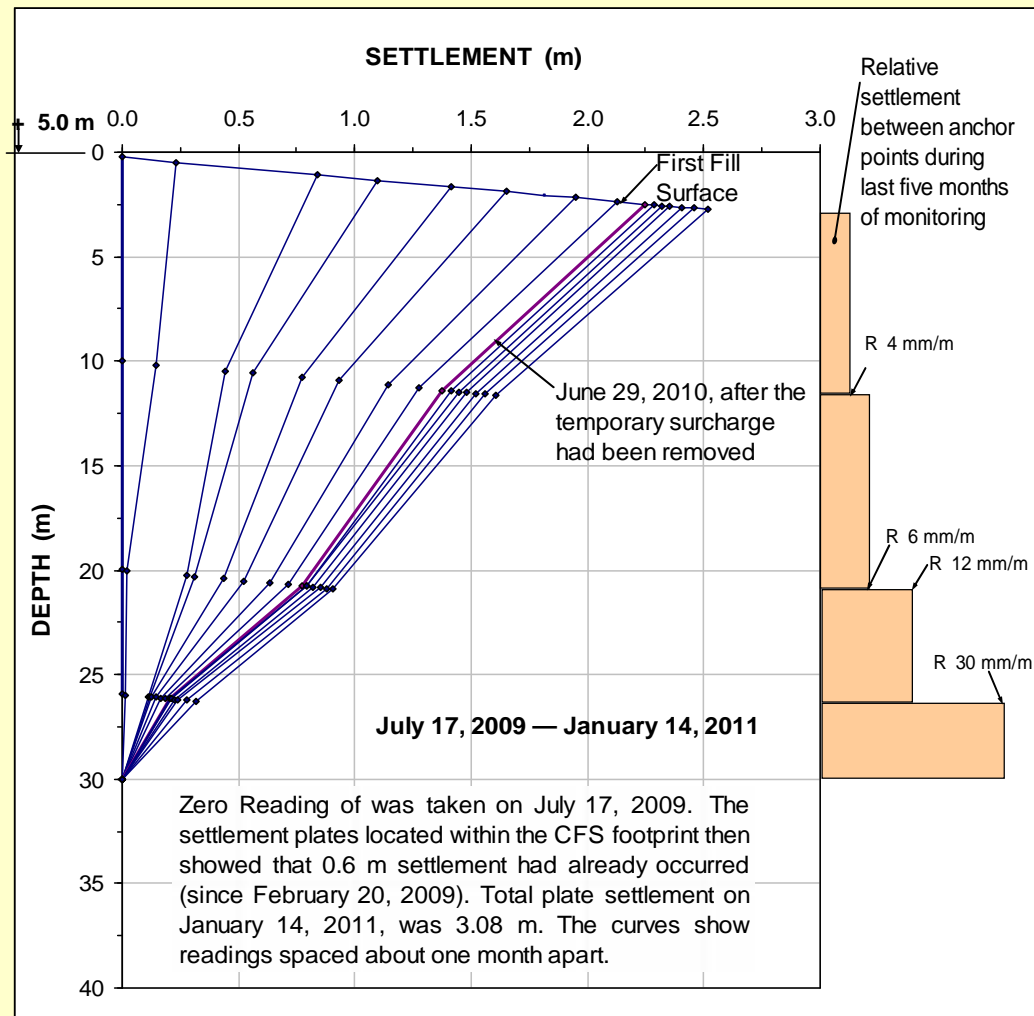
Fill height and settlement Measurements used as input to analysis

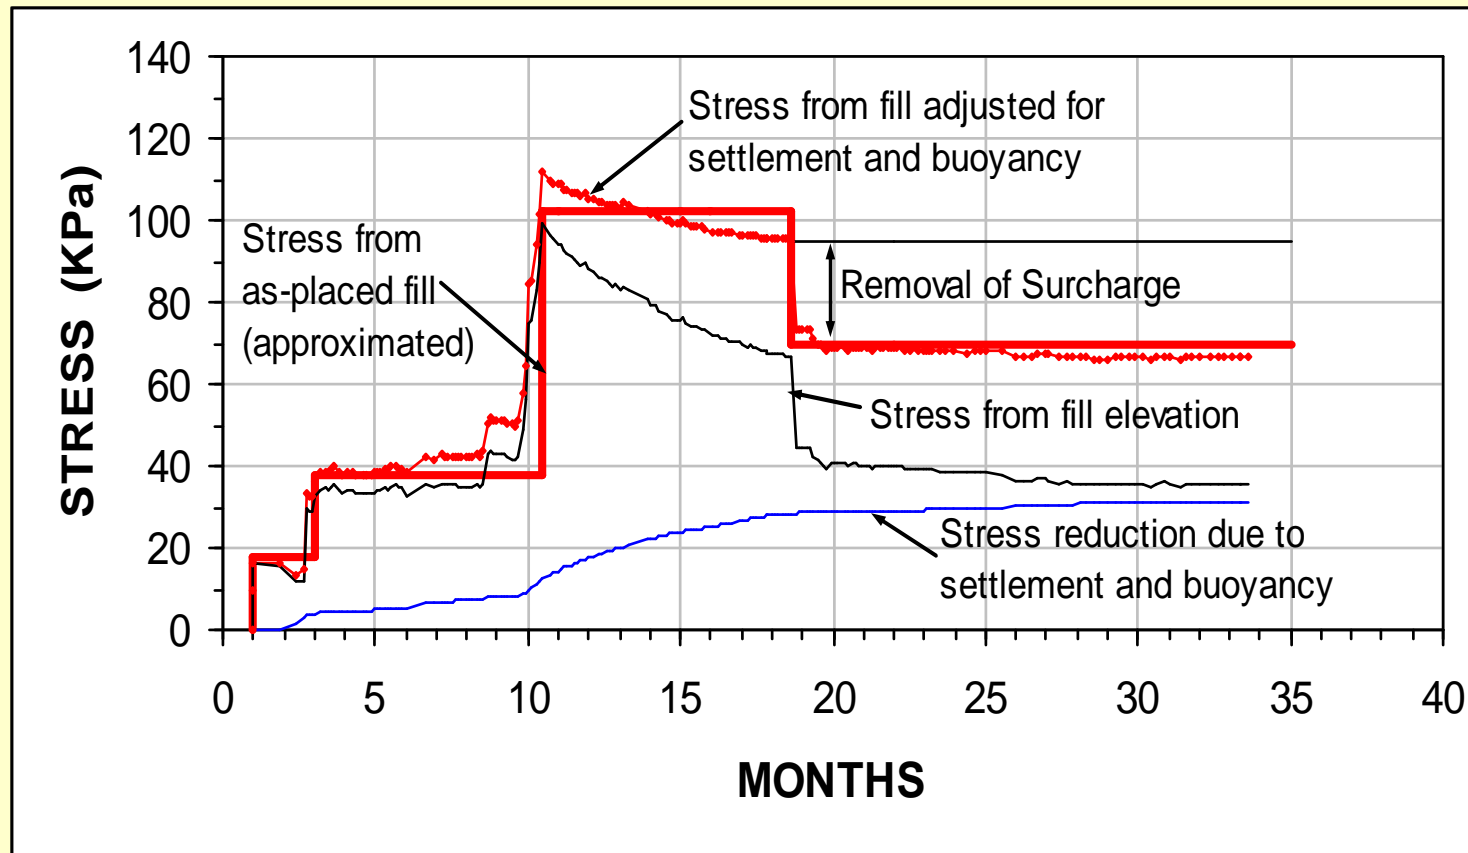
UniSettle4 input and results

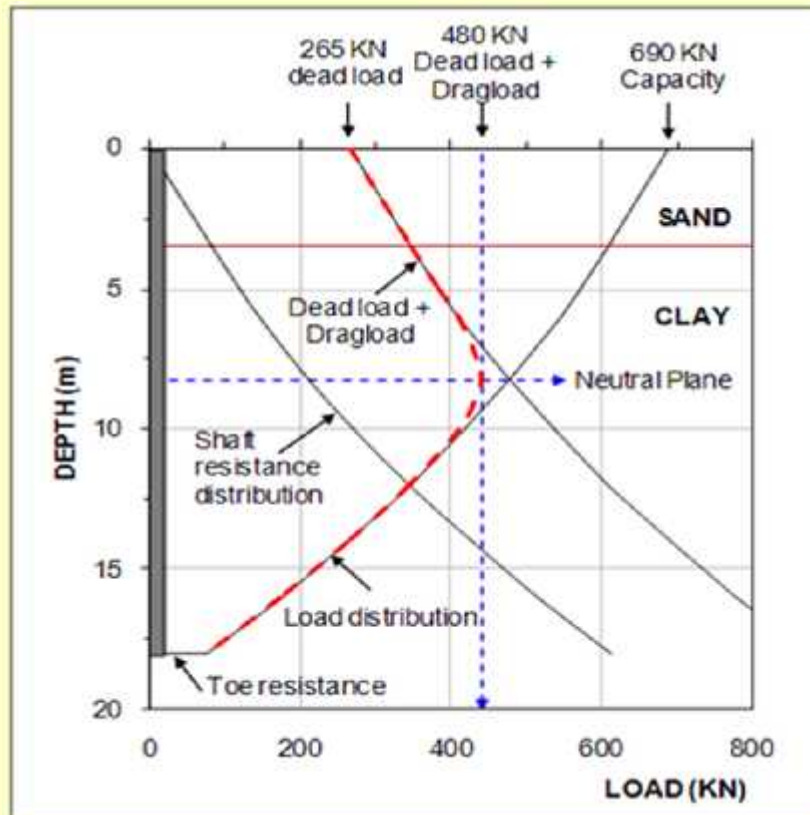
Analysis of the 18 m long pile

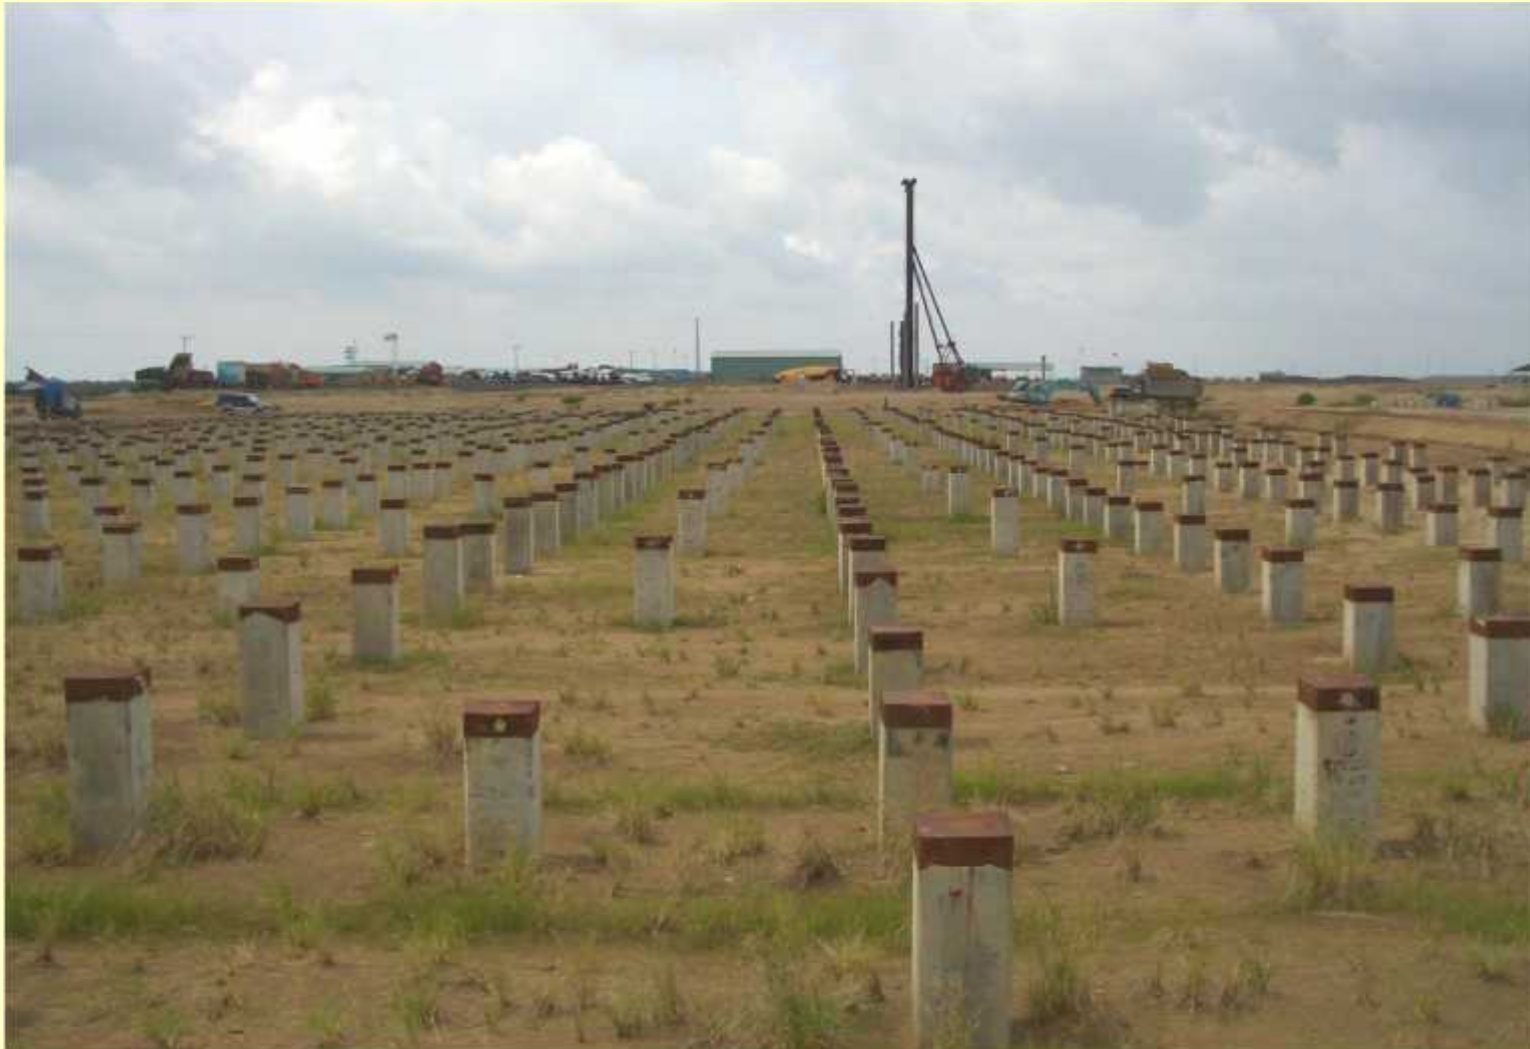
View on October 4, 2011, taken from the south end of CFS building showing some of the about 750 piles driven for the CFS building. In the background, lengthened piles are being driven for the CG building.

The problem with the settling piled foundations can be (and was hopefully) resolved by lengthening the piles to bring the neutral plane (the depth to the settlement equilibrium) into the non-settling sand below the clay.

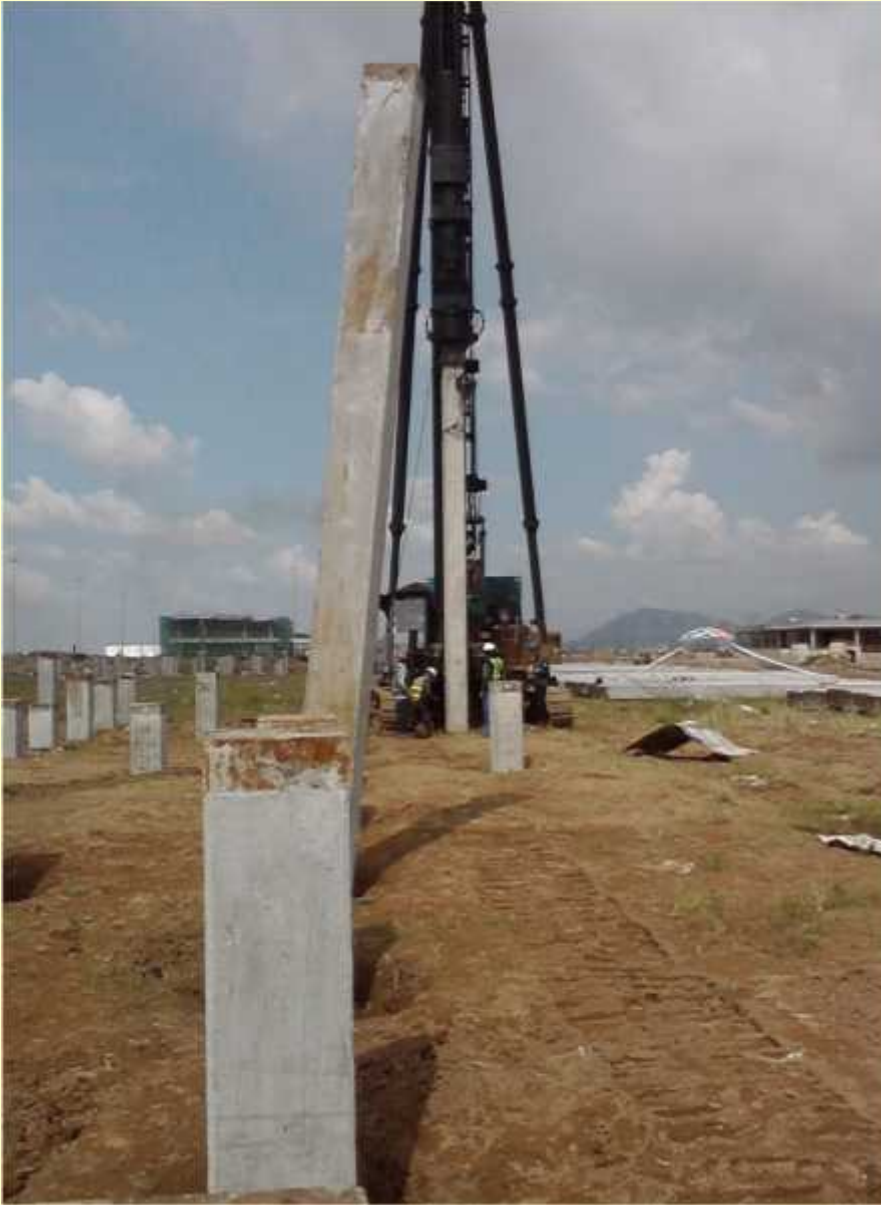
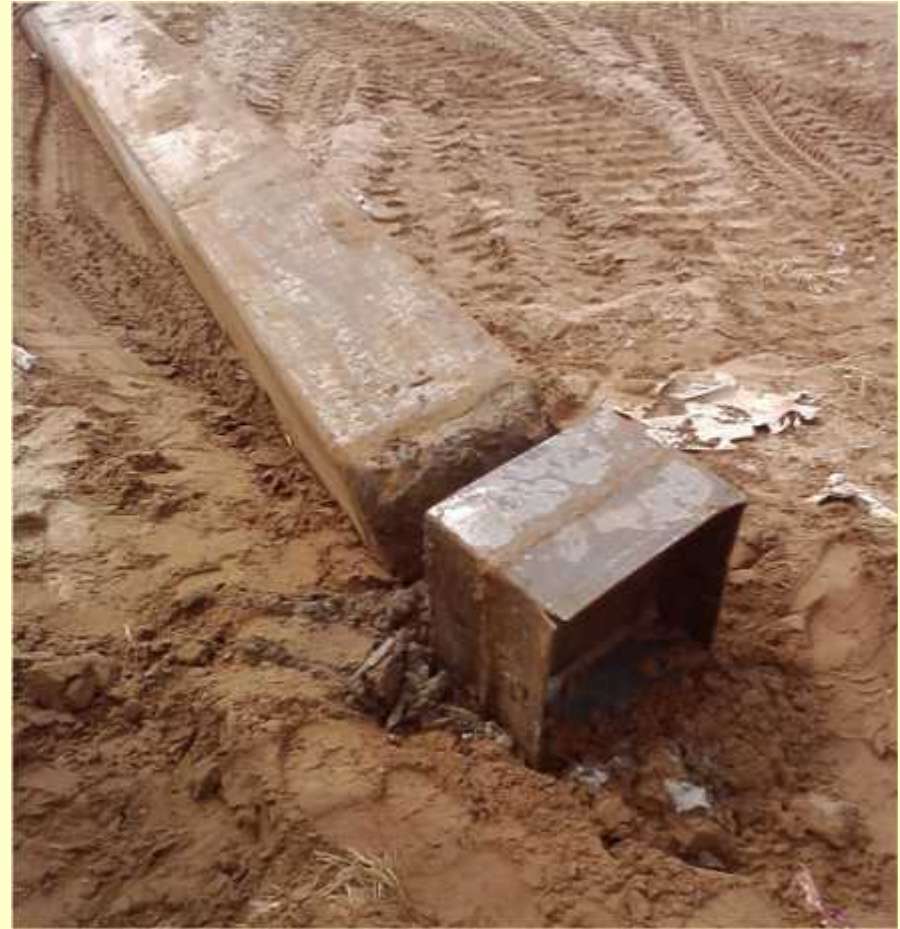
Photos from the driving of piles with extension
