Fukushima Daiichi nuclear accident: spotlight on Unit 4

Cristina P. Tanzi

8 november 2019

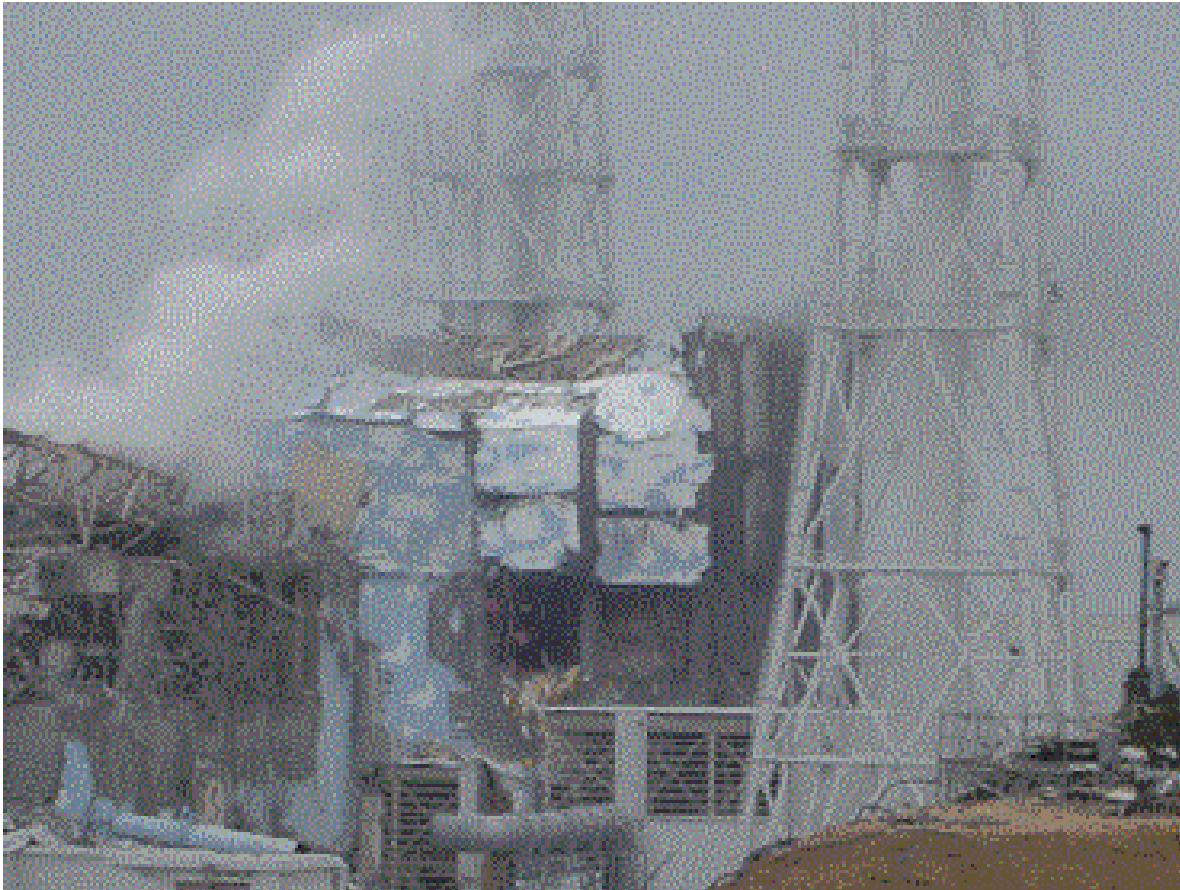
Unit 4 reactor building after the hydrogen explosion

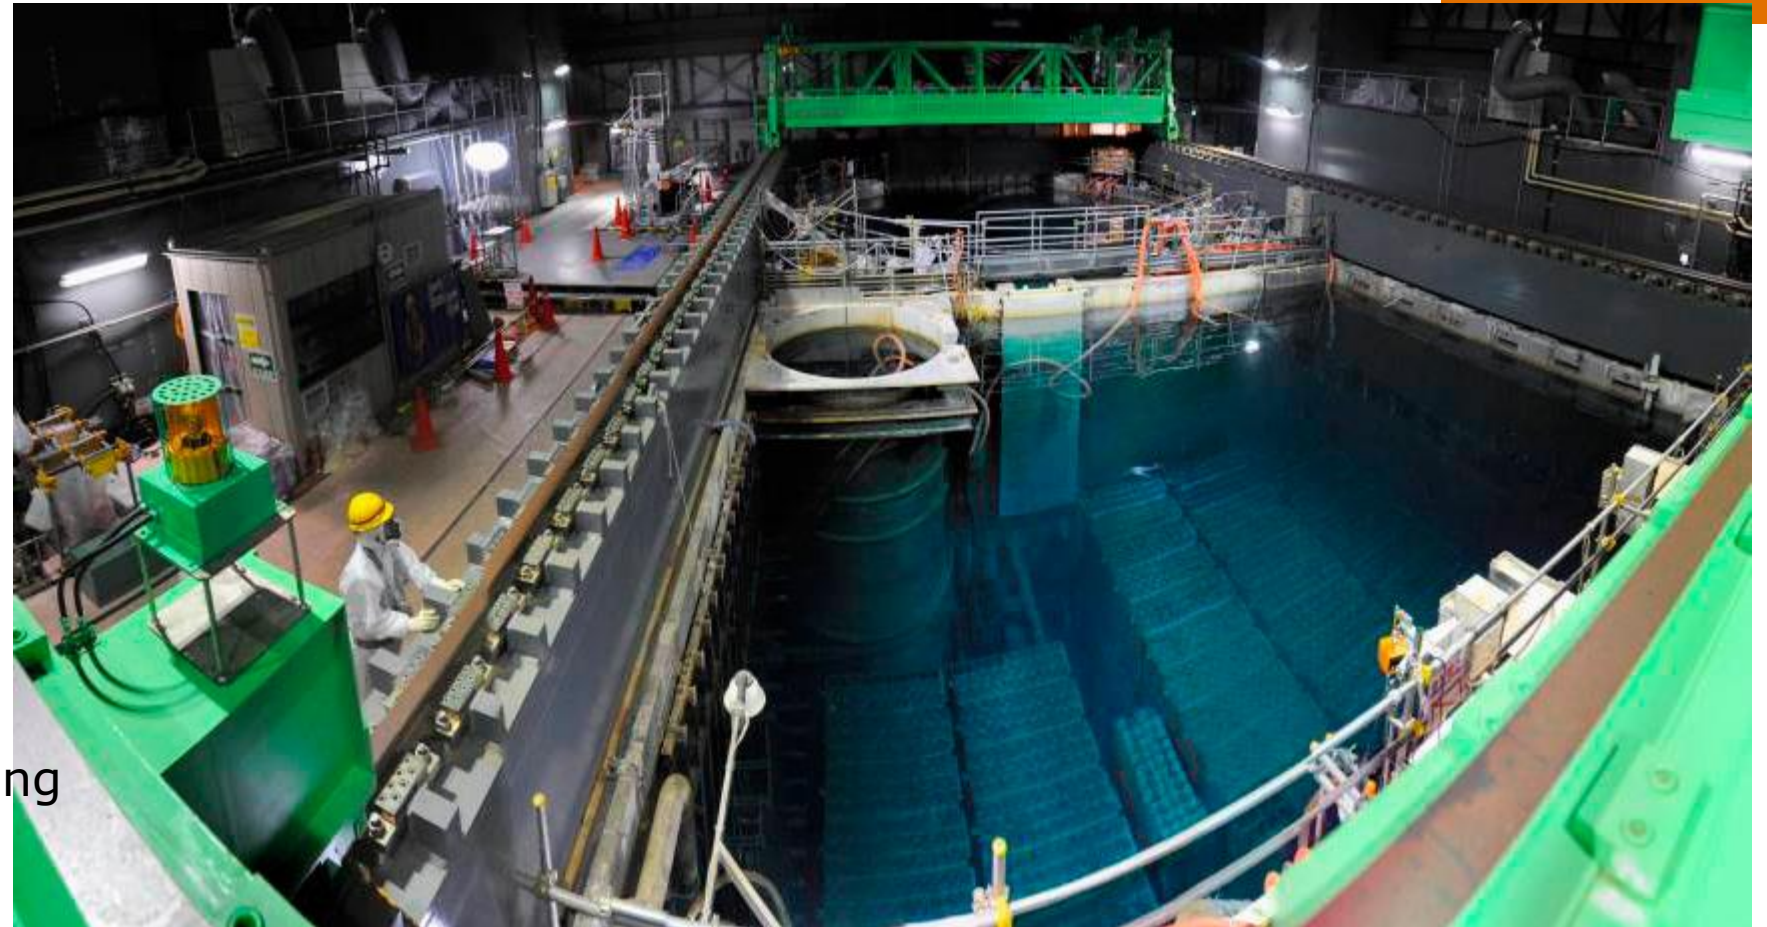
Unit 4 refueling deck on November 7, 2013

- SFP in foreground: fuel racks visible at bottom

fuel handling machine

- reactor well (background) separated by the steel gate far wall
- green apparatus above reactor well lifts gates

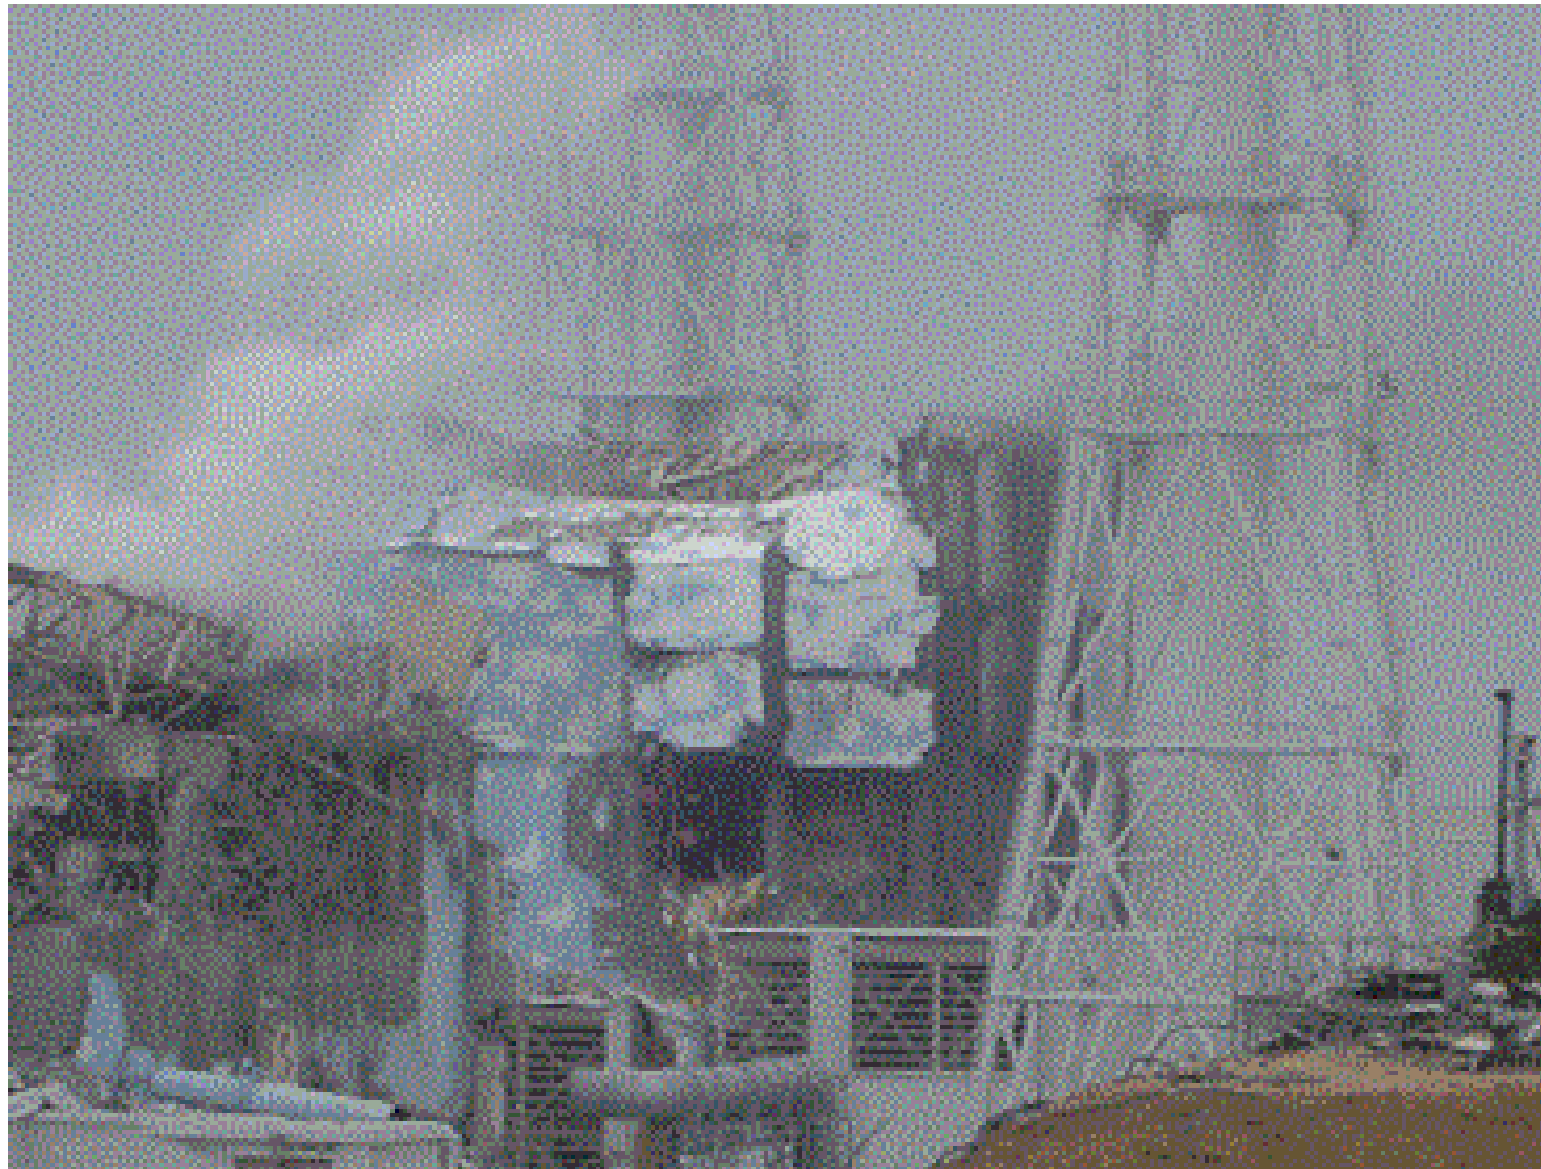
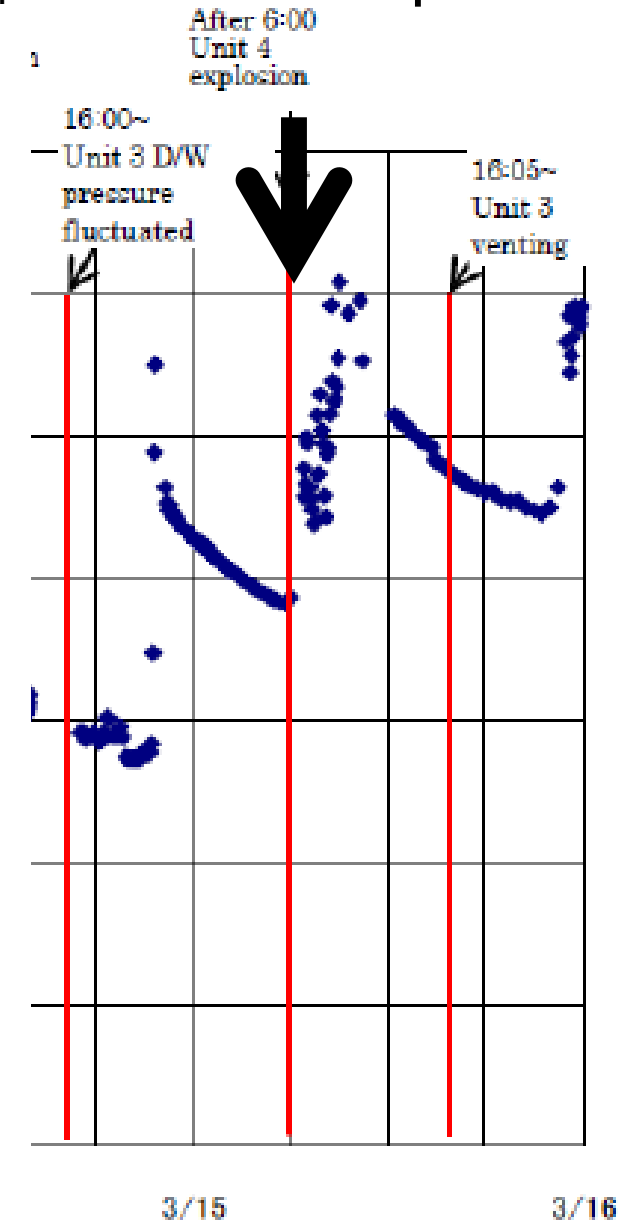
Unit 4 explosion

Unit 4 reactor building after the hydrogen explosion of March 15 06:14

- **explosion in Unit 4 reactor building** at 06:14 JST
- destroys roof, most walls on the fourth and fifth (refueling deck) floors, damages third floor
- ALSO: an explosion noise heard at local HQ
- ALSO: white smoke/steam seen from Unit 2 at 08:25
- ALSO: radiation levels spike
(11.93 mSv/h at main gate 09:00, highest since start)
- ALSO: drop in pressure reading of Unit 2
(0! atm, possible PCV failure)

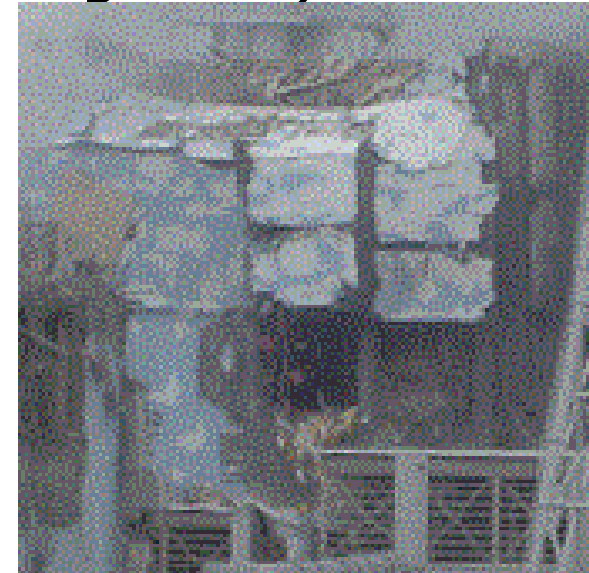
explosion of Unit 4 building observed by survey team, **reported 08:11**

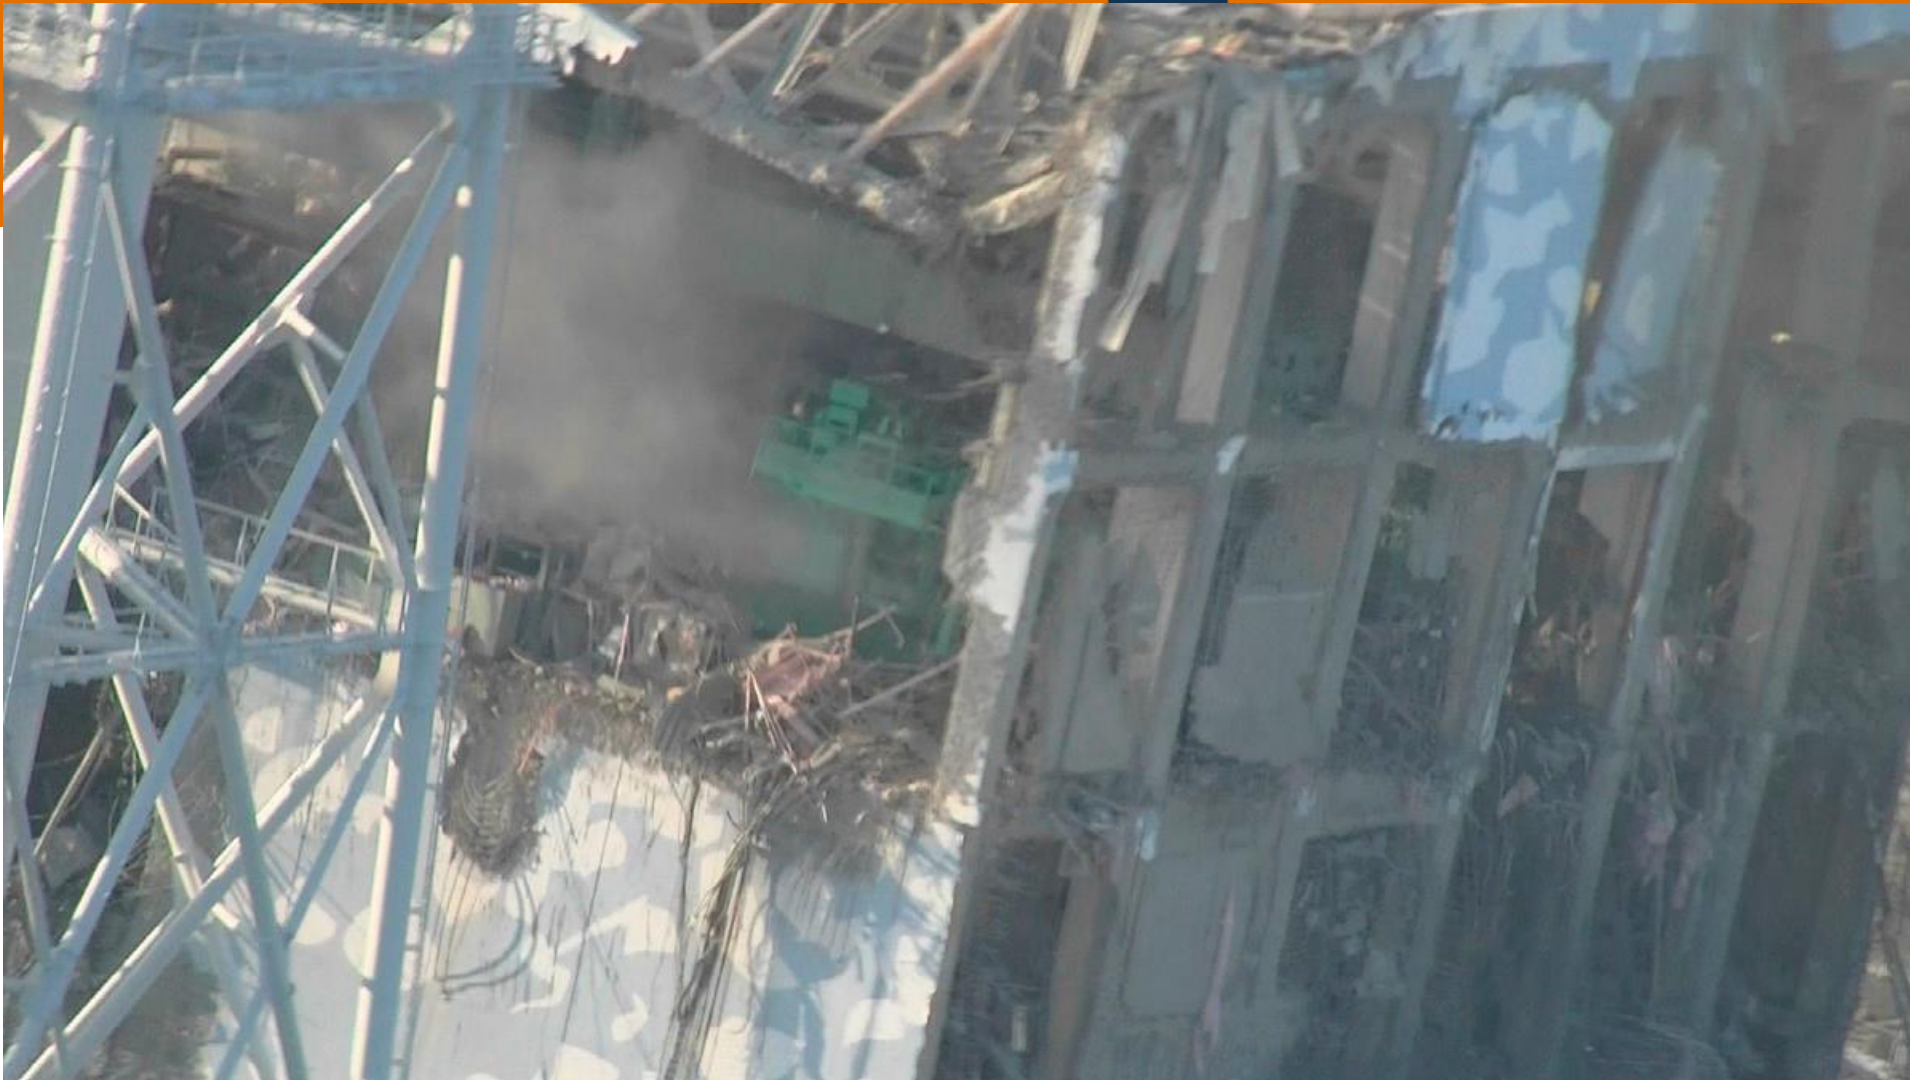
Unit 4 refueling deck
(green equipment in center image is fuel handling machine)

March 16, 2011, helicopter overflight

March 16: helicopter overflight captured video of sunlight glinting off water in SFP

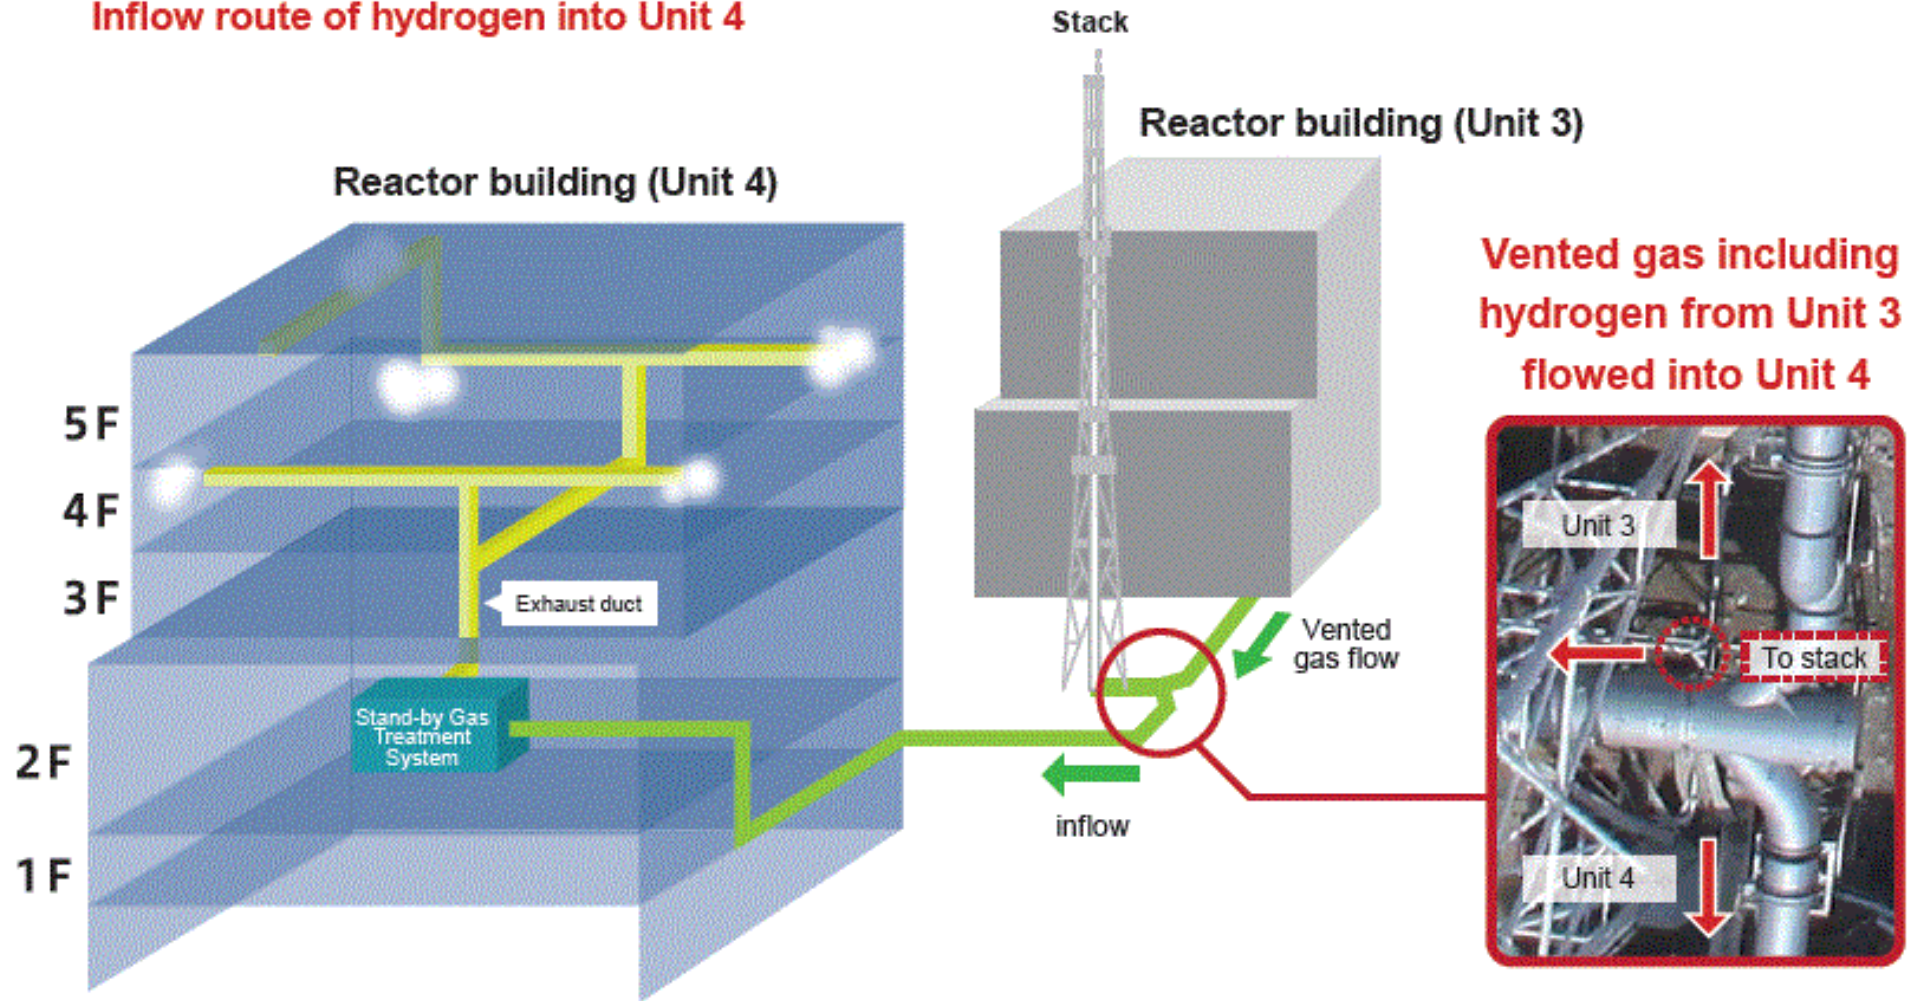
Inflow route of hydrogen into Unit 4

- **What must have happened**
- May 2011: TEPCO says that the explosion was due to the combustion of hydrogen that was generated in Unit 3 and flowed into Unit 4 through the ventilation system.
- WAS TOP OF FUEL EVER UNCOVERED? Unlikely; if so, no damage

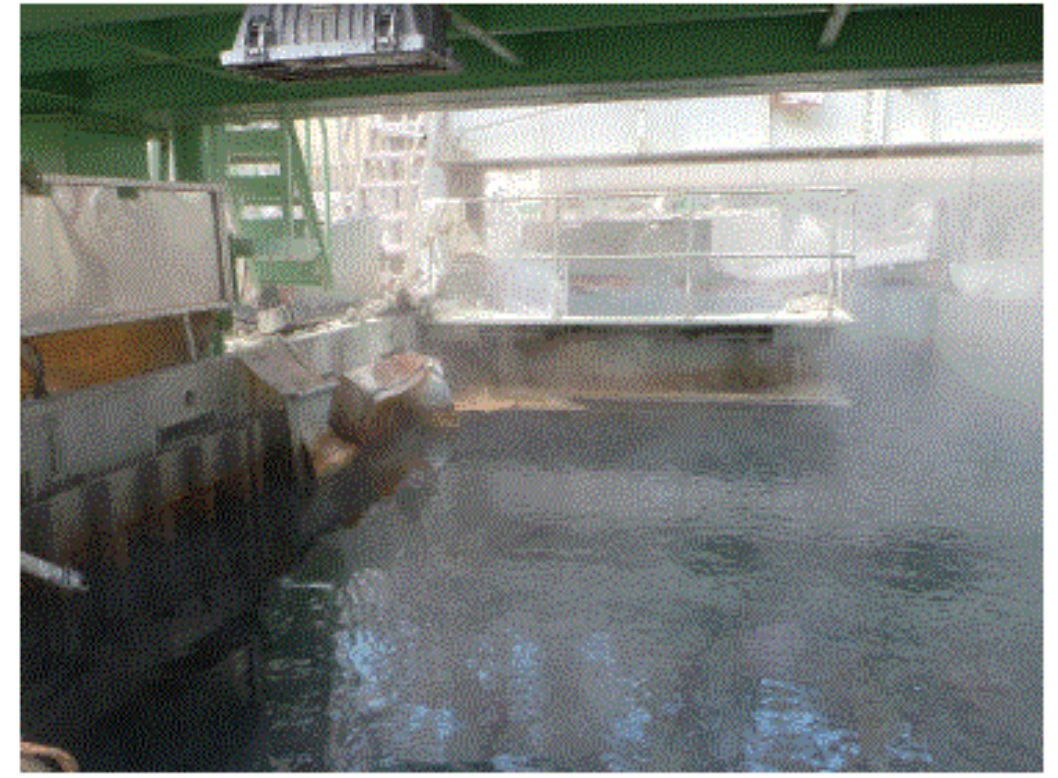
Conditions at the Unit 4 spent fuel pool, photographed June 29, 2011

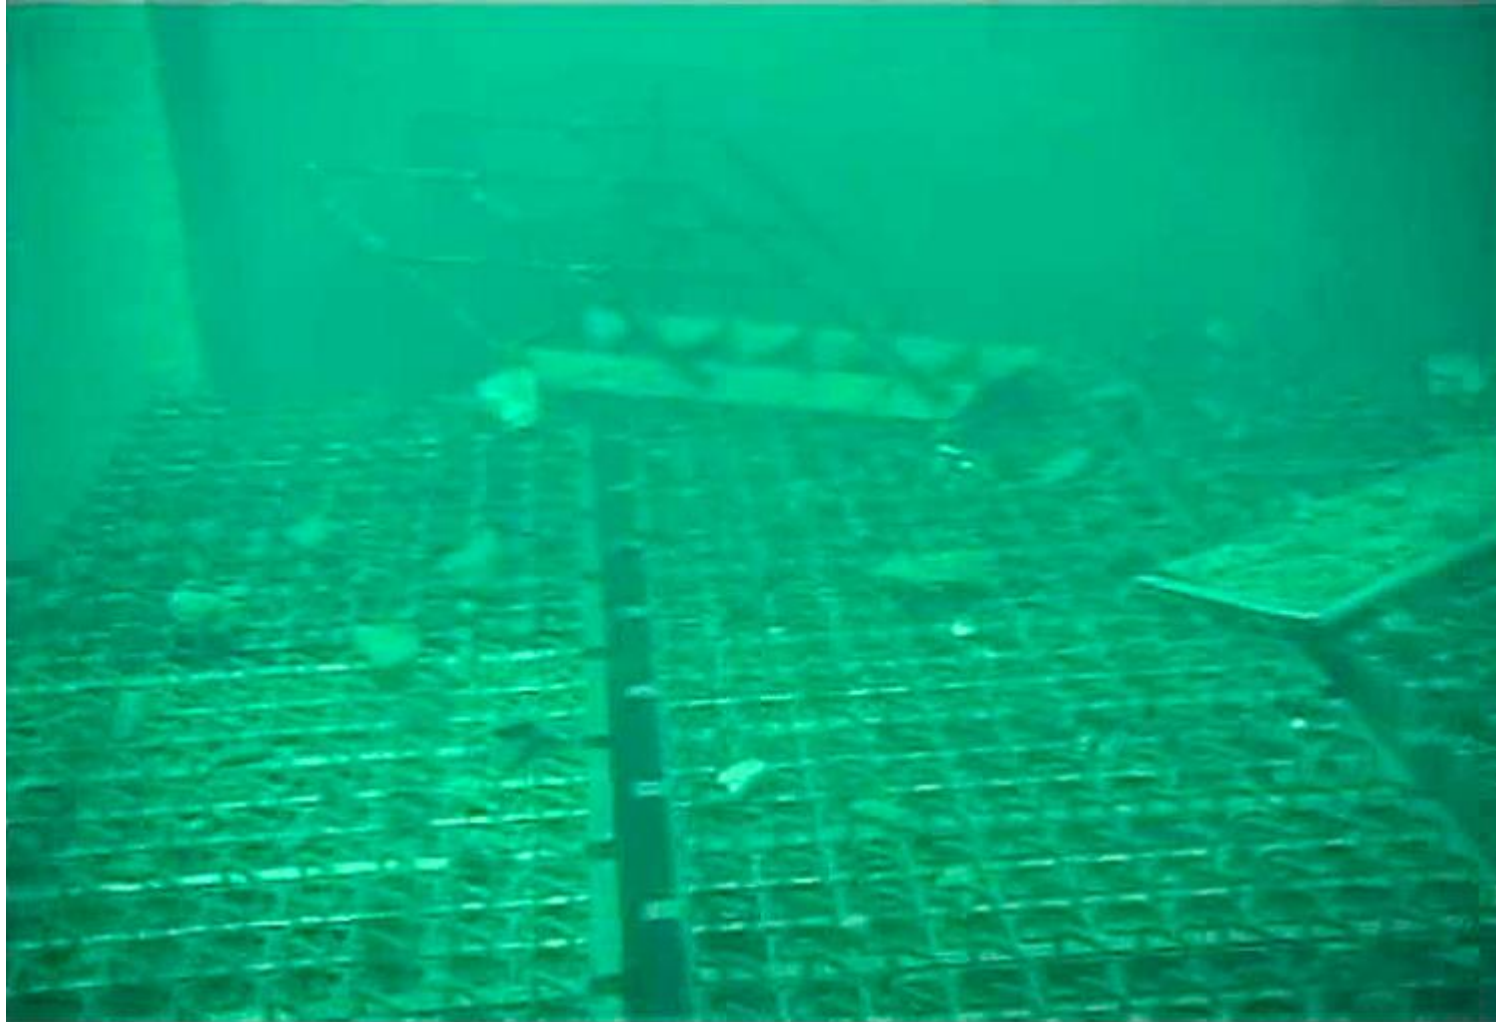
Debris on top of fuel racks in Unit 4 pool

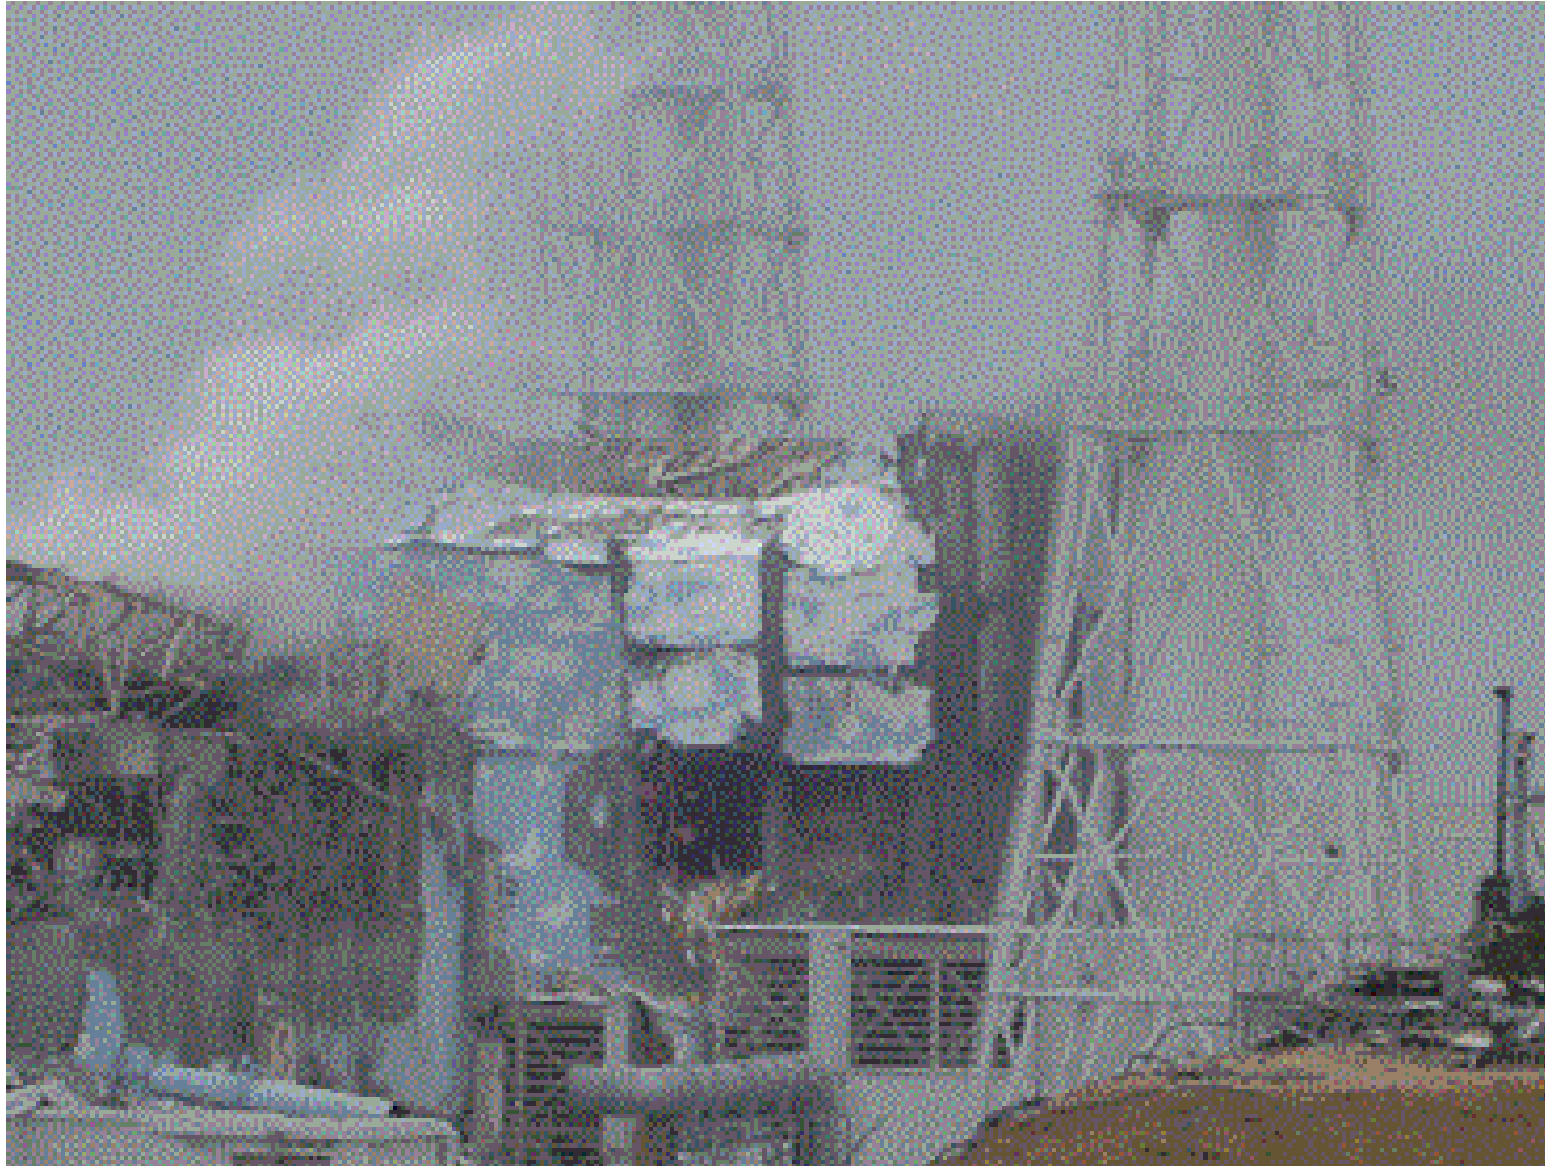
Unit 4 reactor building after the hydrogen explosion

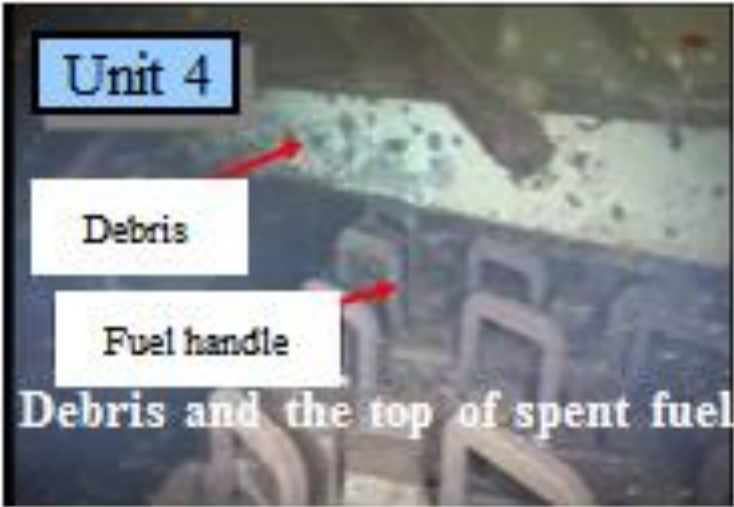
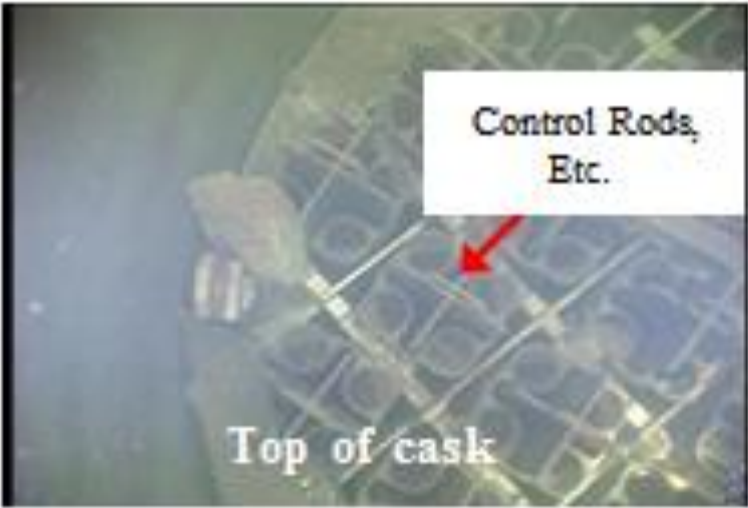
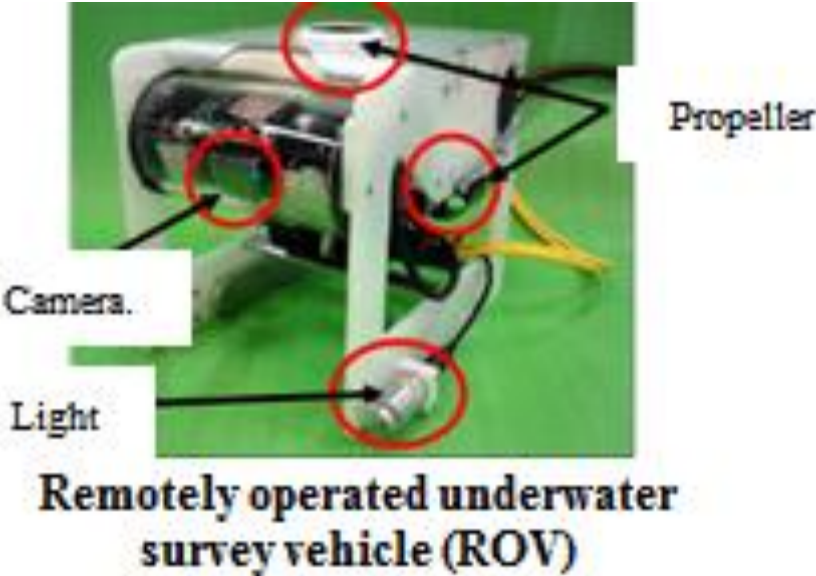
Unit 4 SFP debris dispersion survey

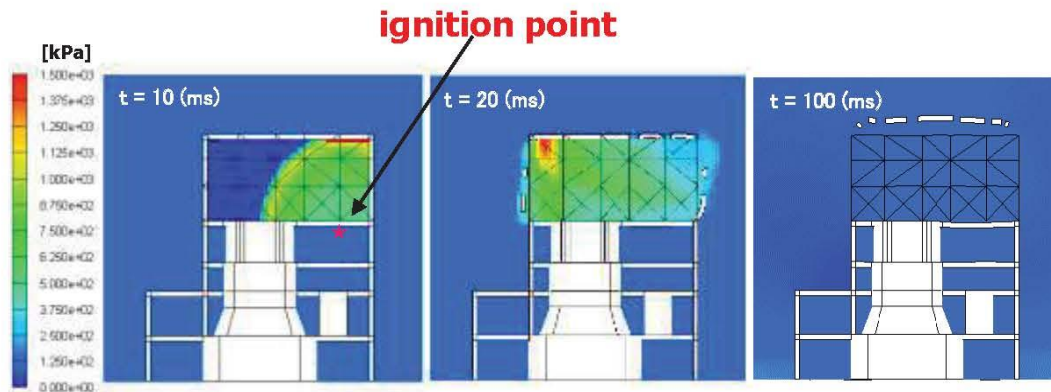
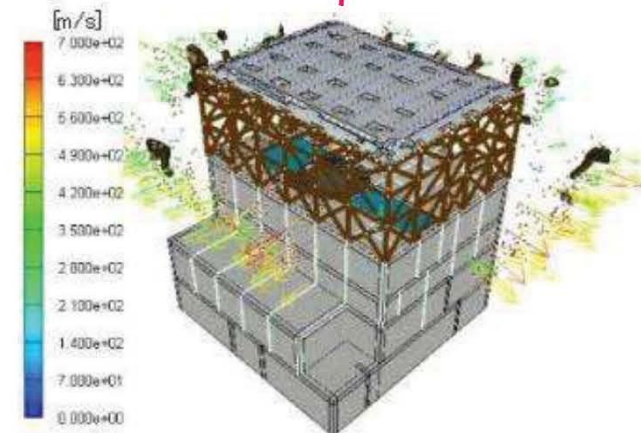
Propagation of detonation pressure in Unit 1

Detonation analysis with AUTODYN

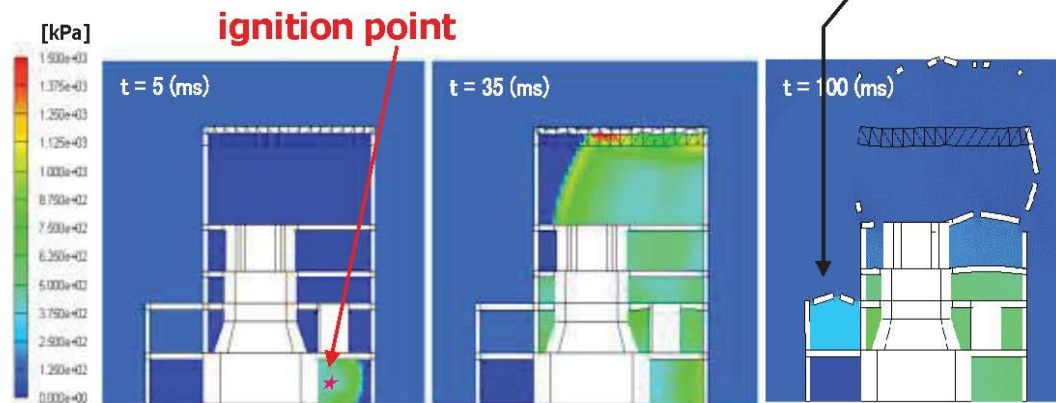
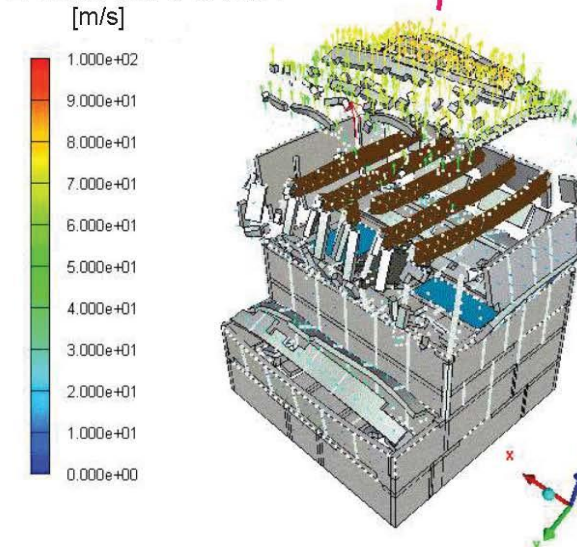
Potential location of leakage: device hatch

Propagation of detonation pressure in Unit 3

Detonation analysis with AUTODYN

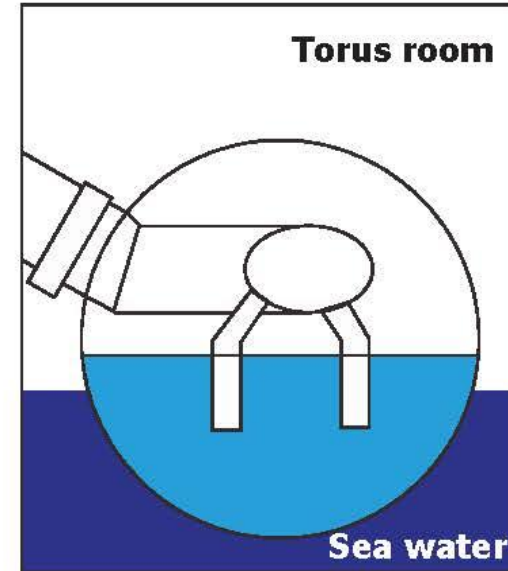
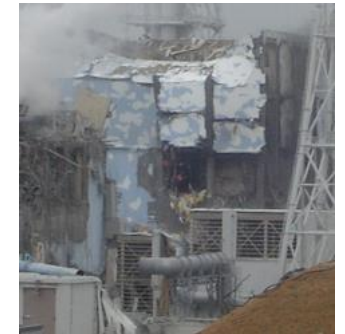
- RCIC operation without DC power.
 - Two phase fluid flew into RCIC turbine that reduced the RCIC flow rate.
- Slow pressurization rate of PCV
 - Possibility of heat removal from S/P by seawater flooded in the torus room.
- A large PCV leakage is assumed to occur in the morning on March 15
 - Based on observed D/W pressure
 - Explosion sound was not from unit 2 but from unit 4, which was confirmed through the analysis of vibration using seismometers by TEPCO*

Pressure indicator Unit 2 S/C 0MPA[abs]

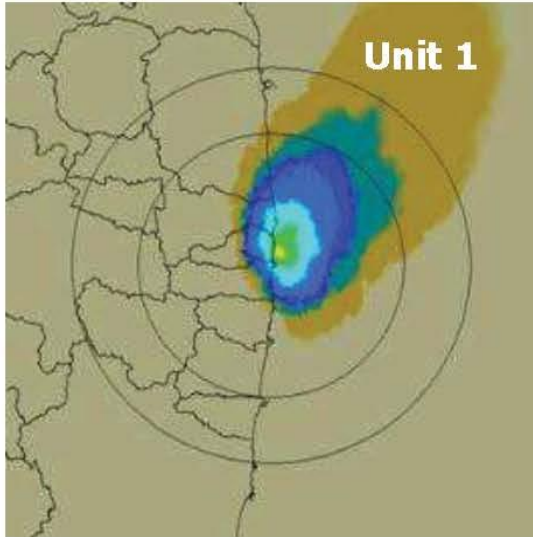
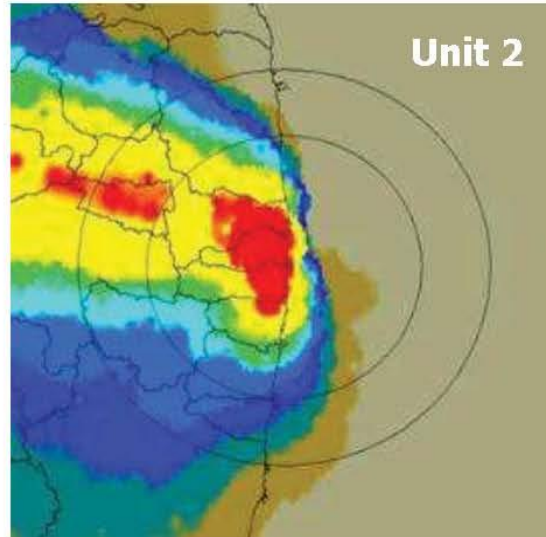
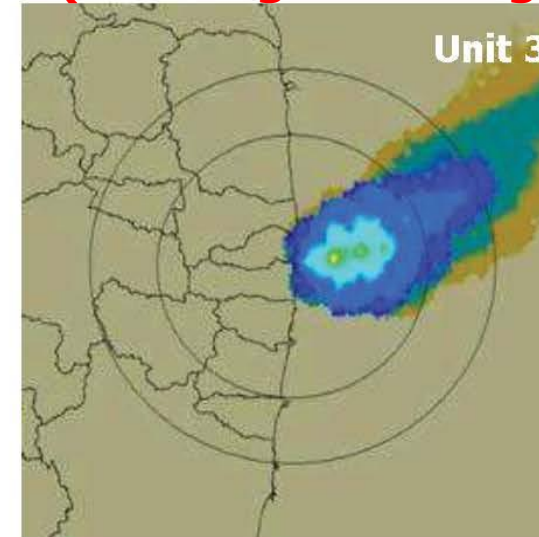
Environmental Consequence Analysis

by JAEA/JNES **largest release from Unit 2 (building undamaged)**
